National Transportation Safety Board

Marine Accident Brief

Flooding and Sinking of Fishing Vessel *Ambition*

Accident no.	DCA16FM045
Vessel name	<i>Ambition</i>
Accident type	Flooding and sinking
Location	Bering Sea, 19 nautical miles north-northeast of False Pass, Alaska 55° 09.2 N, 163° 16.3 W
Date	July 23, 2016
Time	2209 Alaska daylight time (coordinated universal time – 8 hours)
Injuries	None
Property damage	\$700,000 est.
Environmental damage	A light sheen was observed in the days after the sinking near the vessel's last known position, and a diver later saw 4–5 drops of oil per minute rising to the surface. 2,500 gallons of diesel (mostly recovered), 55 gallons of hydraulic oil, and 250 gallons of gasoline were on board the vessel when it sank.
Weather	Overcast with visibility 3 miles, winds west at 25 knots, air temperature 52°F, water temperature about 50°F, seas 10 feet.
Waterway information	The Bering Sea is north of the Alaska Peninsula and the Aleutian Islands, which form an island chain in the north Pacific Ocean.

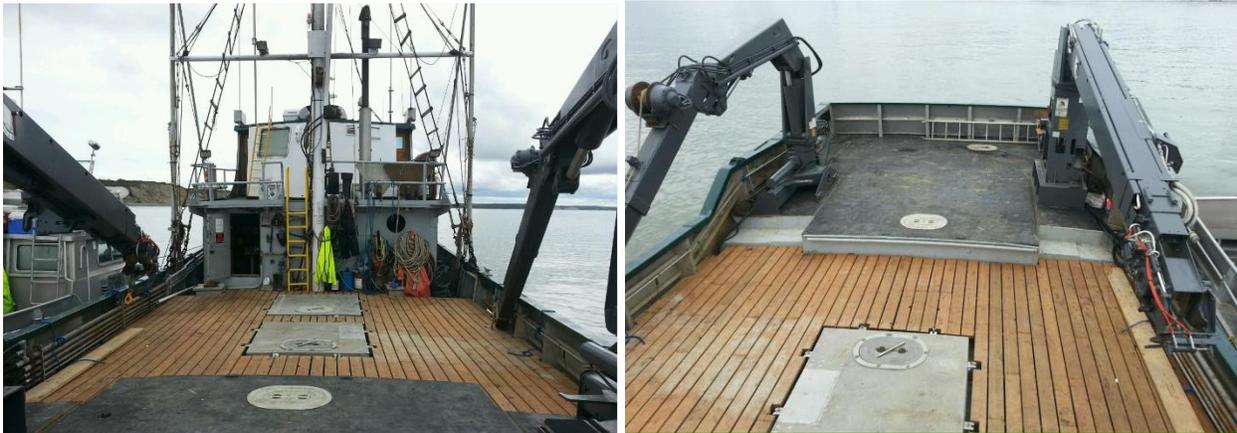
At left is the aft main deck of the *Ambition*, viewed from the stern, showing rectangular bolted hatches for the forward and aft fish holds with access hatches inset. At right is the aft deck, viewed from the deckhouse, showing access hatches to the lazarette and potable-water tank.

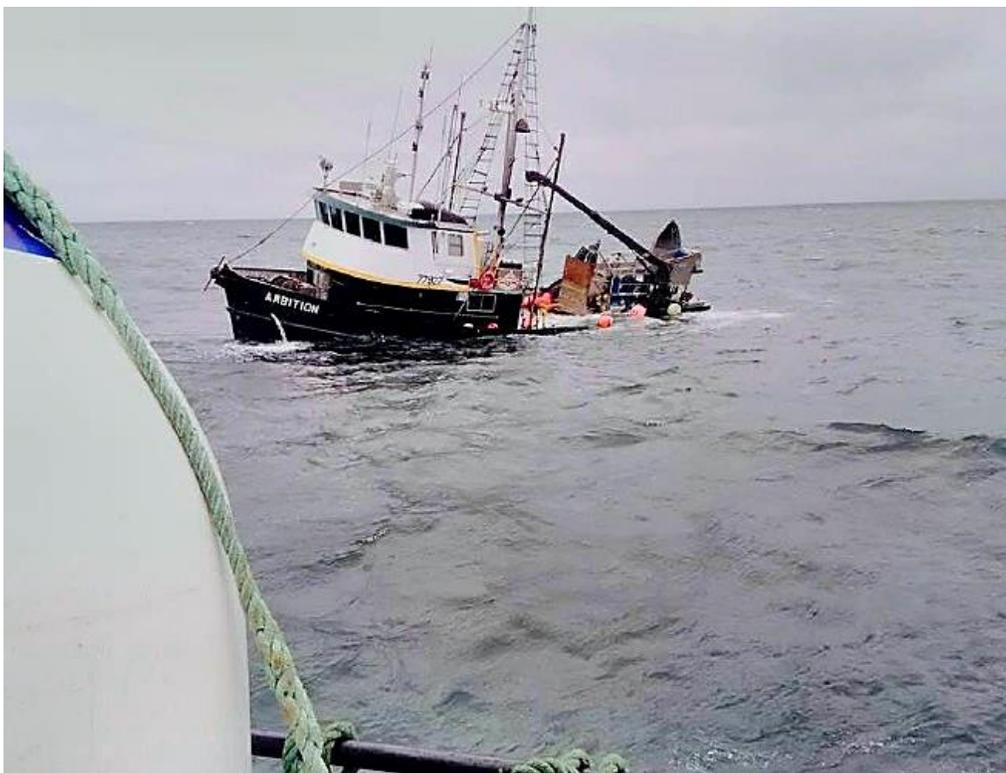
Photo of partially submerged *Ambition* taken from *Star Watcher* deck. (Photo courtesy of M. Potter)

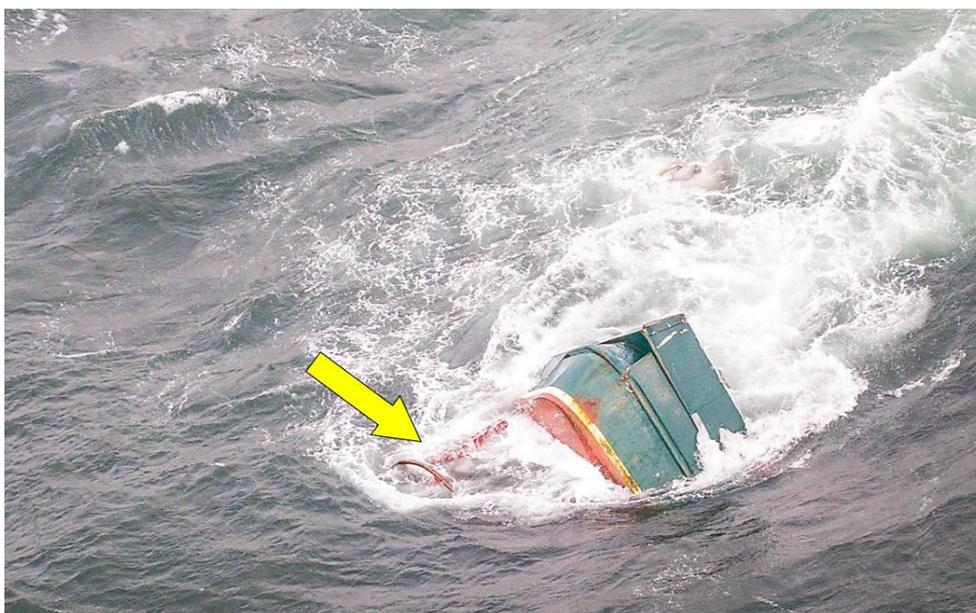
Starboard aft quarter of the *Ambition* prior to final sinking. Arrow shows part of net guard installed to protect the propeller and rudder. (Photo by Coast Guard)

A postaccident overflight photograph (included earlier in this brief) showed struts and bars that were part of the propeller net guard. The vertical strut was fixed to the underwater portion of the hull plate beneath the lazarette at the transom, and other structure supporting the guard was likely attached to the hull forward (no pictures of the guard were able to be obtained). If the guard had contacted the ground, drifting debris (such as a log), or other objects, the weld points where the struts were attached to the hull may have been subject to cracking. Such cracking could have been the source of flooding during the accident voyage. Although the crew did not report a grounding or contact with an object, forces working on the guard over time may have also been transmitted and concentrated to the point of attachment to the hull. The original hull design did not incorporate a guard and investigators found no evidence that engineering work was procured to assess the design.
