National Transportation Safety Board

Marine Accident Brief

Allision of Tanker *Aframax River* with Mooring Dolphins, and Subsequent Fire in Waterway

Accident no.	DCA16FM055
Vessel name	<i>Aframax River</i>
Accident type	Allision and fire
Location	Deer Park, Texas, 29° 44.90 N, 95° 05.97 W
Date	September 6, 2016
Time	About 0005 central daylight time (coordinated universal time – 5 hours)
Injuries	Minor burns to the two onboard pilots
Property damage	\$1.5 million est.
Environmental damage	Release of 88,000 gallons of low-sulfur marine gas oil
Weather	Partly cloudy, visibility of 8 miles*, winds southeast at 4 knots, air temperature 86°F
Waterway information	Houston Ship Channel near the Intercontinental Terminals Company (ITC) facility. The terminal has five deep-draft tanker berths and ten barge docks located on the south side of the channel at the mouth of Tucker Bayou.

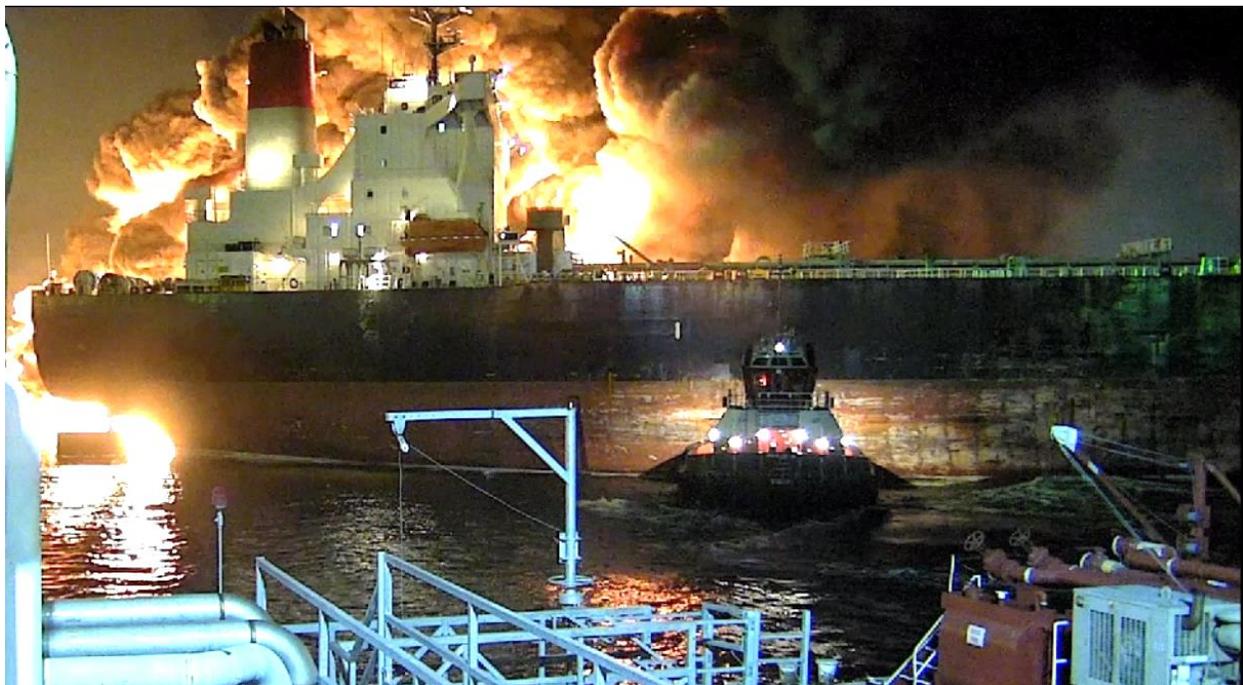
When an allision with the mooring dolphins was imminent, the master ordered the deck crew to stand clear of the stern of the vessel and brace for impact. At 0005, the port side of the *Aframax River* struck the first ITC dolphin, no. 78A, at 3.2 knots. Within seconds of that impact, the tanker's port quarter struck the second ITC dolphin, no. 78B. The second allision tore an approximately 30-foot-long opening on the ship's port quarter hull plating at frame 26, about 8 feet above the waterline near the centerline of the no. 2 fuel oil tank. Marine gas oil (MGO) immediately began pouring out of the hull opening. As the tanker continued aft, its hull plating was further cut and deformed inward by contact with the mooring dolphins. The friction and the cutting of the hull plating generated heat, which ignited the MGO and triggered a large fire with thick, black, bellowing smoke that engulfed the ship's port quarter and the adjacent main deck, all the way up and past the port bridge wing. The general alarm was sounded.

Aframax River after the allision with dolphin no. 78B. Tractor tugboat *David B* is in the foreground rendering assistance. (Image courtesy of ITC City Dock security video)

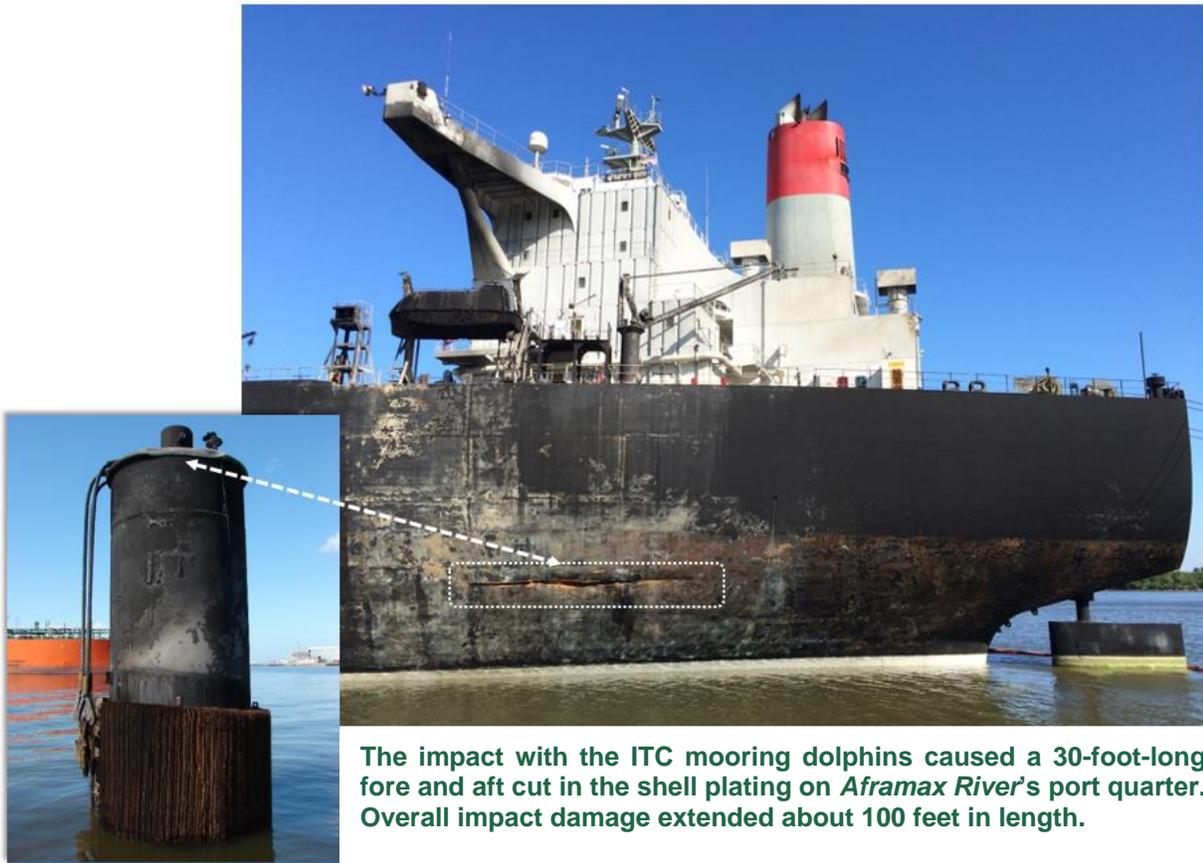
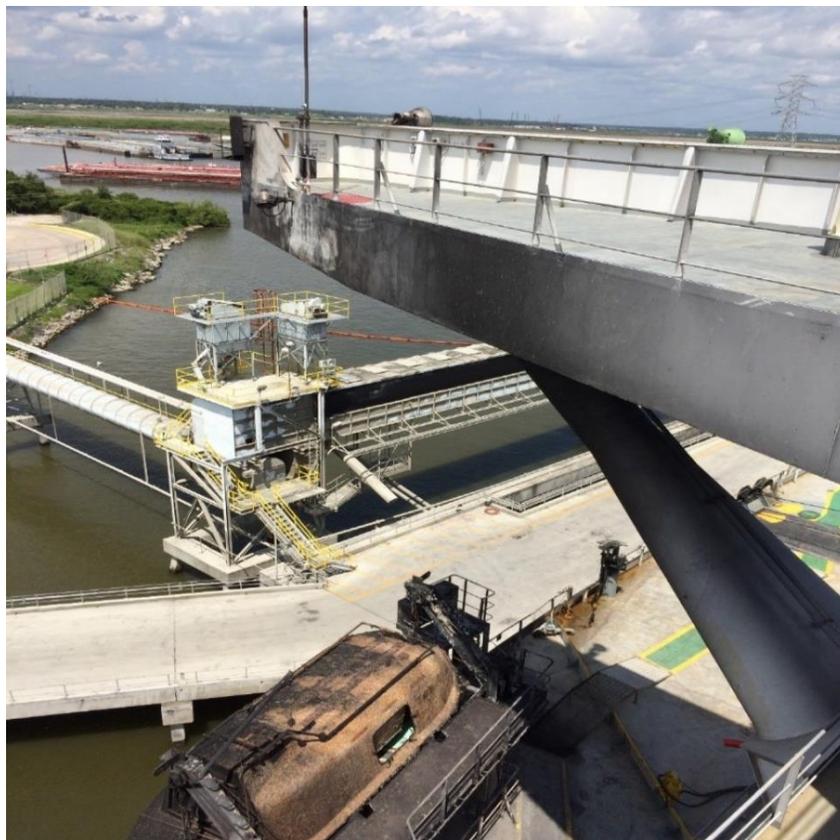
The *Aframax River* crew conducted soundings on all of the tanks to determine the extent of damage to the hull. As a result of the breach in the no. 2 fuel oil tank, about 88,000 gallons of MGO spilled into the waterway. The fire severely damaged the portside lifeboat and davit system, two liferafts, the port crane at frame 27, and an embarkation ladder. Damage extended about 100 feet along the portside hull between frames 24 and 41. Several of the tugboats involved in the response effort also sustained damage to their equipment.

Fire damage to *Aframax River*'s portside bridge wing (where the conning pilot was standing when the fire erupted), lifeboat, and main deck.

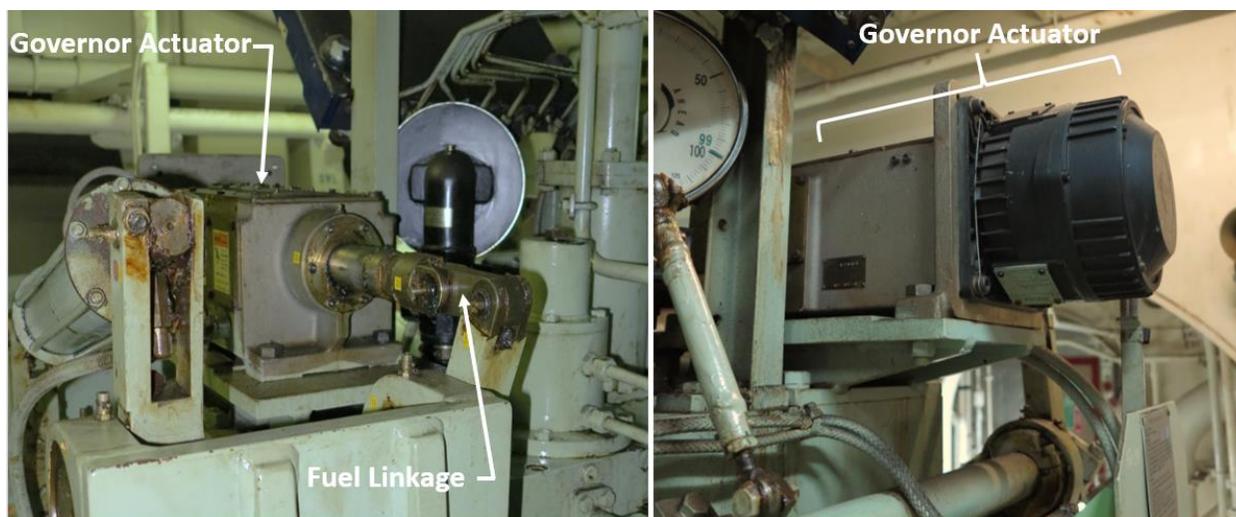
The Diesel United - Sulzer Type 7RTAC2 is a single-acting, slow-speed, two-stroke, reversible marine diesel engine. The engine was directly connected to the propeller, and the engine was designed to come to a complete stop when changing propeller direction from astern to ahead. In the presence of investigators and ClassNK surveyors, technicians from Diesel United, Ltd. inspected and tested the mechanical components of the governor input, fuel control linkage, and other related components. All items were determined to be in good working order.

Front and back of the main engine governor actuator and mechanical fuel linkage.

According to the manufacturer's technicians, the governor's actuator system experienced a momentary abnormality. Investigators believe that the abnormality likely resulted from an electrical and/or mechanical failure of the system, which led to loss of engine control while the vessel was engaged in astern propulsion.

The National Transportation Safety Board determines that the probable cause of the *Aframax River*'s allision with mooring dolphins and the subsequent fire in the waterway was a momentary abnormality of the tanker's main engine governor actuator system in responding to command inputs from the bridge.
