# National Transportation Safety Board

## Marine Accident Brief

### Fire on board Vehicle Carrier *Honor*

<b>Accident no.</b>	DCA17RM007
<b>Vessel names</b>	<i>Honor</i>
<b>Accident type</b>	Fire
<b>Location</b>	Westbound traffic separation scheme in the English Channel, about 55 miles* southwest of the Isle of Wight, United Kingdom, 50° 01.7' N, 002° 35.7' W
<b>Date</b>	February 24, 2017
<b>Time</b>	0302 Greenwich mean time (coordinated universal time)
<b>Injuries</b>	1
<b>Damage</b>	\$699,414 est. for vessel damage
<b>Environmental damage</b>	None
<b>Weather</b>	Visibility unrestricted at night, winds northeast at 30 knots
<b>Waterway information</b>	The English Channel is one of the busiest waterways in the world, providing access to some of western Europe's largest ports.

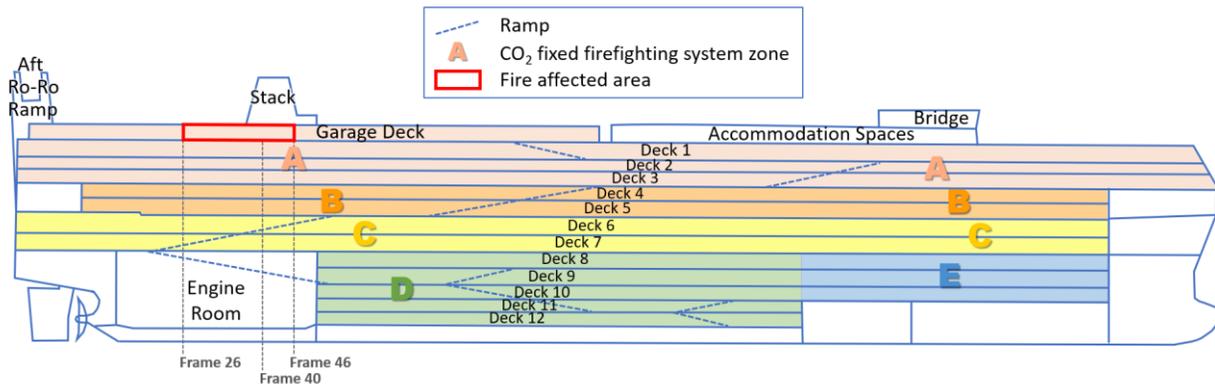
**Simplified diagram of *Honor*'s cargo decks and zones for CO<sub>2</sub> fixed firefighting system.**

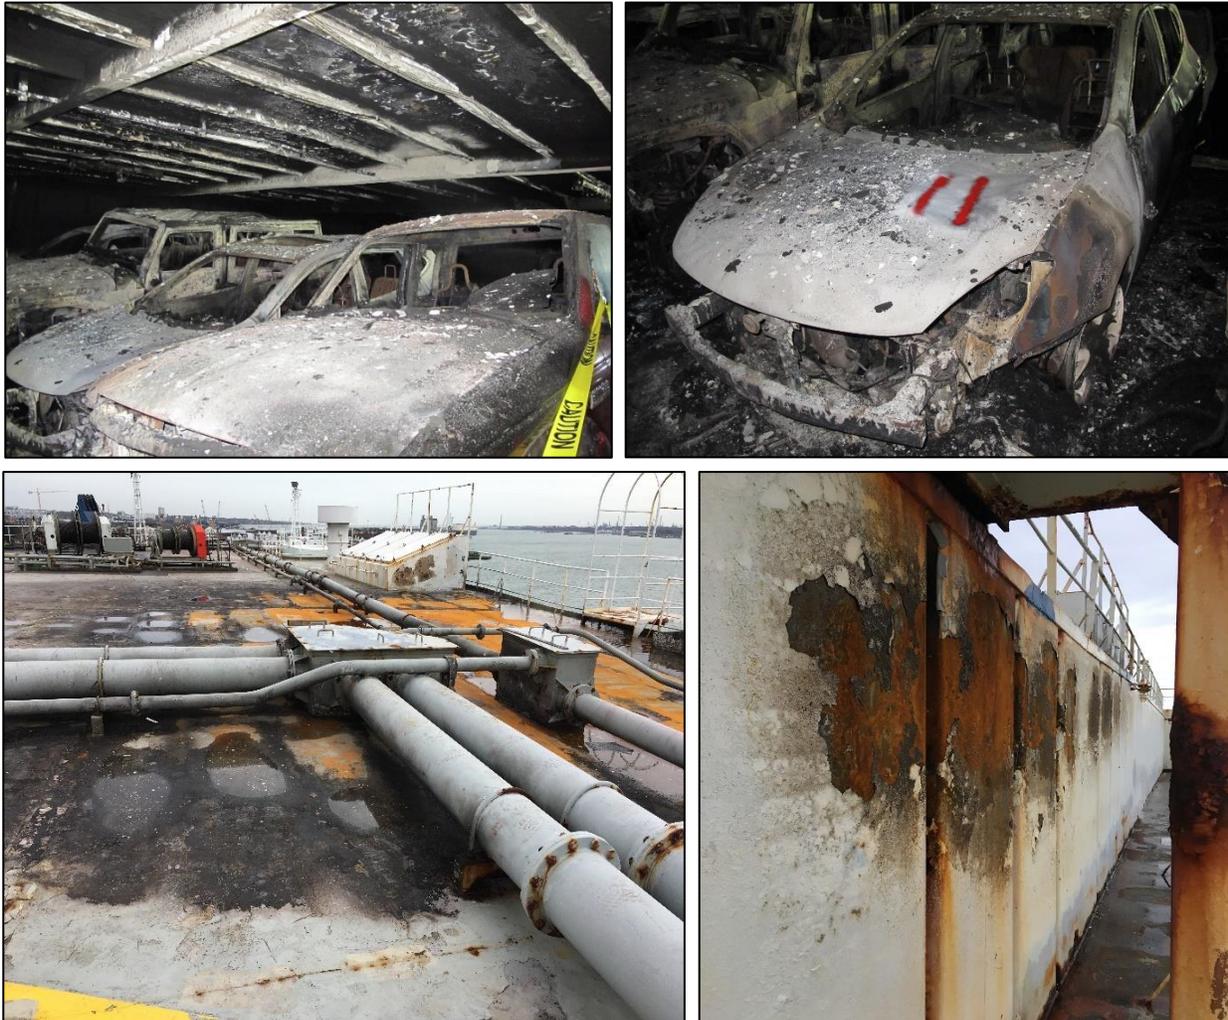
**At top, damaged cars on the garage deck. At bottom from left to right, damage to the top deck above the garage and the exterior bulkhead on the port side of the garage while looking aft.**

Fire investigators examined the affected spaces and identified the likely origin to be about frame 40 port side on the garage deck (see illustration on page 2). There was substantial damage to the deck from frames 22 to 46, and several of the vehicles on this deck were destroyed by fire. These vehicles were all personally owned cars and sport utility vehicles that were being shipped back to the United States. In addition, several new vehicles (that were being shipped to US car

dealerships) located on the deck below (deck 1) sustained fire-related damage. A ventilation duct located at frame 40 port side allowed flaming debris to fall on to the vehicles below.

Sixteen of the personally owned vehicles sustained fire damage significant enough to warrant further examination. On May 15, 2017, fire investigators recovered and performed an initial visual examination of the vehicles along with a damaged section of the vessel's wiring. Evidence of interest removed from several vehicles, along with the damaged wiring, was taken to a third-party laboratory for examination. A joint forensic examination of the evidence was conducted in September 2017. Investigators found that there were three vehicles that were subject to open recalls for fires; however, following an analysis of the debris, none of the recall items were determined to be the cause of the fire. Rather, investigators identified the likely cause of the fire was a fault in the starter motor solenoid in one of the personally owned vehicles in shipment. Preliminary testing of this scenario confirmed that a fault within the solenoid could cause ignition of the insulation and covering on the adjacent wiring.

The National Transportation Safety Board determines that the probable cause of the fire on board the vehicle carrier *Honor* was a fault in the starter motor solenoid in one of the personally owned vehicles being transported in the vessel's cargo space.
