# National Transportation Safety Board

## Marine Accident Brief

### Fire aboard Vehicle Carrier *Alliance St. Louis*

<b>Accident no.</b>	DCA17FM005
<b>Vessel name</b>	<i>Alliance St. Louis</i>
<b>Accident type</b>	Fire
<b>Location</b>	Gulf of Mexico, about 190 miles south of New Orleans, Louisiana 26° 35' N, 089° 23.9' W
<b>Date</b>	January 16, 2017
<b>Time</b>	About 0252 central standard time (coordinated universal time – 6 hours)
<b>Injuries</b>	None reported
<b>Property damage</b>	>\$3,750,000 est.
<b>Environmental damage</b>	None reported
<b>Weather</b>	Partly cloudy, visibility 8 miles; winds southeast at 4 knots, air temperature 65°F; calm seas
<b>Waterway information</b>	Open waters of the Gulf of Mexico along the outer continental shelf, water depth about 7,000 ft.

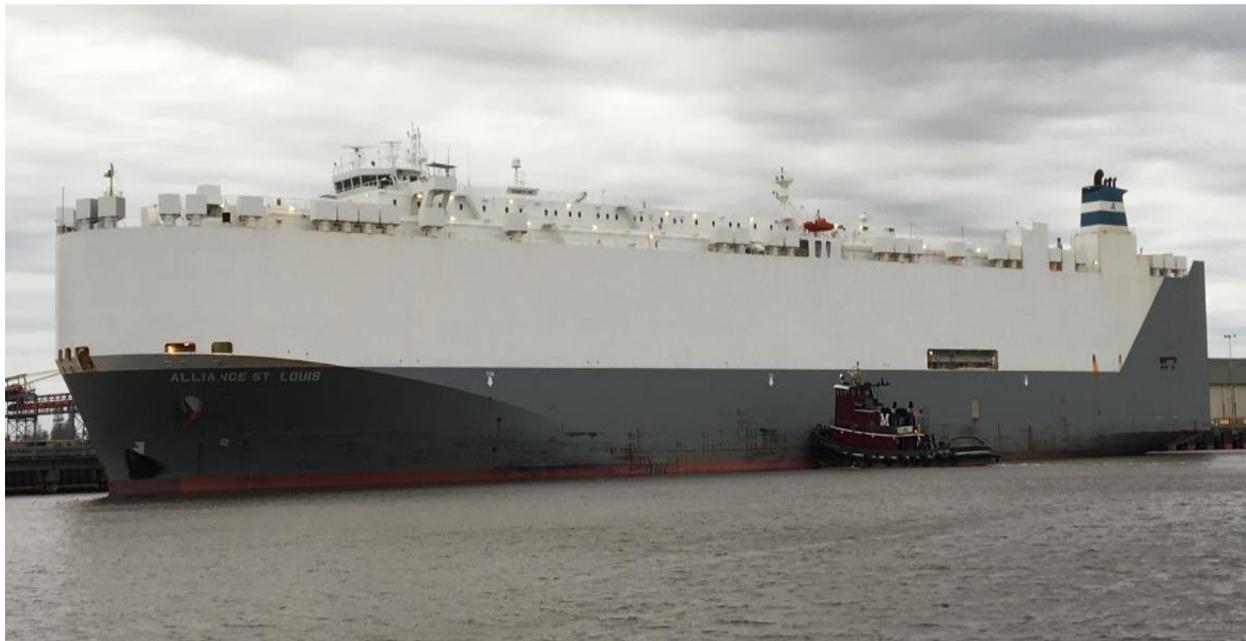
***Alliance St. Louis* pierside in Port Arthur, Texas, undergoing repair after the fire.**

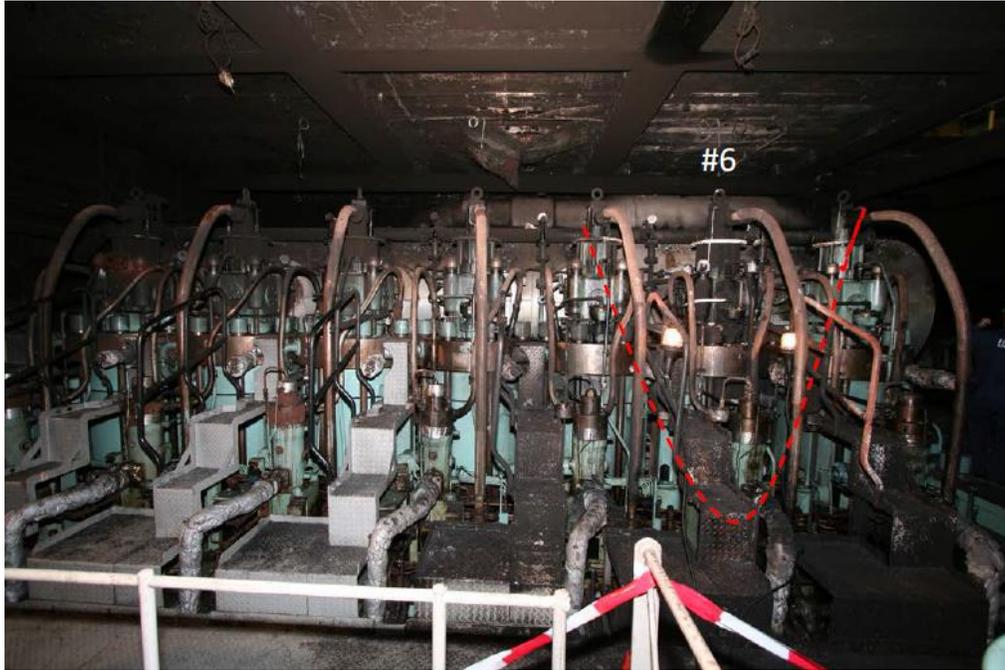
The photograph below shows the concentrated thermal damage (highlighted by the red dotted line) near the no. 6 cylinder. Thermal damage extended forward to cylinder no. 5 and aft to cylinder no. 7. Most of the fire damage was located on the engine room's 1st platform level and along the overhead and included charred paint, melted gauge faces, and melted aluminum components. On the engine room floor level, a stain from a liquid spill was found. This general

area was also heavily covered in soot and coated with an oily residue (see NTSB’s fire factual report for a detailed description of the fire damage).<sup>1</sup>

**View of the entire cylinder head bank, showing concentrated thermal damage and staining centered around the no. 6 cylinder.**

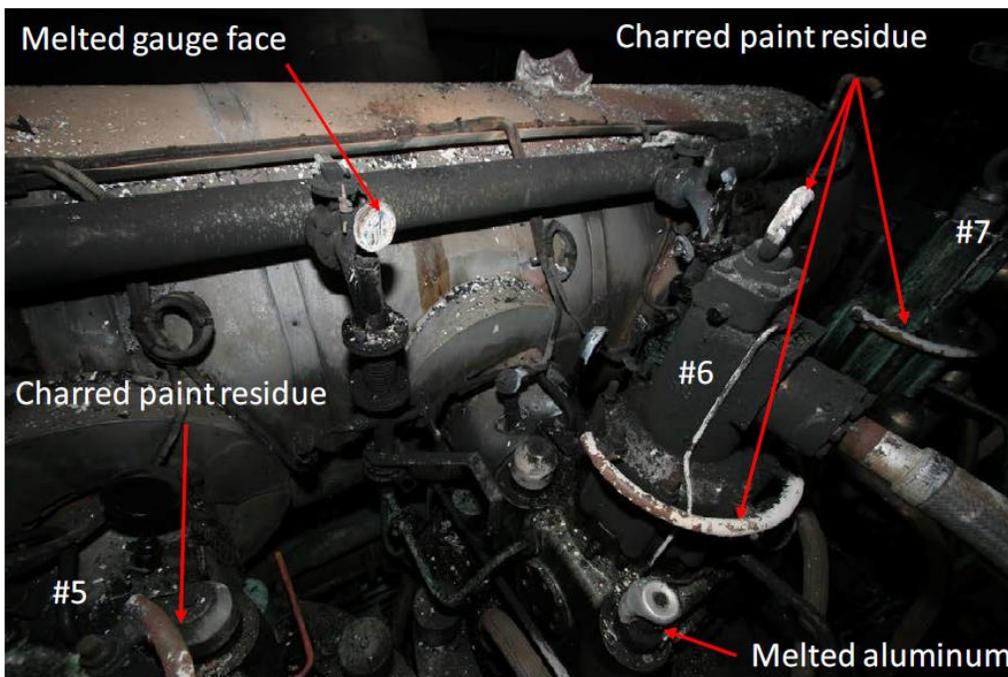
**Thermal damage, including charred paint, melted gauge faces, and melted aluminum components.**

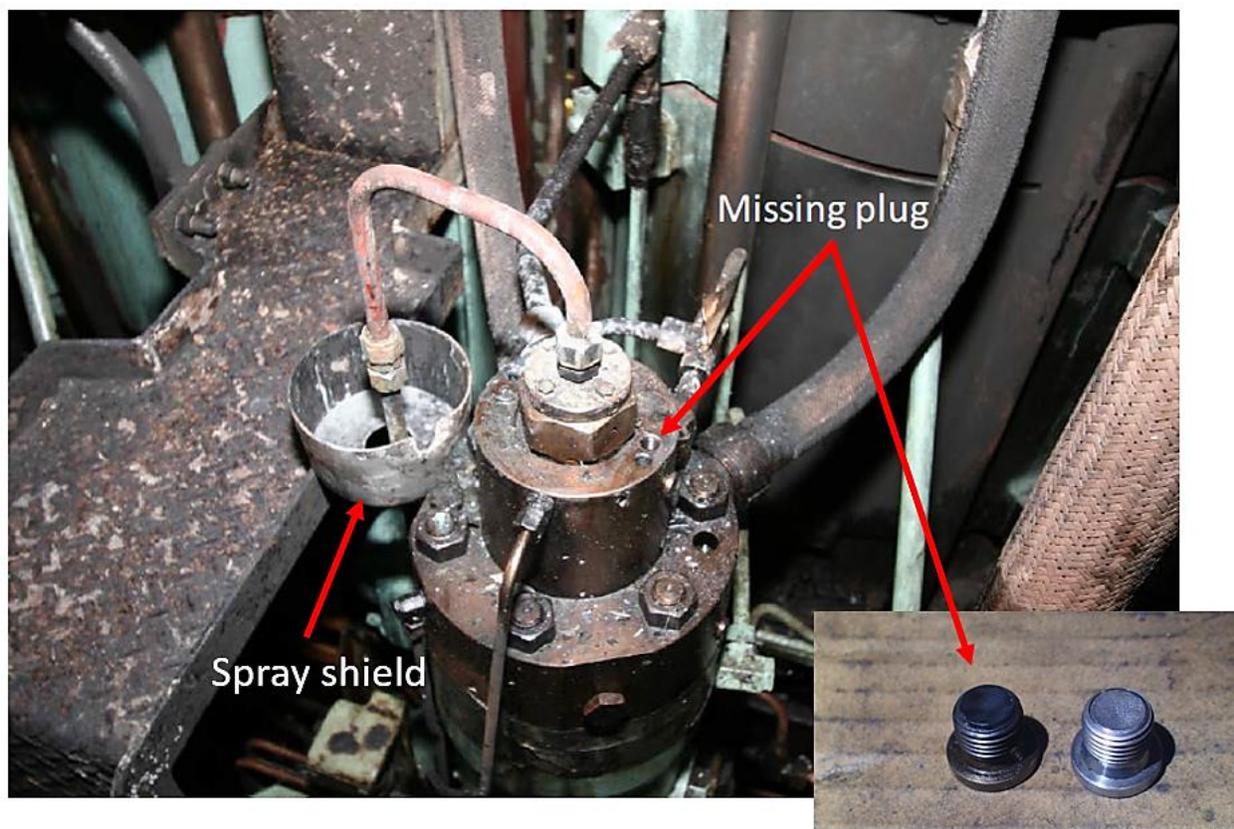
During the postaccident examination, the chief engineer discovered the fuel pump's displaced aft pipe plug in the engine's catch-all area (an area around the base of the no. 6 cylinder). Investigators compared the aft pipe plug to an unused pipe plug and found them to be identical. None of the threads on the aft pipe plug were found to be damaged, nor was the plug itself deformed.

The pipe plug was likely not sufficiently torqued into the top cover during the last inspection because the crew did not recognize this as a crucial step in maintaining the reliability of the fuel oil system. The instruction book's section *Overhaul of Top Cover Complete* contributed to the crew's lack of awareness about this hazardous situation because it did not depict the fuel oil return passages or describe the purpose of the pipe plugs.

The engineers on board the *Alliance St. Louis* had never previously experienced a situation where a pipe plug vibrated out of a pump's top cover. The aft pipe plug on the no. 6 cylinder fuel pump top cover likely loosened over time due to normal main engine vibration, fuel oil pressure acting on the plug, and switching of fuels. The missing pipe plug would have provided a path for MGO to spray out of the top cover at an approximate pressure of 7–8 bars (101–116 psi). Several engineering crewmembers stated in their interviews that they had experienced an increased number of fuel oil system leaks and seepages from gaskets, flanges, seals, o-rings, and other fittings due to thermal expansion or contraction of the components and material when changing from heated heavy fuel oil to ambient and sometimes cooled MGO.

Fuel pump housing and top cover for the no. 6 cylinder, with missing pipe plug. The lower-right image shows the dislodged pipe plug (left) next to a new unused plug.

The National Transportation Safety Board determines that the probable cause of the engine room fire aboard the *Alliance St. Louis* was improper tightening of a pipe plug on the top cover of the no. 6 cylinder fuel pump housing, which resulted in a high-pressure release of marine gas oil. Contributing to the fire was the improper attachment of a fuel spray shield to the top cover, which allowed fuel to spray directly onto the cylinder's hot exhaust pipe and ignite.

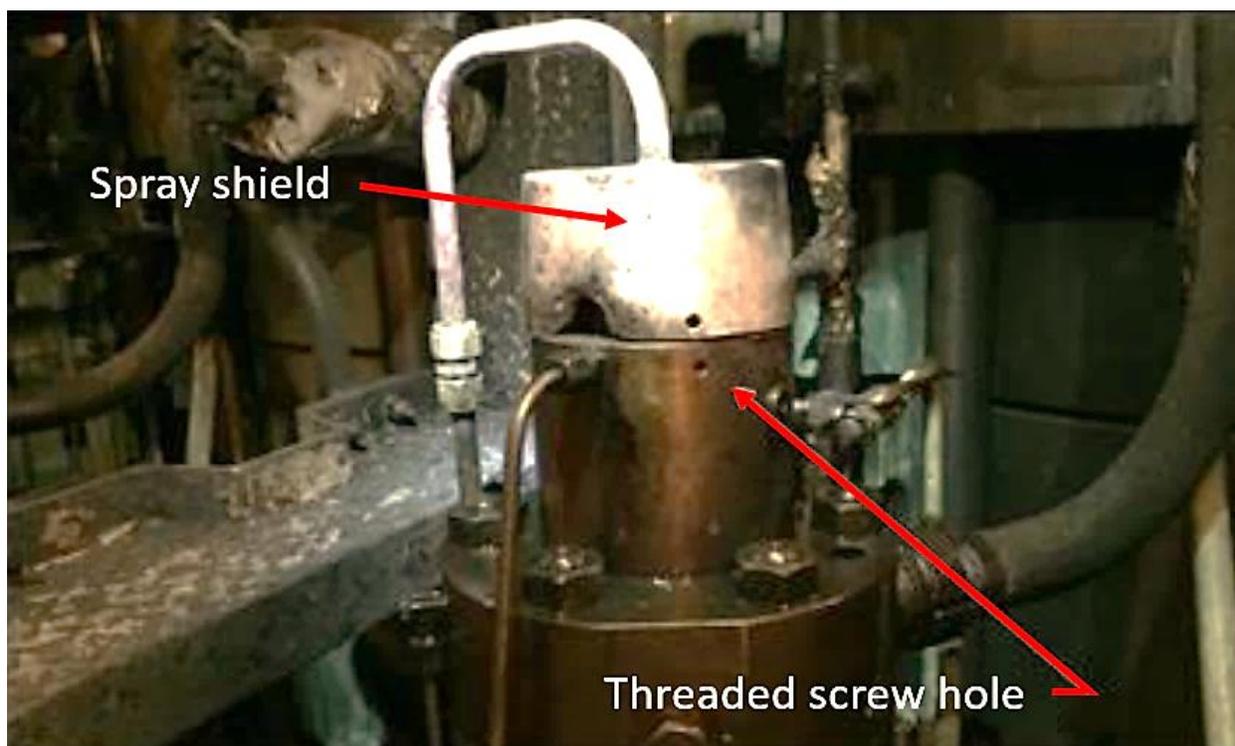
Spray shields are used to prevent fuel sprays and leaks from contacting hot surfaces and other sources of ignition. The last step of the top cover overhaul procedures stated, “mount the protective cap (spray shield) over the puncture valve, three drain oil pipes, return oil pipe, air pipe and safety system on the top cover.” There were openings for screwing spray shields to the top covers. However, none of the ship’s spray shields were screwed to their top cover. The spray shield on the no. 6 cylinder’s top cover was found hanging off the air pipe next to the pump housing during the postaccident inspection. It was likely knocked off the top cover by the pipe plug and spraying MGO because it was not properly secured with two screws. A properly secured spray shield (per the manufacturer’s instruction manual) would have kept the MGO from spraying directly into the air and contacting the no. 6 cylinder exhaust gas pipe/receiver. Instead, the MGO would have sprayed into the shield and run down the fuel pump housing to the decks below where there were fewer, if any, potential sources of ignition.

**Inboard view of the no. 6 cylinder fuel pump and top cover postaccident, with the spray shield slightly elevated to illustrate alignment of fastener holes.**
