National Transportation Safety Board

Marine Accident Brief

Collision and Sinking of Towing Vessel *Todd Brown*

Accident no.	DCA17FM010
Vessel name	<i>Todd Brown</i>
Accident type	Collision and sinking
Location	Lower Mississippi River, mile marker 940, near Columbus, Kentucky 36°48.6' N, 89°08.6' W
Date	April 17, 2017
Time	1530 central daylight time (coordinated universal time – 5 hours)
Injuries	None reported
Property damage	\$1.5 million est.
Environmental damage	Approximately 100 gallons of diesel fuel (recovered during salvage operations)
Weather	Cloudy, winds north-northwest about 5 knots, air temperature 64°F
Waterway information	The accident occurred on the Lower Mississippi River about 20 miles south of the confluence with the Ohio River. At the time, the river gauge was about 36 feet (major flood stage) and the current flowing downstream was estimated at 8 mph (7 knots).

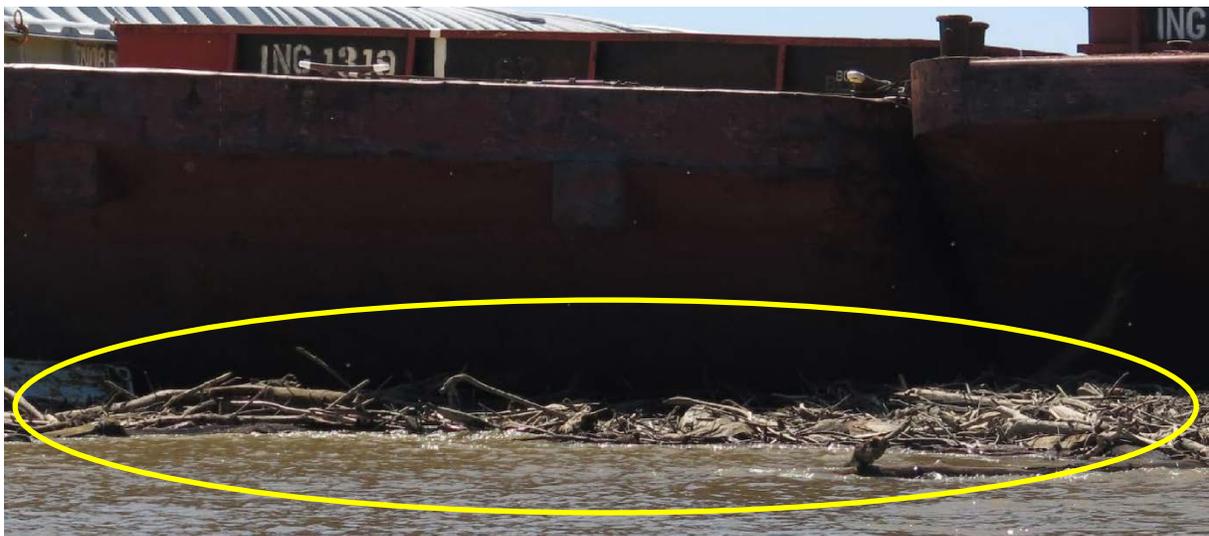
With the high water and increased current, debris such as tree trunks, limbs, and other accumulating litter collected from the shorelines and drifted downstream. A substantial amount of debris accumulated at the heads of the moored barge fleets due to the bends in the river. The barge fleets were secured by bridle and stern lines attached to large cement blocks buried in the ground on the river banks.

The accumulating debris led to an increased strain on the moorings, thus elevating the risk of the wires parting. In order to remove the debris, or “drift,” from the moored barges, fleet towboats such as the *Todd Brown* would perform “de-drifting” operations: maneuvered by one or more towboats, barges would be uncoupled from the remainder of the fleet and repositioned to allow the river current to flush the debris from their upstream end.

Accumulating debris (circled) under the rakes of fleeted barges.

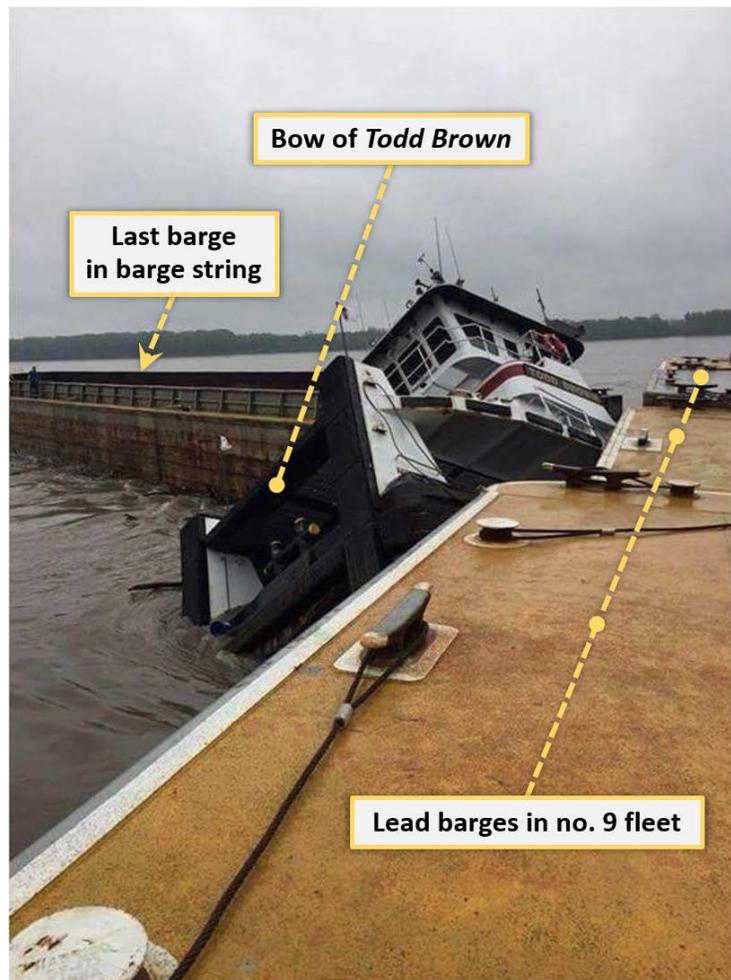
The barge string pinned the *Todd Brown*'s port side against the bow of one of the lead barges in the no. 9 fleet and the force of the river current pushed it under the barge's angled bow rake, causing the *Todd Brown* to list to starboard. After the pilot sounded the general alarm, the crew abandoned the vessel by climbing onto the moored barges. Swamped with water, the *Todd Brown* sank at about 1530 and came to rest in about 35 feet of water. The vessel was loaded with approximately 17,900 gallons of diesel fuel, along with 150 gallons of lube oil and 150 gallons of hydraulic fluid.

***Todd Brown*, listing to starboard, after striking the barges. (Photo by crewmember)**

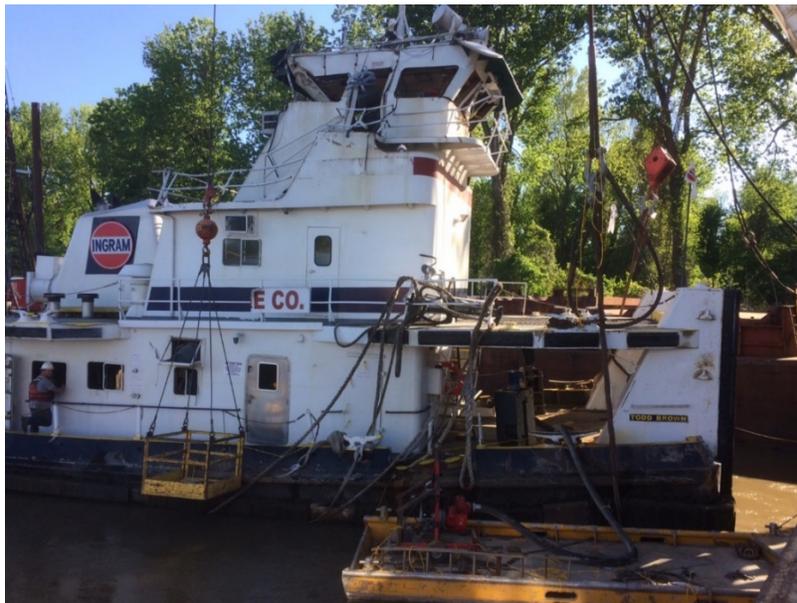
Five days later, on April 22, the *Todd Brown* was brought to the surface by a salvage team. A containment boom was deployed and captured approximately 100 gallons of diesel fuel that escaped from the vessel. After all the water was removed from interior

spaces, the vessel was refloated and drydocked for inspection. The hull was not damaged, but the wheelhouse structure was distorted, handrails and decks were bent, and all interior spaces were water-damaged, amounting to an estimated \$1.5 million in repairs. There was no damage to the *Ot Adkins* or to any of the barges in fleeting area nos. 8 and 9.

***Todd Brown* after being recovered to the surface on April 22. (Photo by Coast Guard)**
