National Transportation Safety Board

Marine Accident Brief

Capsizing and Sinking of Towing Vessel *Gracie Claire*

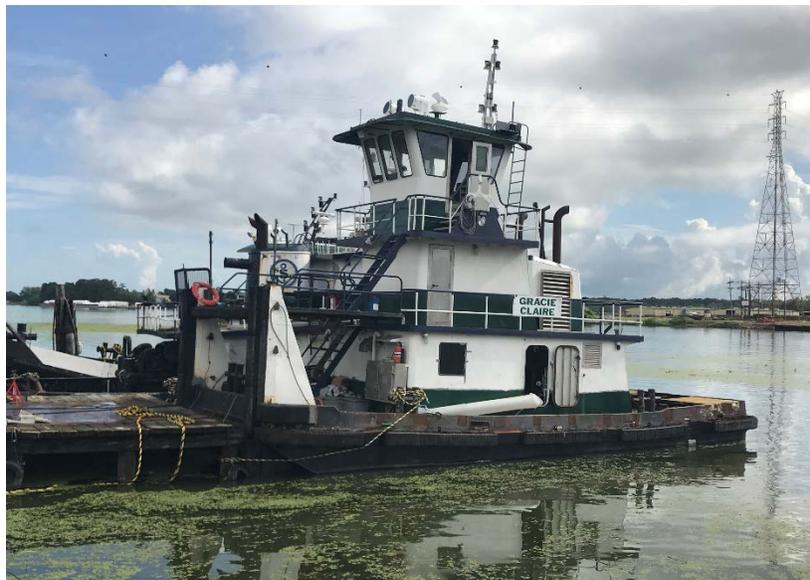
Gracie Claire moored for repair following sinking. (Courtesy of Triple S Marine)

The *Gracie Claire* was salvaged 2 days later. Due to the water damage, the owner refurbished or replaced machinery and equipment, including wiring, motors, electrical fixtures, and galley equipment. Additionally, the owner converted the rudder compartment into three separate compartments, each with access from the main deck, by installing two longitudinal watertight bulkheads.

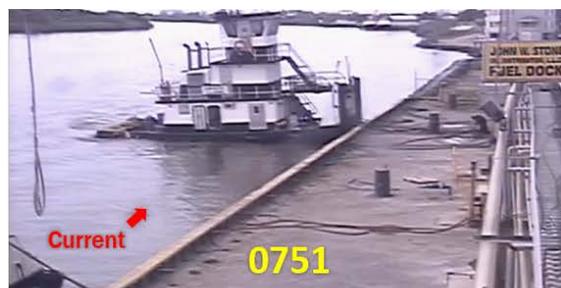
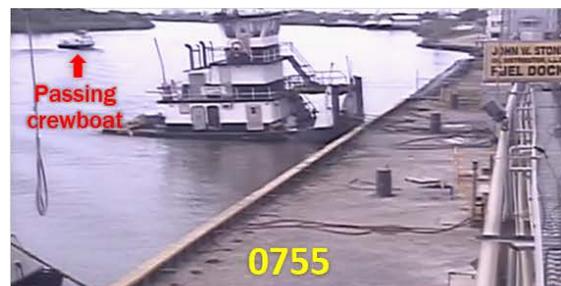
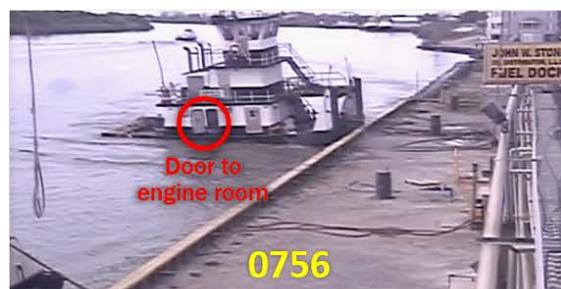
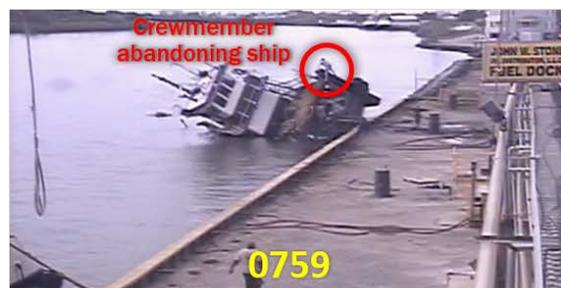
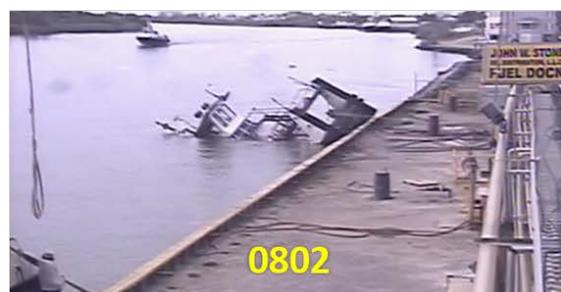
As loading continued, video captured by the camera on the dock shows a disturbance on the surface of the water at the stern of the *Gracie Claire*. The water motion indicated a current acting on the starboard side.

The video footage showed that at 0755 an unidentified crewboat was traveling in the middle of the channel. When the crewboat passed the *Gracie Claire*, its wake washed onto the starboard side of the towboat's stern. The towboat then slowly rolled to starboard as more of the starboard-side main deck became submerged. Within 90 seconds, water began flowing over the sill of the open engine room door on the starboard side. As the crew began evacuating to the dock, the *Gracie Claire* continued to roll until it was almost completely submerged at 0802. The mooring lines held the bow above the water's surface.

Screenshots of *Gracie Claire*, starting a minute after loading began through sinking, from video captured by southwest view of dock's camera. (Video courtesy of John W. Stone Oil Distributor)

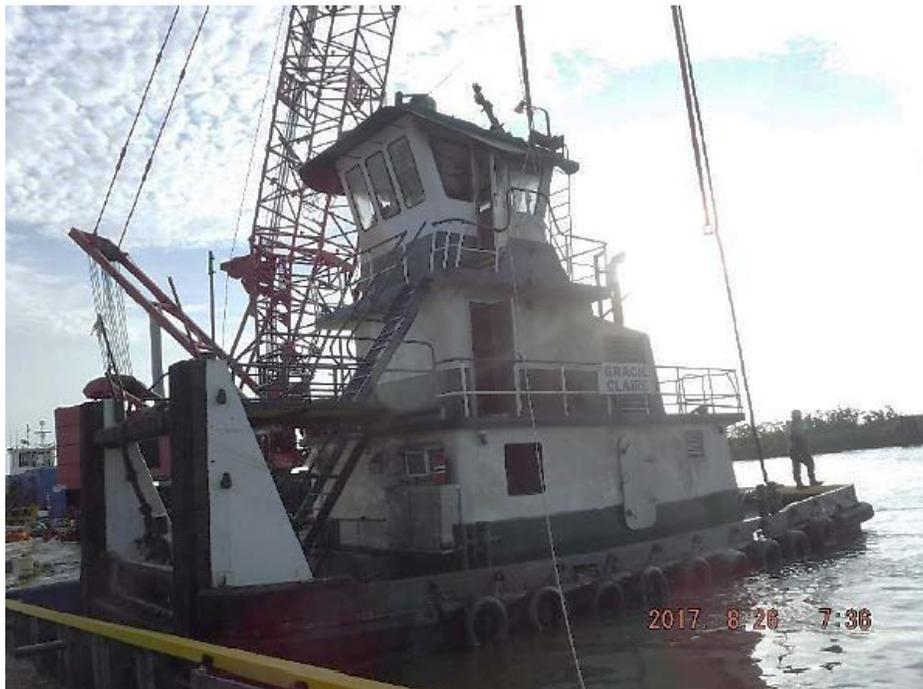
Gracie Claire during salvage. (Courtesy of Central Maritime)

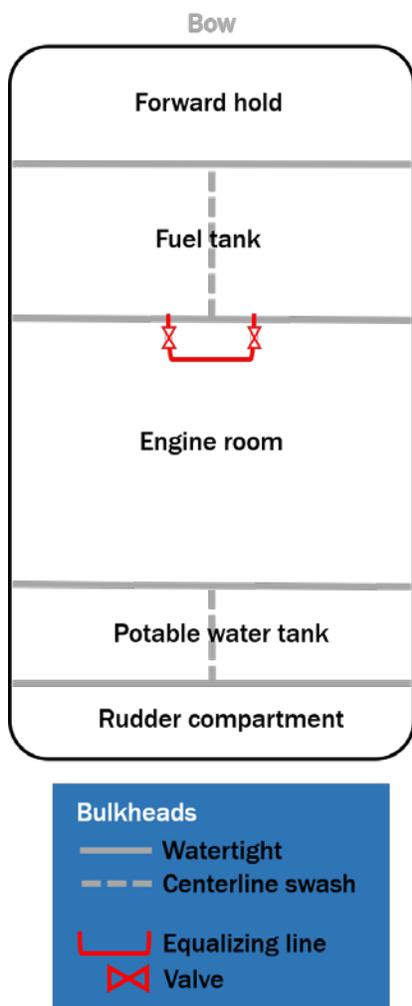
Beneath the main deck, four watertight bulkheads divided the hull into five compartments. In the fuel and water tanks, centerline swash bulkheads were installed to improve the towboat's stability by preventing the quick shift of the weight of fuel and water from one side to the other when the tanks were slack (not full). The first opening in these bulkheads was 24 inches above the bottom of the tank.

Plan view of *Gracie Claire's* hull, not drawn to scale. (Based on postaccident sketch by marine surveyor)

Following the accident, a damage assessment of the vessel during drydock revealed a 1-inch diameter hole in the bottom of the rudder compartment. The marine surveyor performing the assessment told investigators that the hole was likely present before fuel was loaded onto the towboat.
