# National Transportation Safety Board

## Marine Accident Brief

### Capsizing and Sinking of Fishing Vessel *Langley Douglas*

<b>Accident no.</b>	DCA17FM027
<b>Vessel name</b>	<i>Langley Douglas</i>
<b>Accident type</b>	Capsizing
<b>Location</b>	60 miles <sup>1</sup> east of Cape Charles, Virginia, 37°12.22' N, 074°31.41' W
<b>Date</b>	September 11, 2017
<b>Time</b>	1117 eastern daylight time (coordinated universal time – 4 hours)
<b>Injuries</b>	None
<b>Damage</b>	Loss of vessel, \$1.95 million est.
<b>Environmental damage</b>	No pollution reported; 6,000 gallons of diesel fuel and 700 gallons of hydraulic and lube oil on board; some floating debris noted near the site of the sinking
<b>Weather</b>	Clear, visibility 8 miles, winds northeast at 20 mph, 6–8-foot seas, air temperature 73°F, water temperature 70°F
<b>Waterway information</b>	Atlantic Ocean along the edge of the continental shelf just north of the Norfolk Canyon, depth 850–900 feet.

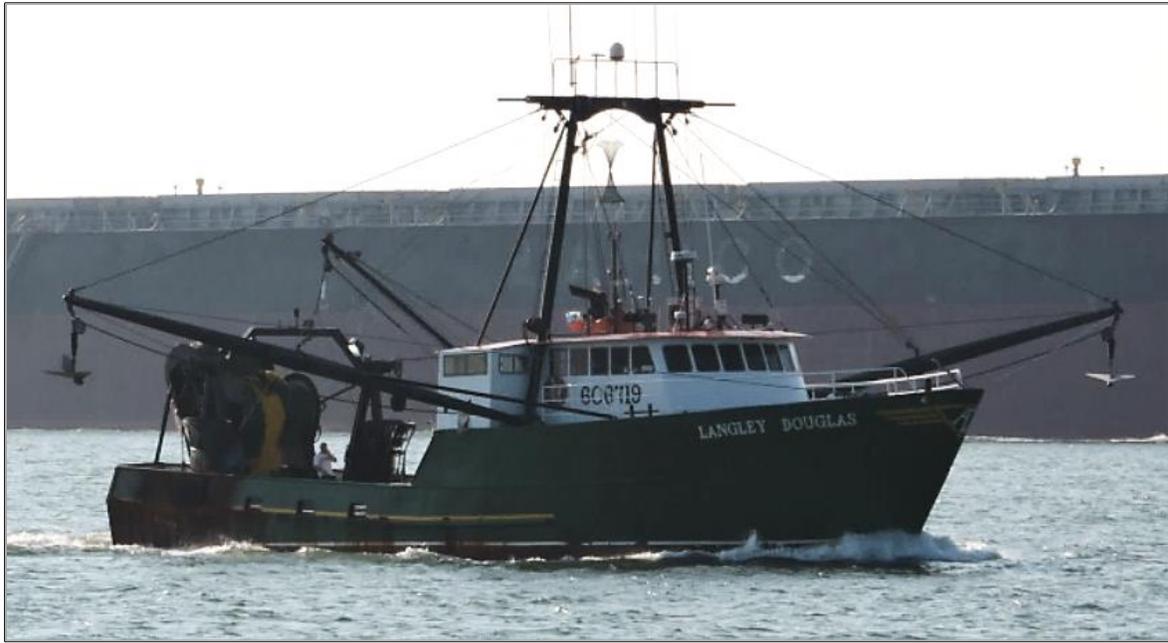
**Langley Douglas** with its outriggers extended and paravanes stowed at the end of the outriggers. (Photo courtesy of Steven Collingwood)

6. The captain stated that he raised the portside paravane out of the water in an effort to counteract the list of the vessel; however, it is unlikely that doing so had any noticeable impact on vessel stability. Paravanes rely on a combination of forward speed, surface area, rolling, and length of the boom to resist or dampen rolling. If the vessel is actively rolling to port, the starboard paravane will resist the roll. The paravanes are generally tuned to minimize resistance and therefore are lightly loaded (and impart minimal moment on the vessel) if the vessel is not rolling. The benefit of lifting the paravane would be that rolls to starboard had less resistance. Also, elevating the port paravane likely did not significantly degrade stability.

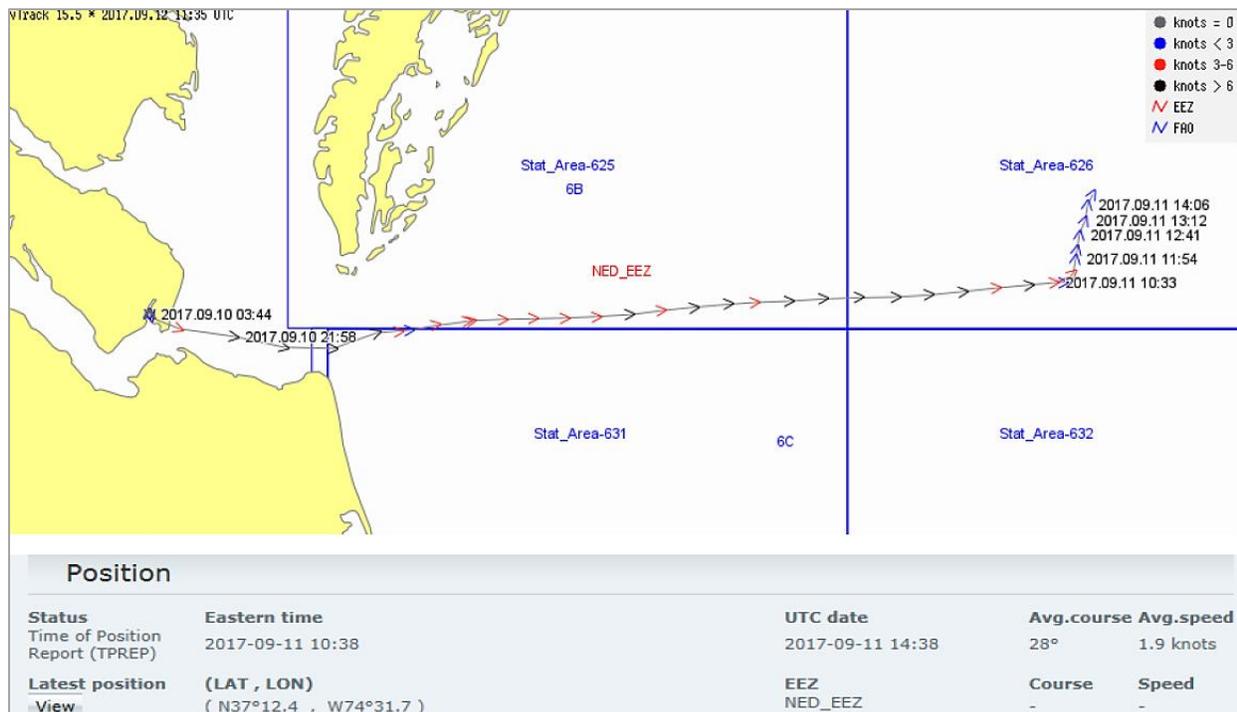
The *Langley Douglas* trackline and heading on the day of the sinking. (Screenshot courtesy of NOAA Fisheries Atlantic Region Vessel Monitoring System)

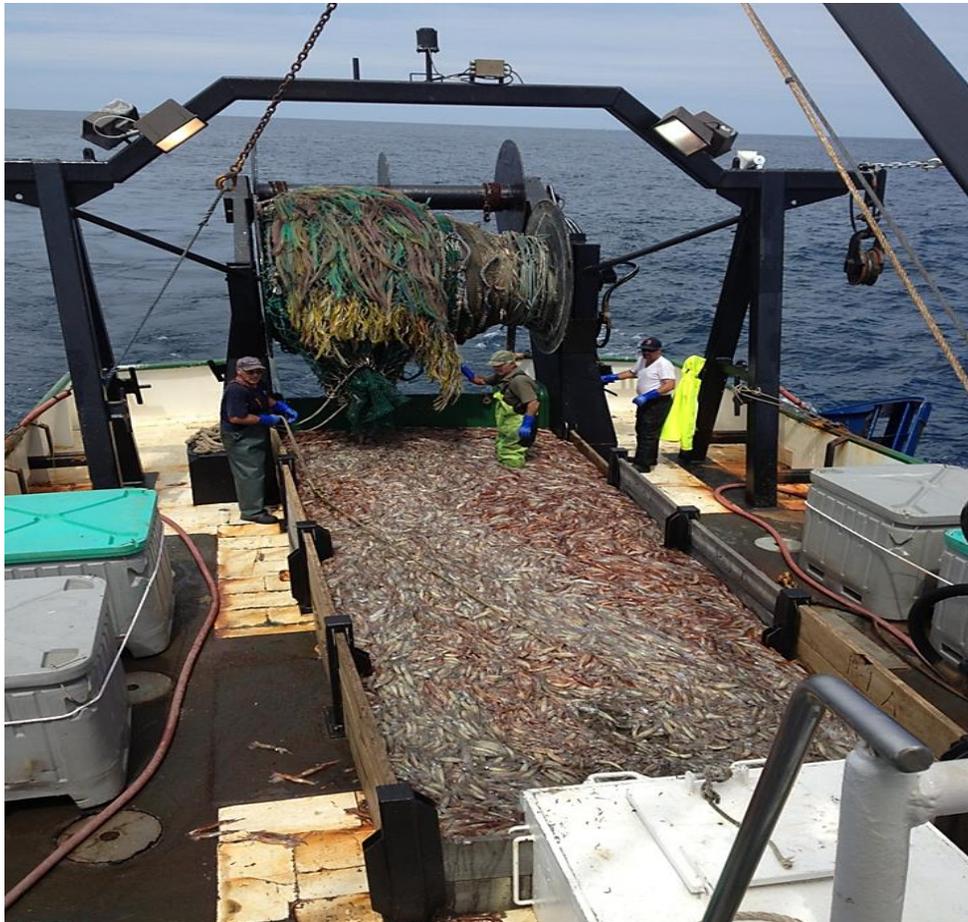
***Langley Douglas*' main deck during a previous voyage, with about 18,000–20,000 pounds of squid in the hog pen. (Photo by crewmember)**

The crew planned to remove the shark from the vessel using the centerline boom (the NOAA observer said the shark had likely died in the net). However, after the crew discharged the shark and squid into the hog pen, the squid started to overflow the pen and spill out onto the port side of the deck, and the vessel immediately developed a port list. In addition, the vessel was beam to the 6–8-foot seas and taking waves over its port quarter, which the crew said further increased the list. Normally, the crew would open fish hatches on both the port and starboard side to distribute the squid evenly into the fish holds, but to try to counter the port list, the captain ordered the crew to open the hatches to the two forward starboard fish holds and commence sweeping (with brooms) the squid from the pen into those holds. The senior deckhand and the deckhand started to carry out the captain's order, but the vessel continued to take seas over its port quarter, heeling the vessel further to port with each passing wave.

The crew saw that the totes, bins, boards, and gear on the back deck also began to shift to port. The vessel now listed about 10–20 degrees and the port quarter of the vessel was submerged as waves continued to break over the bulwark. The crew reported that the near-20-degree port list caused the body of the shark to shift to the port side of the hog pen and about 2,500 pounds of squid to slide toward the stern and collect against the aft portside bulwark, blocking the freeing ports and preventing release of trapped seawater on deck.

**Fishing vessel operators are reminded to avoid unloading large catches that exceed the pen height and can result in spillover and cargo on deck. Catch sliding around on deck has an adverse effect on vessel stability. Additionally, freeing ports (scuppers) in the bulwarks should be kept clear for rapid draining of water on deck. A deck filled with water creates an undesirable free-surface effect, and the weight of the additional water also increases the height of the vessel's center of gravity and decreases its freeboard, consequently reducing overall stability.**

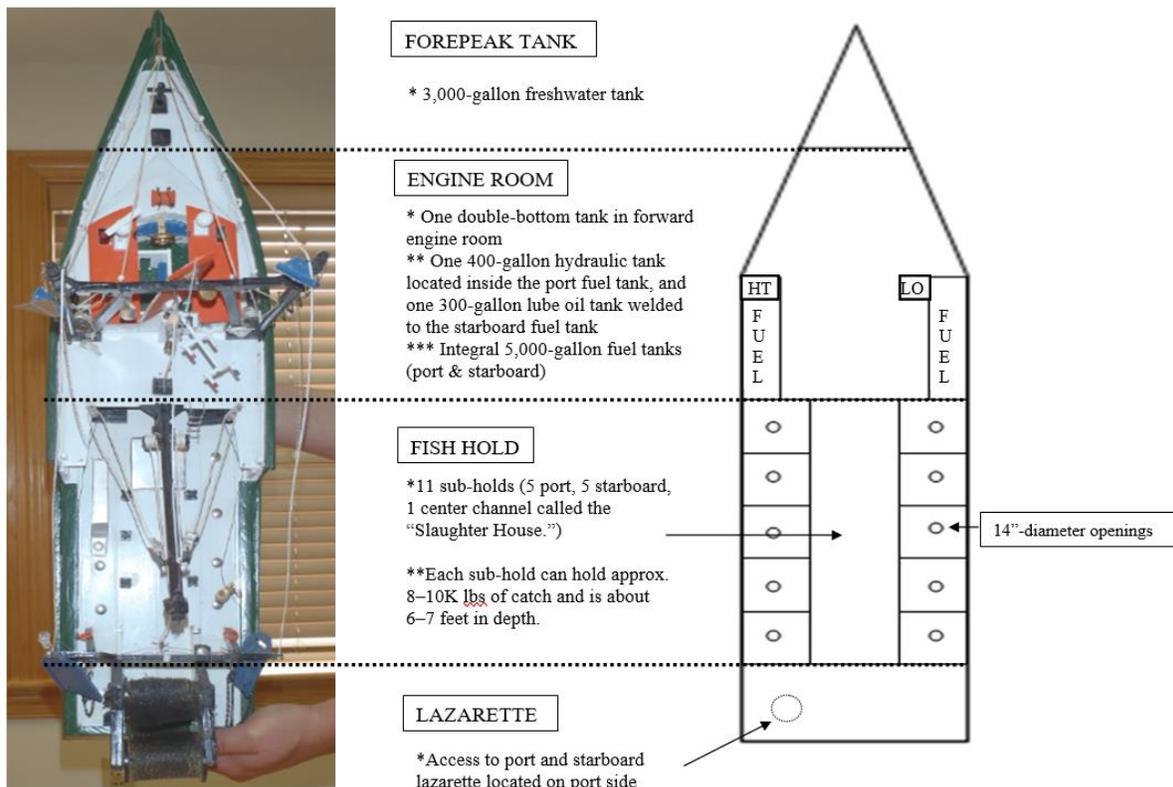
Simplified top-view diagram of below-deck compartments on the *Langley Douglas*. (Image provided by the Coast Guard)

Investigators determined that the vessel had at least five downflooding points on the main deck: one 36-inch access to the fish hold; two 36-inch deck vents on the stern; and the first and second cargo hold hatches on the starboard side, which the crew opened in an attempt to move cargo (squid) into those holds to correct the port list.

2. When the vessel rolled past 20 degrees to port per witness statements, the squid and shark spilled onto the deck. This weight shifting to the port side would have increased the vessel’s roll. The crew indicated that the main cargo hold was about half full of water, and the two fuel tanks were each about three-quarters full, while other small tanks were nearly full. In this case, when the vessel rolled to port, the liquid in the partially filled tanks would have displaced to the low side of the tank and moved the center of gravity of the liquid in the same direction as the roll. Collectively, weight of the cargo on deck and liquid in the tanks shifted and settled to the port side. The vessel was trimmed slightly by the stern; therefore, any water trapped on deck would flow toward and settle at the stern, as would any liquid in the vessel’s tanks.
