National Transportation Safety Board

Marine Accident Brief

Allision of Bulk Carrier *Mia S* with Nashville Avenue Wharf

Accident no.	DCA17FM023
Vessel name	<i>Mia S</i>
Accident type	Allision
Location	Lower Mississippi River near mile 101, New Orleans, Louisiana 29°54.87' N, 090°07.72' W
Date	August 18, 2017
Time	1920 central daylight time (coordinated universal time – 5 hours)
Injuries	None
Property damage	\$2 million est.
Environmental damage	None
Weather	Visibility clear, winds calm, air temperature 93°F
Waterway information	The Lower Mississippi River has a project depth of 45 feet for over 233 miles, from Southwest Pass near the entrance to the Gulf of Mexico to Baton Rouge, Louisiana (about 135 miles above New Orleans). At the site of the accident, the river measured 1,800 feet wide, and the current was approximately 1 knot.

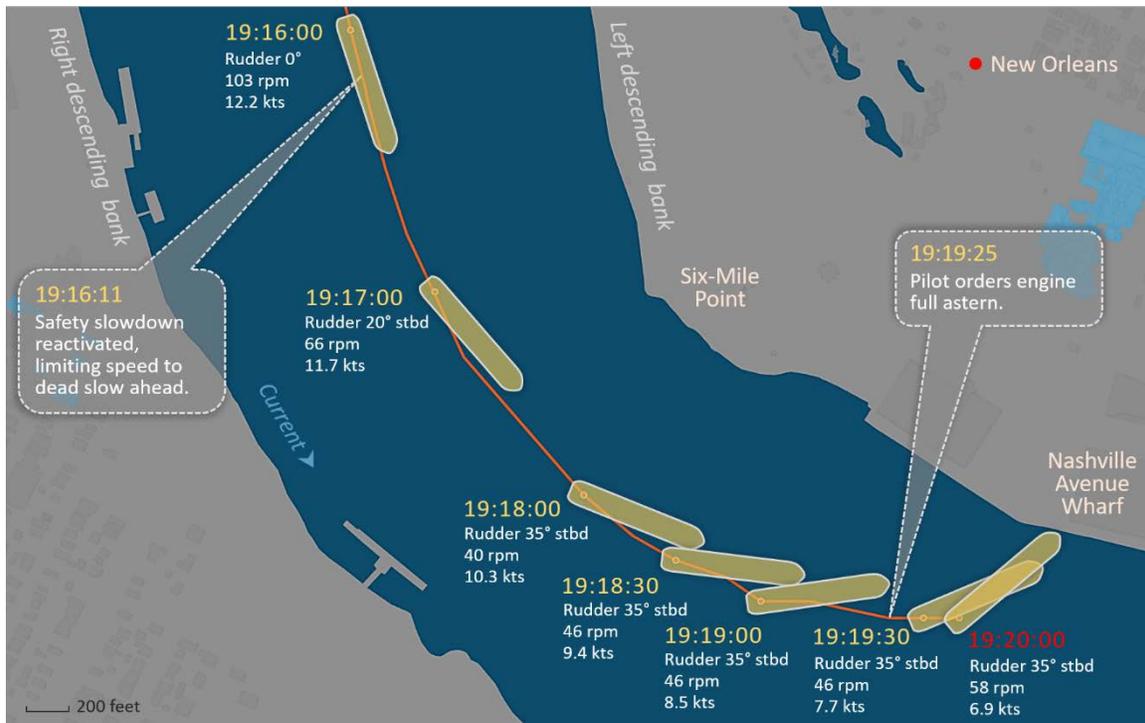
Trackline of *Mia S* over last 4 minutes leading up to accident shows change in vessel's heading and speed over ground following engine slowdown. (Background from Google Maps)

As the *Mia S* continued its transit downriver, the slowing speed reduced the rudder's effectiveness in the following current, which was flowing at 1 knot. Despite the pilot's order of hard to starboard (35 degrees) at 19:17:30, the vessel's heading continued to swing to port.

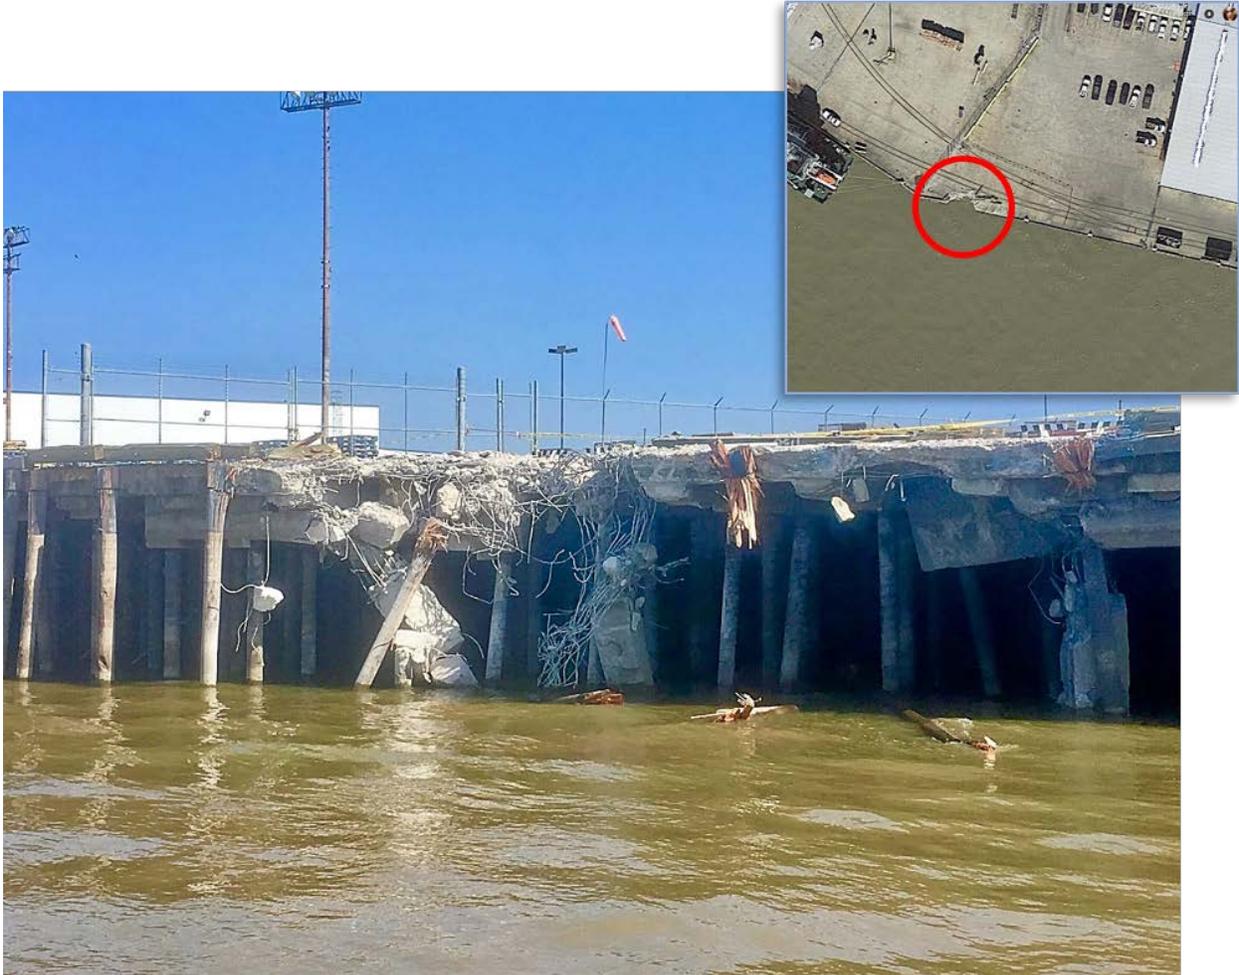
Damage to the wharf included destruction of the concrete dock—reinforced with rebar, crossbeams, stringers, and timber pilings—where the *Mia S* struck at a 90-degree angle. The vessel incurred damage above the waterline: to the hull plate, web frames, and stiffeners; to the forward bulkhead of the no. 1 ballast tank on the port side; and to the main and forecastle deck.

Damage to Nashville Avenue Wharf where vessel left impression of bow. (Photo by Coast Guard; satellite image from Google Maps)

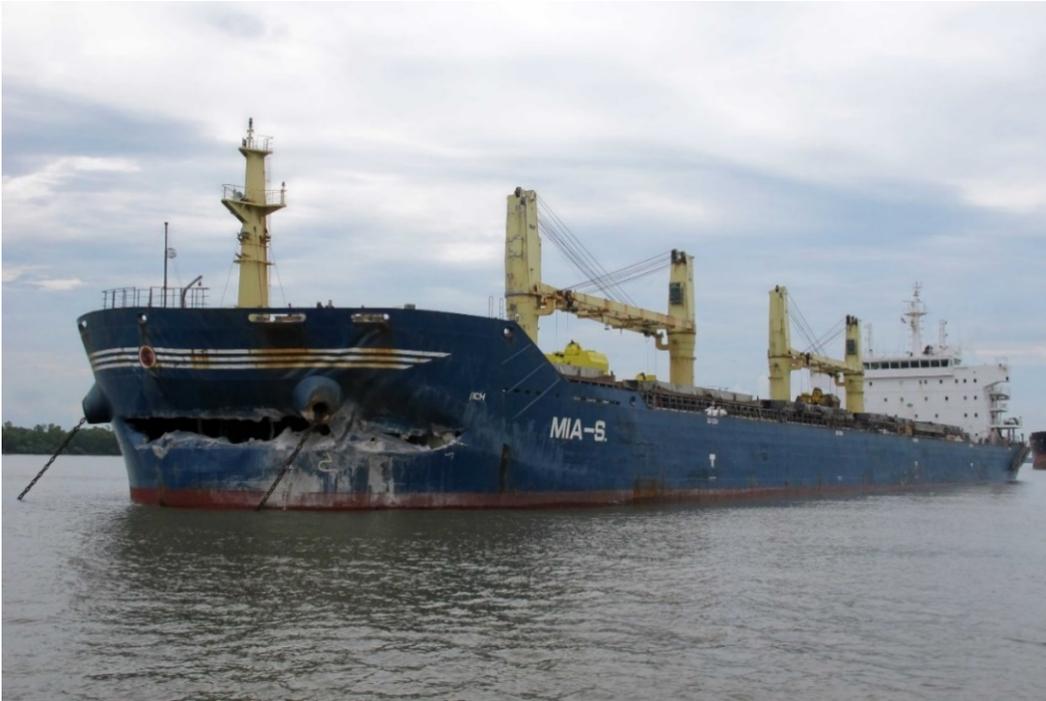
Bow damage sustained by *Mia S*.

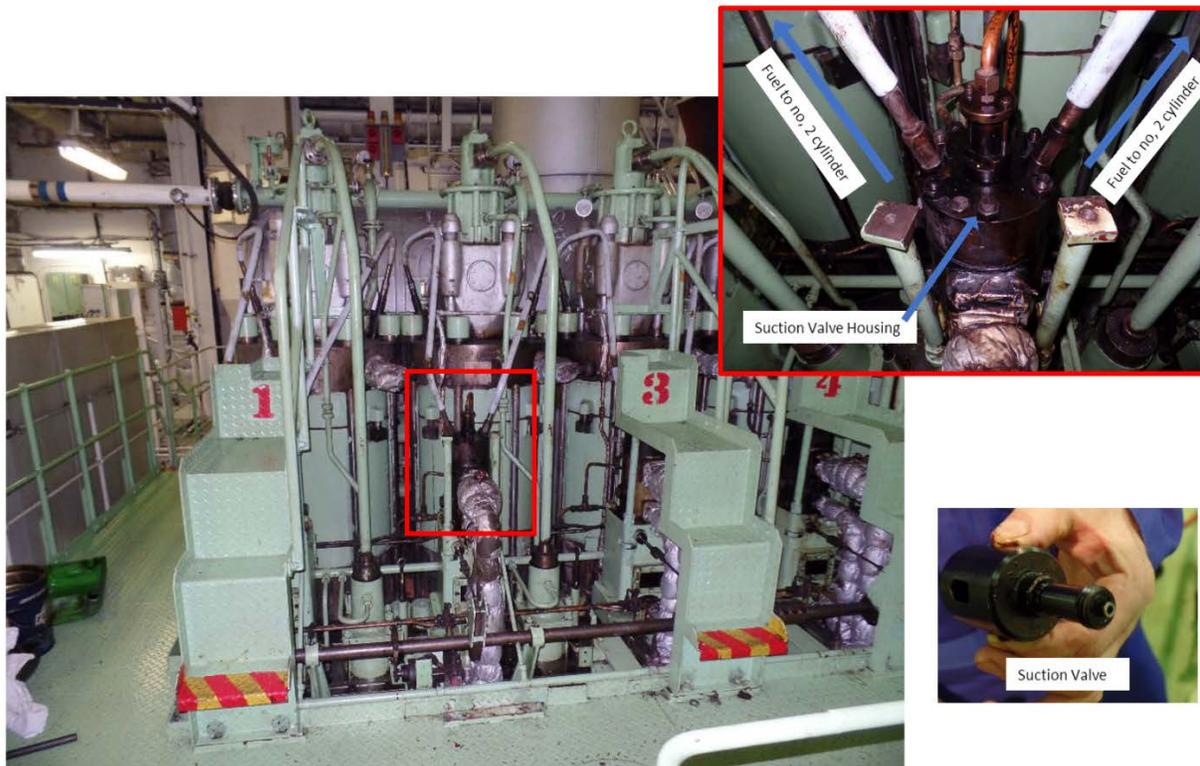
The chief engineer told investigators that the fuel pump for the no. 2 main diesel engine cylinder had not been providing fuel. He said that the exhaust temperature for the cylinder did not rise when the engine began operation, which indicated that the fuel injection system for that cylinder was not operating properly. The exhaust temperature was only about 100 degrees Celsius (212 degrees Fahrenheit), when it should have been near 275 degrees Celsius (527 degrees Fahrenheit). The chief engineer said the non-return valve for the fuel pump “remained stuck, not injecting fuel [into the cylinder]” and that attempts were made “to unstuck” the valve, but the fixes were temporary as the problem persisted.

In addition to fuel not flowing to the no. 2 cylinder, the bulk carrier experienced the same issue with the fuel injection pump for the no. 5 cylinder the day following the accident, during a nearly 2.5-hour transit to Belle Chasse Anchorage. While anchored there, each non-return valve for the six fuel injection pumps of the main engine were replaced by the crew. The previously installed valves had another 833 hours of service until they were due for an overhaul at 8,000 hours.

In assessing why the non-return valve did not function during the time leading up to the accident, the crew considered the use of low-sulfur fuel. Considering that sulfur improves the lubricating properties of the fuel, the lack of sulfur in the fuel oil may have caused the non-return valve to seize and thereby prevented fuel from injecting into the cylinders. The fuel required for usage when the vessel was within 200 miles of land contained less sulfur (to reduce emissions) than the “heavy” fuel used when the vessel was in the open ocean. Also, given that the fuel injection valves were scheduled to be replaced soon, based on the engine’s operating hours, the crew believed that the non-return valves may have been worn. Non-return valves have precision tolerances and can malfunction when those tolerances are not met.

Clockwise from left: cylinder nos. 1 through 4 of the direct-drive diesel engine on *Mia S*; fuel pump for no. 2 cylinder; and non-return/suction valve for no. 2 cylinder fuel pump. (Photos by Coast Guard)

On August 25, while the vessel was still in Belle Chasse Anchorage, a test was conducted on the main engine; the newly installed non-return valves were found to be operating satisfactorily.
