National Transportation Safety Board

Marine Accident Brief

Allision of *Cooperative Venture* Tow with St. Paul Union Pacific Rail Bridge

Accident no.	DCA18FM003
Vessel name	<i>Cooperative Venture</i>
Accident type	Allision
Location	Upper Mississippi River at mile 835.7, near St. Paul, Minnesota 44°55.13' N, 93°03.02' W
Date	October 26, 2017
Time	About 0230 central daylight time (coordinated universal time – 5 hours)
Injuries	None reported
Property damage	\$953,000 est.
Environmental damage	None
Weather	Visibility 10 miles, clear skies, winds north-northwest at approximately 15 mph, air temperature 45°F
Waterway information	The Upper Mississippi River has a controlling depth of 9 feet and a width of approximately 350 feet at the site of the accident. The current on the morning of the accident was estimated at 2 mph.

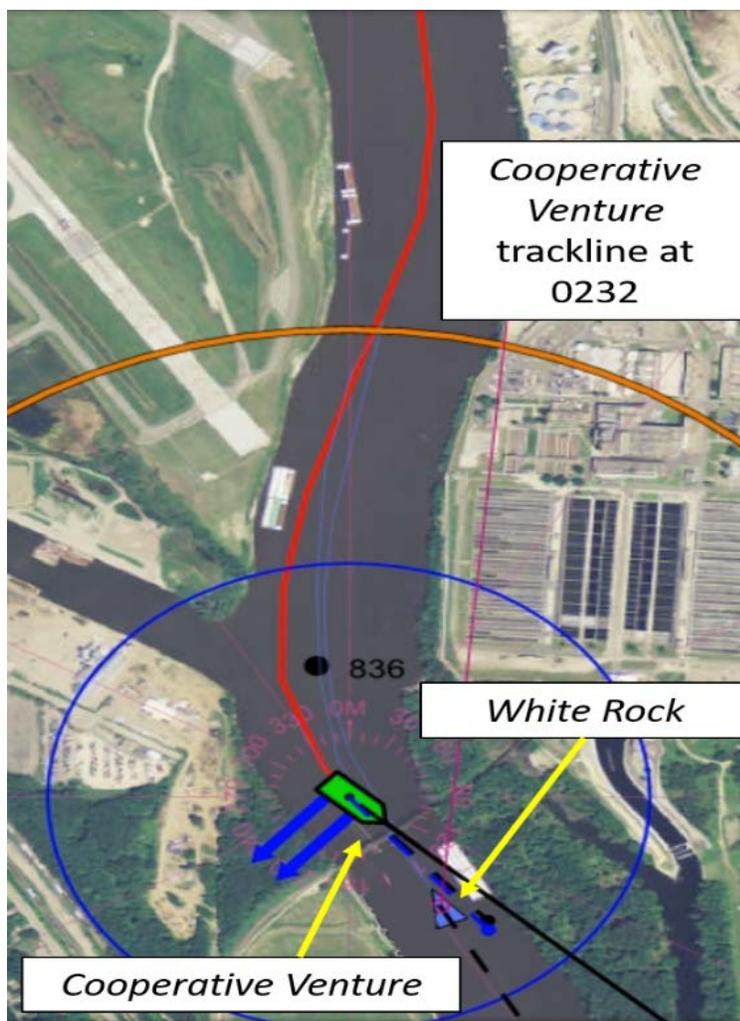
Screenshot from *Cooperative Venture*'s ECS about 2 minutes after vessel struck pier. Red trackline represents position of vessel through turn upon approach to bridge. The blue arrows generated by the ECS indicate the vessel's predicted movement.

According to data from the vessel's ECS, the pilot of the *Cooperative Venture* had been traveling in the center of the channel as he approached the St. Paul Union Pacific Rail Bridge until 0223, at approximately mile 836.3, where he then began maneuvering to the right descending bank. The reason the pilot deviated from the center of the channel is unknown, but it placed the stern of the *Cooperative Venture* into the stronger following current in the bend along the right descending bank, thereby reducing the pilot's ability to correct the heading and properly align the tow with the channel for safe passage through the bridge span.

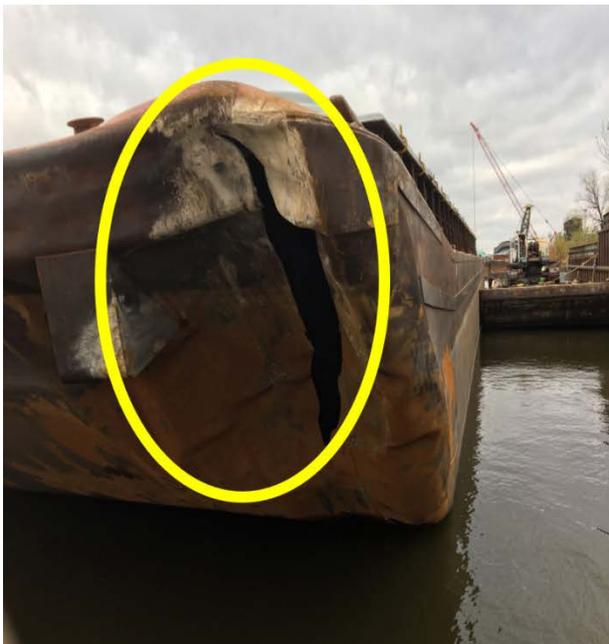
The port lead barge sustained damage and took on water in the raked (angled) bow, but none of the other barges were affected. Designed to transport bulk cargo, *ART 35157* was a hopper barge constructed of welded steel with fiberglass cargo covers. Due to the allision, the double-bottom hull sustained a 17-foot-high-by-1.5-foot-wide hole, along with deformation of the steel framing. There was no damage to the cargo in the holds.

Damage from allision: (at left) raked bow of port lead barge, *ART 35157*; (at right) fixed pier of swing bridge near left descending bank struck by barge (downstream view).

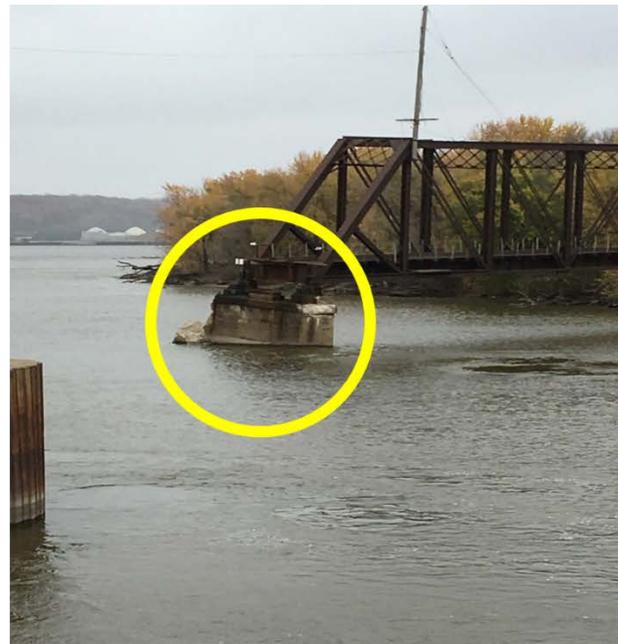
The concrete pier that was struck by the tow was displaced by approximately 4 to 5 feet and angled approximately 5 degrees, preventing the bridge's swinging portion from connecting to the fixed support. Consequently, no railroad traffic was permitted to cross the bridge. The waterway remained open to river traffic, but only for passage of one tow at a time through the span near the right descending bank (right span).
