National Transportation Safety Board

Marine Accident Brief

Flooding and Sinking of Fishing Vessel *Ben & Casey*

Accident type	Flooding	No. DCA18FM004
Vessel name	<i>Ben & Casey</i>	
Location	Gulf of Mexico, about 6 miles* east of South Padre Island, Texas 26°6.79' N, 97°3.45' W	
Date	October 30, 2017	
Time	About 2215 central daylight time (coordinated universal time – 5 hours)	
Injuries	None reported	
Property damage	\$191,000 est.	
Environmental damage	None reported; 7,400 gallons of diesel, 50 gallons of hydraulic oil and lube oil on board; some floating debris noted near site of sinking	
Weather	Clear visibility, winds south at 5 knots, air temperature 77°F, water temperature 80°F	
Waterway information	Open waters of the Gulf of Mexico; water depth about 62 feet at accident site.

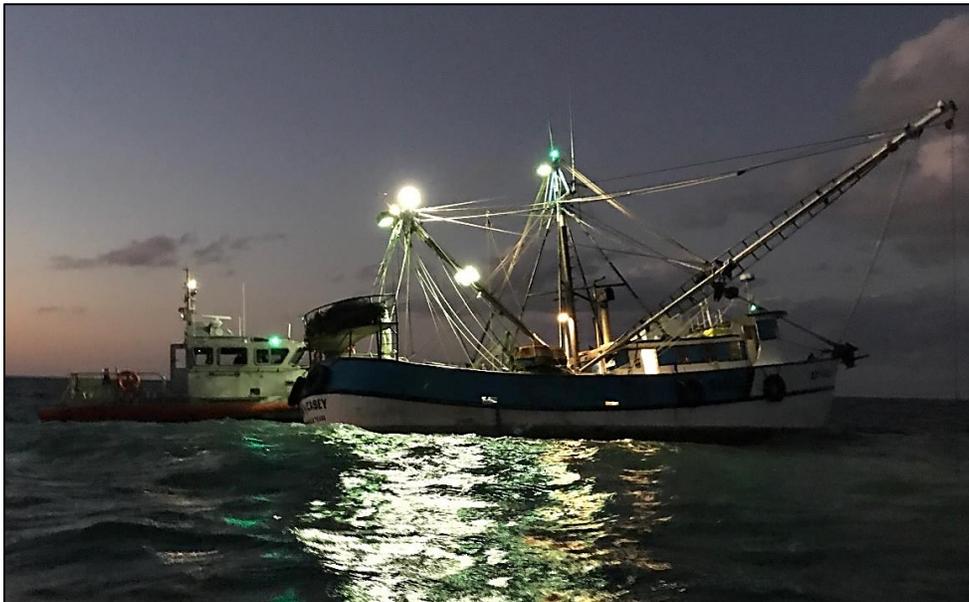
***Ben & Casey* with Coast Guard response vessel on the accident date. (Photo by Coast Guard)**

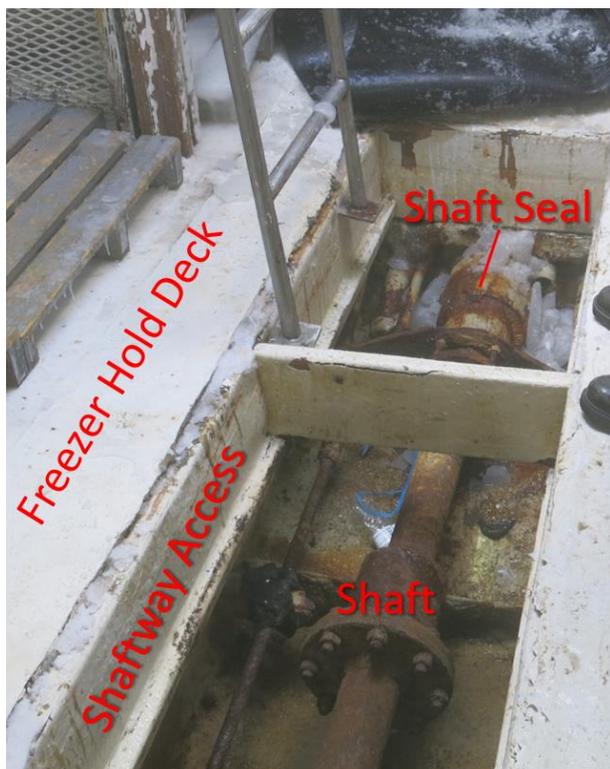
Shaftway of *Jake M*, vessel with identical shafting to *Ben & Casey*, as viewed from freezer hold, facing aft.

sounded on the bridge. According to the owner and the captain, there were bilge alarms in both the engine room and the shaftway, but investigators could not determine which alarm sounded during the accident. The captain and the rigman went to the engine room and freezer hold to investigate. In the freezer hold, they found about 6 inches of water above the deck. Lifting the shaftway access floor panels, they found water entering the hold at the aft end of the shaftway, near the shaft packing seal. However, they could not visually see the shaft through the rising water. In the engine room, the captain and rigman found all equipment operating normally, but water was entering the engine room from the shaftway via the non-watertight bulkhead penetration for the propeller shaft.

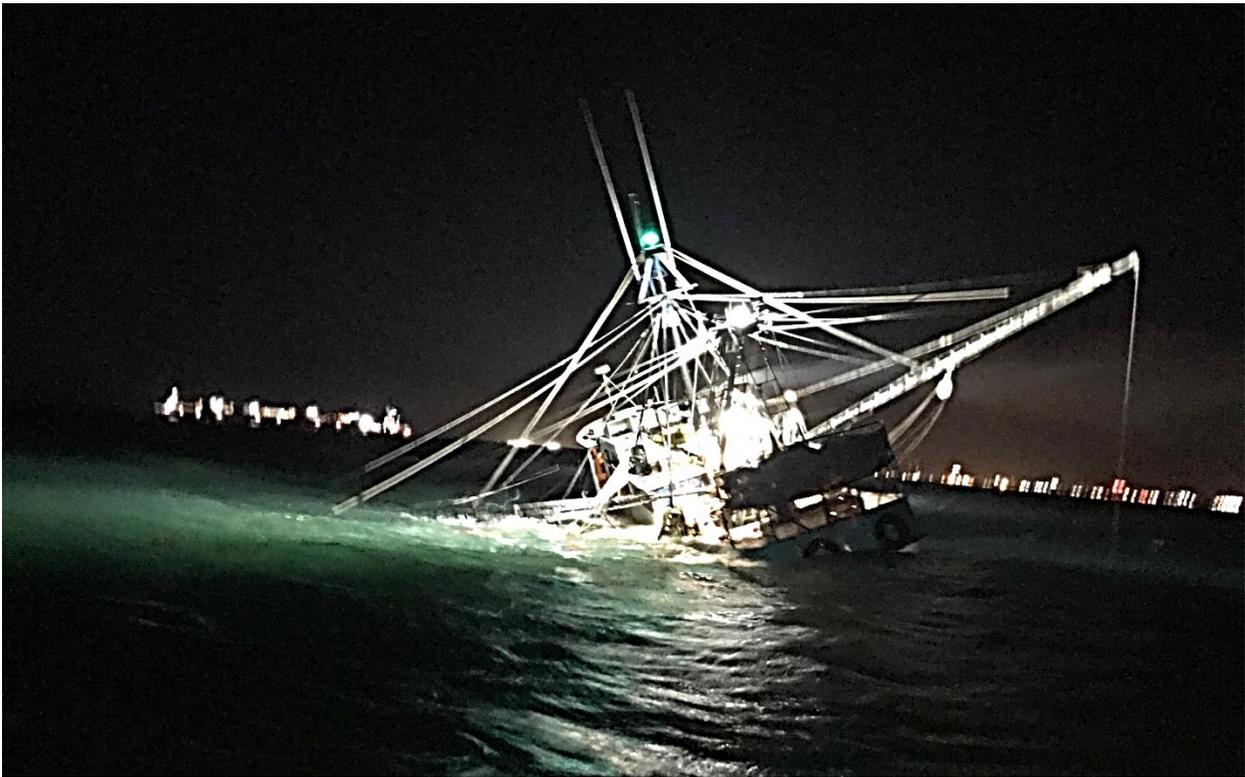
The vessel developed a severe list to port, then began to founder by the stern. At 2215, the vessel fully submerged. The crew of the *Ben & Casey* was returned to shore by the Coast Guard small boat.

Ben & Casey just prior to sinking. (Photo by Coast Guard)

The National Transportation Safety Board determines that the probable cause of the flooding and sinking of the fishing vessel *Ben & Casey* was a sheared propeller shaft that allowed water ingress into the hull through the shaft seal.
