# National Transportation Safety Board

## Marine Accident Brief

### Engine Room Fire aboard Towing Vessel *George King*

<b>Accident type</b>	Fire/explosion	<b>No.</b>	DCA18FM012
<b>Vessel name</b>	<i>George King</i>		
<b>Location</b>	Lower Mississippi River, at mile 393.6, near St. Joseph, Louisiana, 31° 53.95' N, 091° 12.17' W		
<b>Date</b>	January 24, 2018		
<b>Time</b>	About 2041 central standard time (coordinated universal time – 6 hours)		
<b>Injuries</b>	None reported		
<b>Property damage</b>	>\$500,000 est.		
<b>Environmental damage</b>	None reported		
<b>Weather</b>	Clear, visibility of 10 miles*, winds light from the north, air temperature 59°F		
<b>Waterway information</b>	The Lower Mississippi River near mile 393 is about 1 mile wide. The charted water depth in the channel is 24.9 feet.

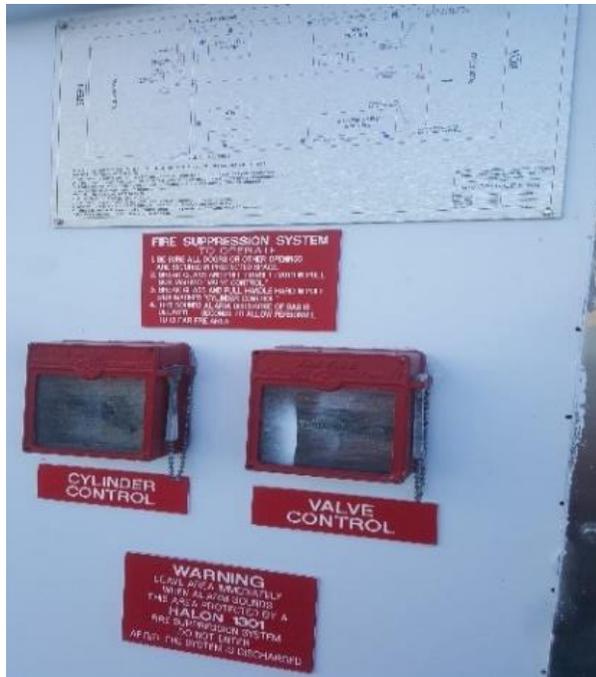
Halon activation station

The *George King*'s electrically driven fire pump stopped when the generator shut down, and thus the fire hoses lost water pressure. Therefore, the captain directed that the vessel's halon fixed firefighting system be activated to extinguish the fire. The chief engineer tried to reach the port halon activation station located on the aft section of the house. This required him to walk past the engine room doors. However, the flames erupting from the broken engine room windows and open double doors prevented him from proceeding down the port side of the vessel.

Because of the risks associated with engine room fires, the effectiveness of fixed firefighting systems is critical. The crew did not activate the halon system because of the inability of the chief engineer to reach the halon activation station on the port side and a misunderstanding between crewmembers regarding activation from the starboard side. Had the system been activated, its effectiveness would have been limited because the portside doors to the engine room were open and several engine room windows were broken. In addition, engine room inlet and exhaust vents were fitted with fixed louvers that were not able to be closed. These openings would have allowed a significant amount of the discharging halon to escape the space instead of being contained in large enough volume to extinguish the fire. Additionally, these openings allowed for continued air draft to the fire, allowing it to spread.

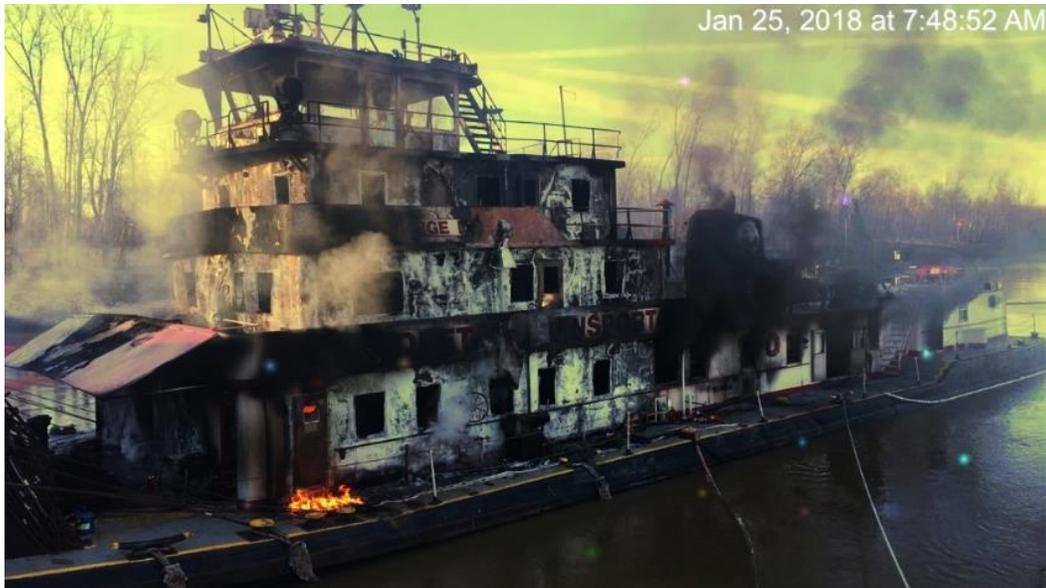
*George King* still burning about 0749 on the day after the fire started. (Photo by US Coast Guard)

The *George King* was extensively damaged by the fire, but the main structure of the vessel and the main propulsion system remained intact. The fire, as witnessed by the chief engineer and other crewmembers, was initially located on top of the forward section of the port main propulsion engine.

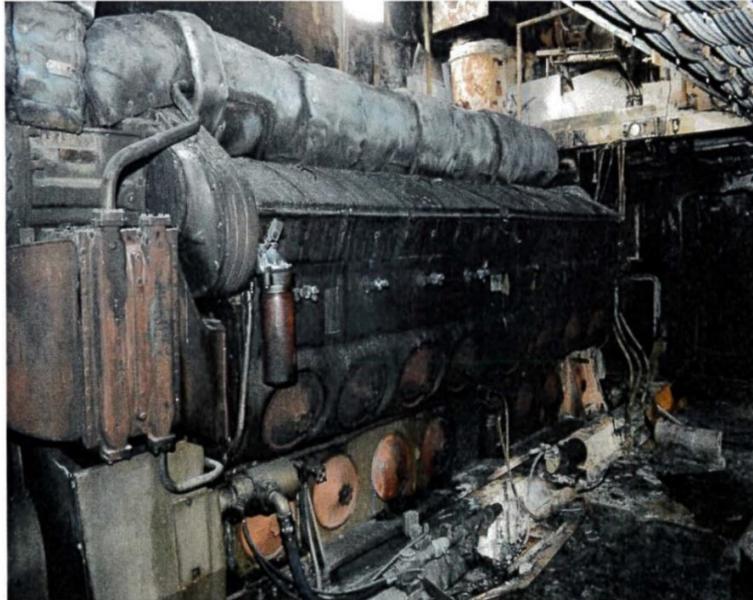
When the captain first saw flames, they were coming from the port stack. Upon opening the door from the galley to the engine room, the chief engineer saw flames engulfing the forward section of the port engine. After the fire, the port lube oil strainer housing was completely gone, suggesting that the strainer was subjected to heat greater than 1,221 degrees F, the melting point of aluminum. This evidence supports the fire examiners' determination that the fire originated in that general area.

Port main propulsion engine, looking forward. (Photo courtesy of Rob Harshman Forensic Science & Engineering, LLC)

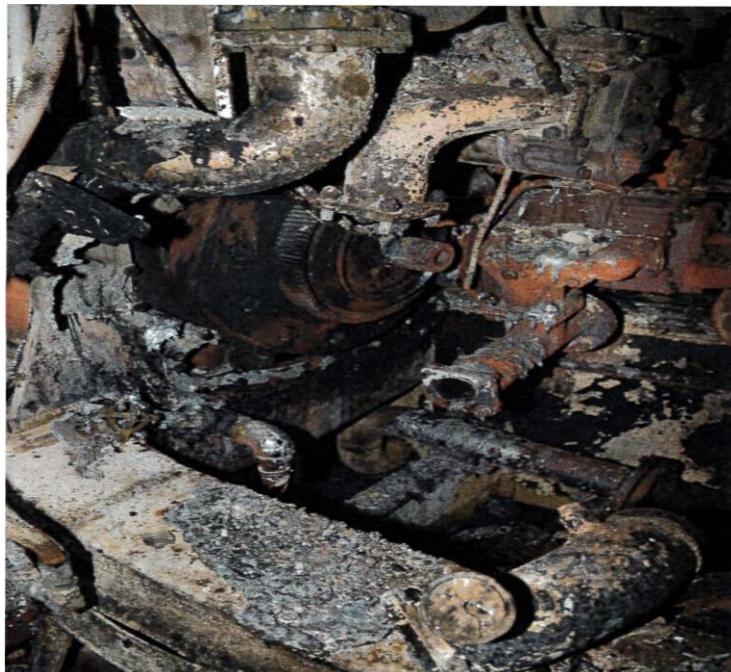
During a postaccident examination of the port engine, investigators discovered that the entire lube oil strainer housing, located just forward of the engine and constructed of aluminum, was gone. In addition, internal parts of the strainer, not made of aluminum, were found on the deck plates forward of the engine, as well as in the bilge located below the location of the strainer. The lube oil strainer on the starboard main engine remained intact.

Because the lube oil system was a pressurized system, a small leak in the strainer's housing or at the covers for the strainers could have caused escaping oil to atomize. Atomized oil is susceptible to ignition and flashover if there is a viable heat source located nearby, and there were a number of hot surfaces within the *George King's* engine room. It is likely that atomized lube oil spraying from the port strainer was ignited after making contact with a hot surface near the strainer housing, which progressed into a continuous burning fire after an initial flashover. This scenario coincides with the statements of the captain, which identified a flash followed by flames coming from the engine room exhaust vents on the port stack.

Remains of the port lube oil strainer. (Photo courtesy of Rob Harshman Forensic Science & Engineering, LLC)

The National Transportation Safety Board determines that the probable cause of the engine room fire aboard the towing vessel *George King* was the ignition of oil spraying from the pressurized lube oil strainer on the port main diesel engine. Contributing to the severity of the fire was the fixed-open engine room ventilation system and the inability of the crew to close all engine room windows and doors, which allowed the fire to spread and would have limited the effectiveness of the halon fixed firefighting system had it been activated.
