# National Transportation Safety Board

## Marine Accident Brief

### Engine Room Fire aboard Fishing Vessel *Cape Cod*

<b>Accident type</b>	Fire/Explosion	<b>No.</b> DCA18FM024
<b>Vessel name</b>	<i>Cape Cod</i>	
<b>Location</b>	Pago Pago Harbor, American Samoa 14°16.30'S 170°41.19'W	
<b>Date</b>	May 20, 2018	
<b>Time</b>	1536 Samoa standard time (coordinated universal time – 11 hours)	
<b>Injuries</b>	None	
<b>Property damage</b>	\$650,000 est.	
<b>Environmental damage</b>	None reported	
<b>Weather</b>	Winds east-northeast at 6 knots, air temperature 82°F, sea temperature 86°F	
<b>Waterway information</b>	Pago Pago Harbor is a large natural inlet on the central south coast of the island of Tutuila in American Samoa.

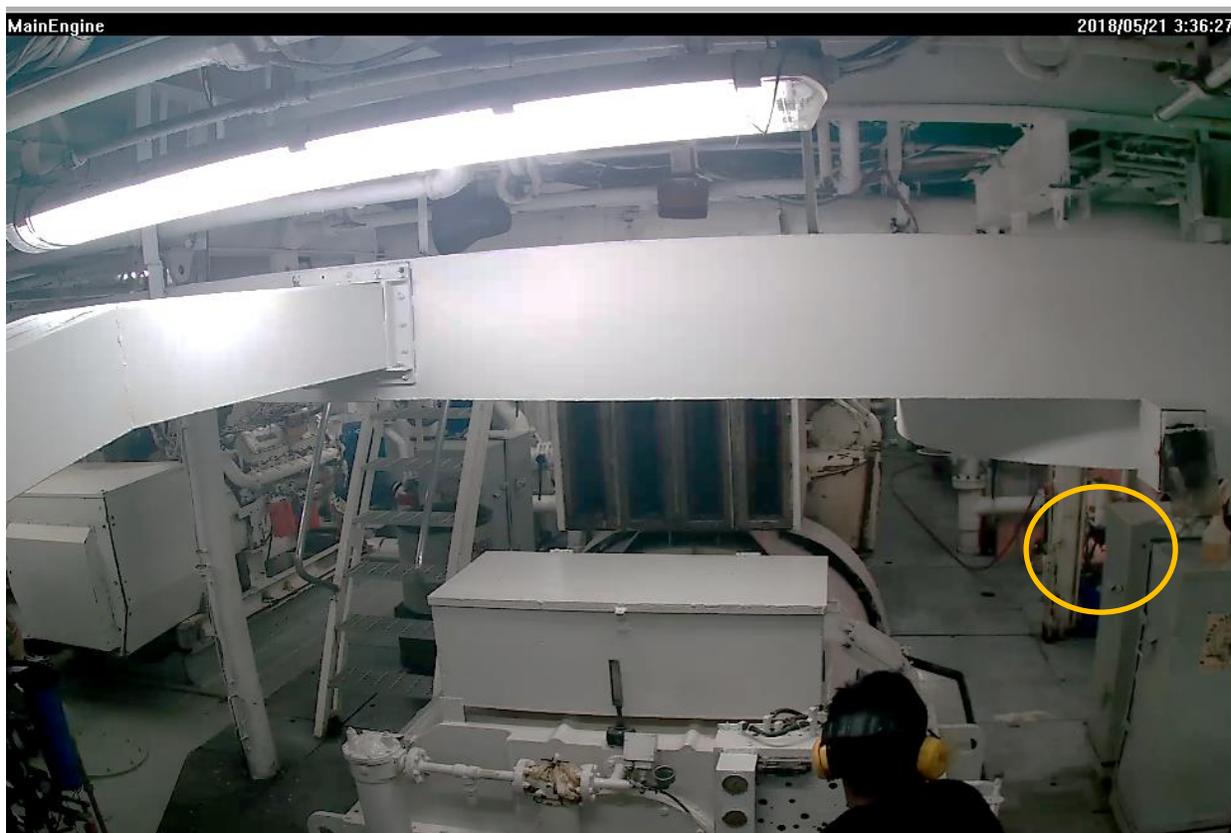
Screenshot from the closed-circuit television camera in the lower engine room, looking forward. The initial fire began in the area overlaid by a yellow circle (starboard side). (Photo by US Coast Guard)

Investigators also reviewed available the closed-circuit television (CCTV) footage. Although ducting blocked the origin of the fire in the CCTV footage, the glow of the fire seen in the video revealed a quick and intense ignition with little smoke, suggesting an electrical ignition source forward of generator no. 2. Also, the engine room appeared clean and free of loose combustibles. The crew's initial response with portable extinguishers was ineffective, given that the electrical power near the fire had not yet been shut down.

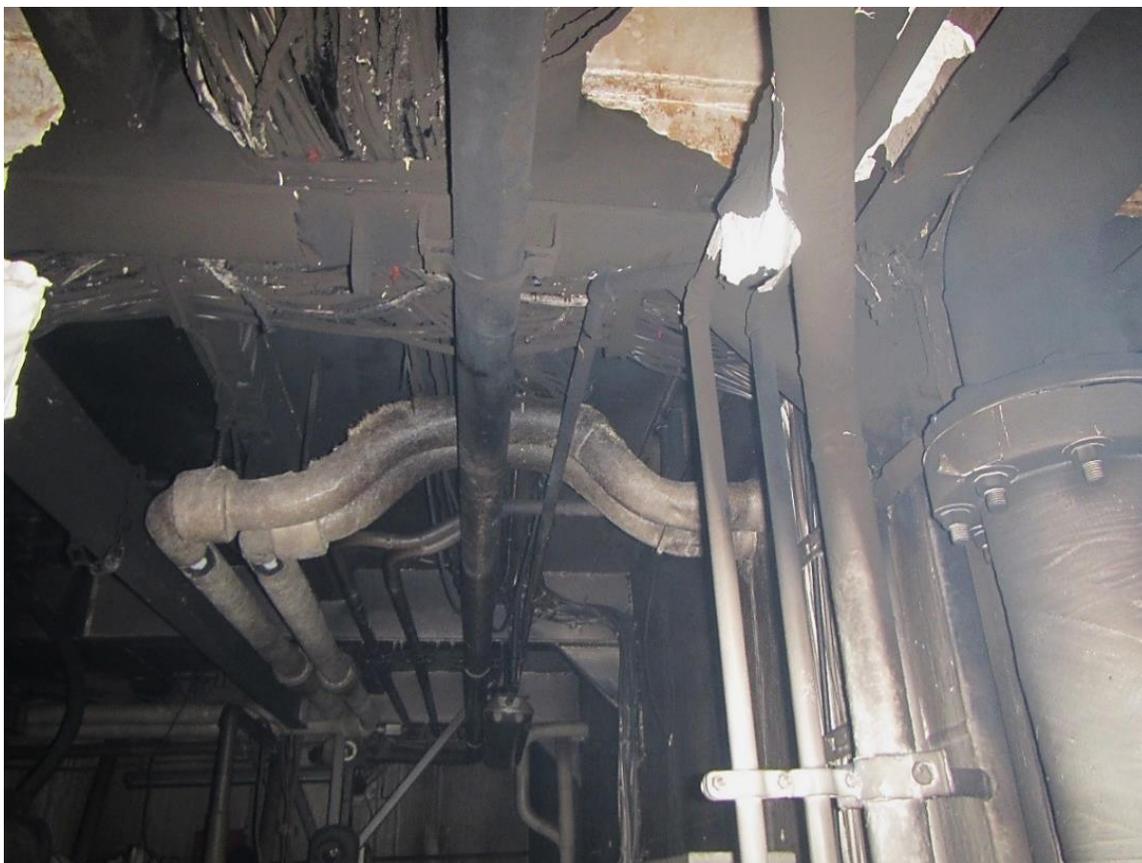
Investigators noted significant heat damage in the lower and upper engine rooms. Both generator nos. 1 and 2 were removed for repair and most of the electrical cables, lighting, and other equipment had to be replaced.

**Smoke and heat damage in the overhead of the starboard forward corner of the lower engine room. (Photo by Coast Guard)**

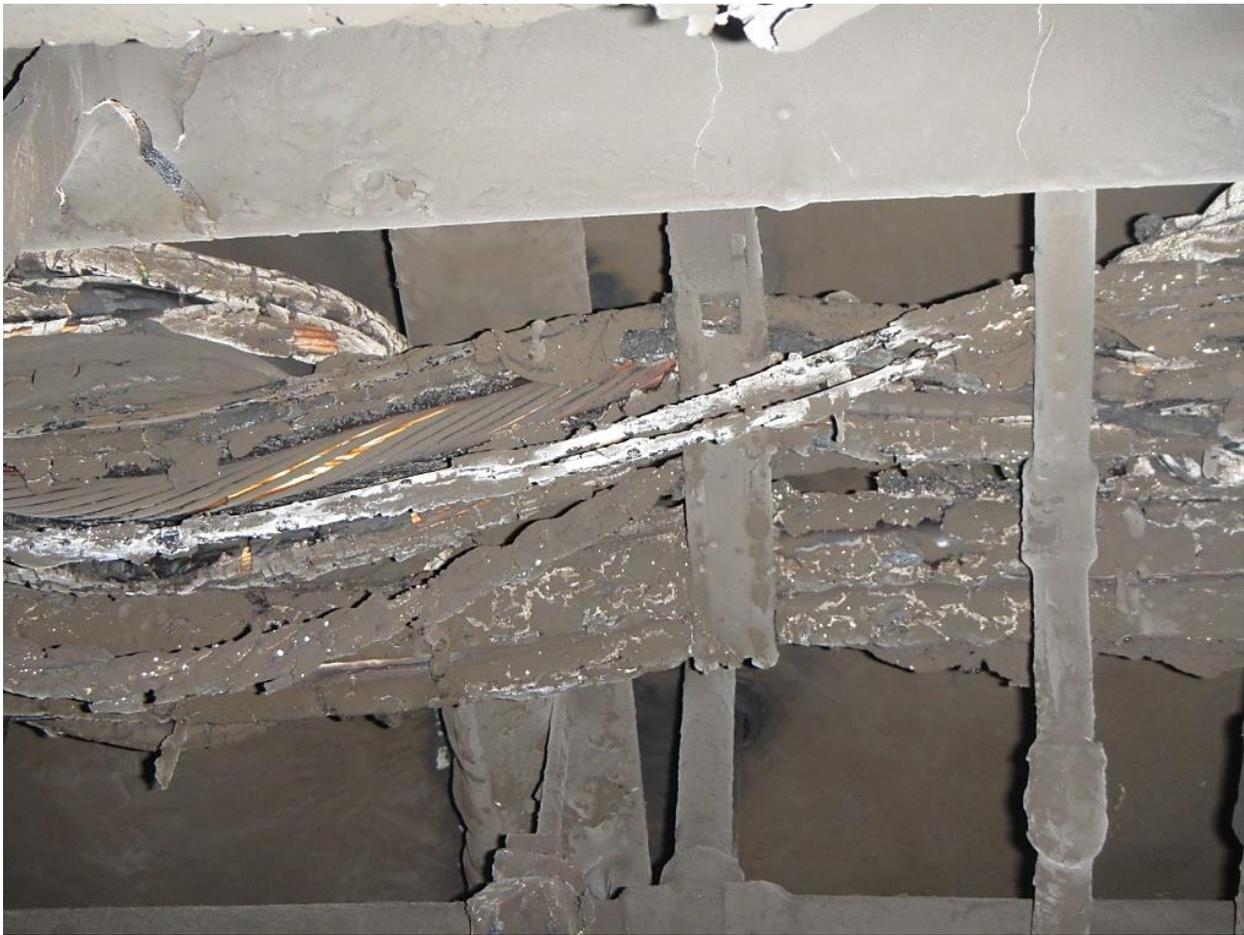
Based on the location of the damage in the engine room, the intensity of the fire observed in the CCTV footage, and the lack of operating machinery near generator no. 2, investigators concluded that the fire likely resulted from an electrical source and was fueled by electrical cable housing material, control boxes, light fixtures, and paint. The vessel had recently undergone extensive work in the engine room, although with no subsequent regulatory or classification society drydock exam or sea trial.

**Electrical cabling above generator no. 2. (Photo by Coast Guard)**

The National Transportation Safety Board determines that the probable cause of the engine room fire aboard fishing vessel *Cape Cod* was an undetermined electrical ignition source near electrical distribution cabling in the lower engine room.
