National Transportation Safety Board

Marine Accident Brief

Anchor Contact of Articulated Tug and Barge *Clyde S VanEnkevort/* *Erie Trader* with Underwater Cables and Pipelines

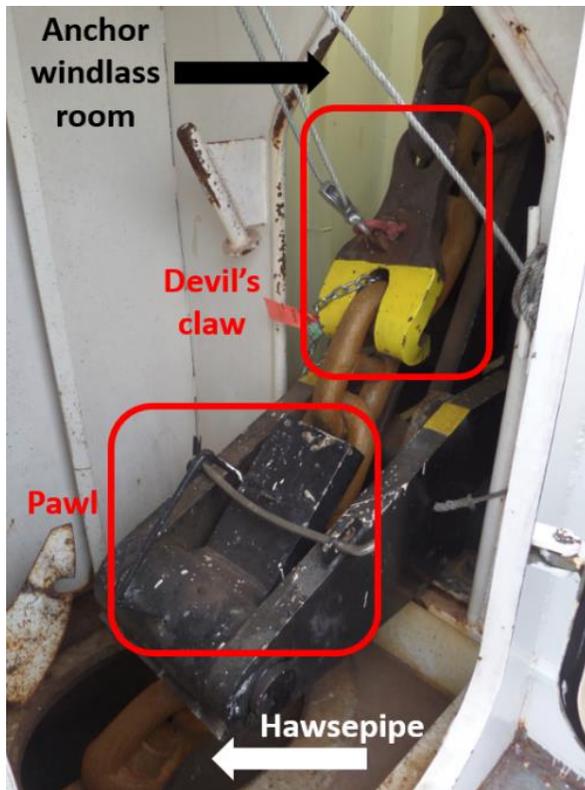
Postaccident photo of the starboard anchor's devil's claw and pawl in the secured and stowed (home) position.

The condition of the starboard pawl, devil's claw, and wildcat indicated that the anchor had been intentionally cleared and had not let go due to any failure of those components. In addition, no problems were apparent with the wildcat or windlass motor, given that the crewmembers could immediately retrieve the anchor once they found it paid out.

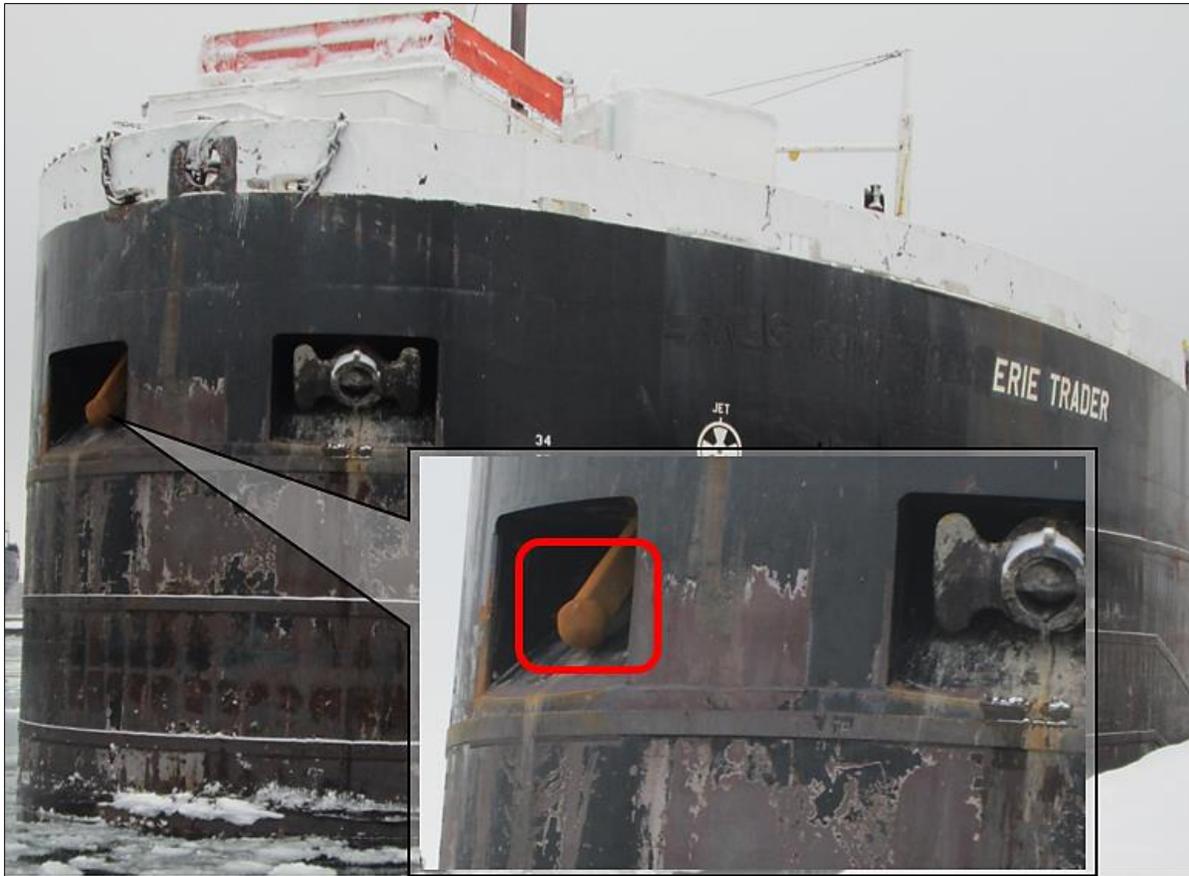
The bow of barge *Erie Trader* after the accident. An inset highlights the remnant shank of the starboard anchor in the anchor pocket. (Photo by Coast Guard)

The marine casualty report that the vessel captain submitted on April 6, 2018 stated that “the starboard-side anchor was not secured properly and released without anyone’s knowledge at an unknown place and time.”

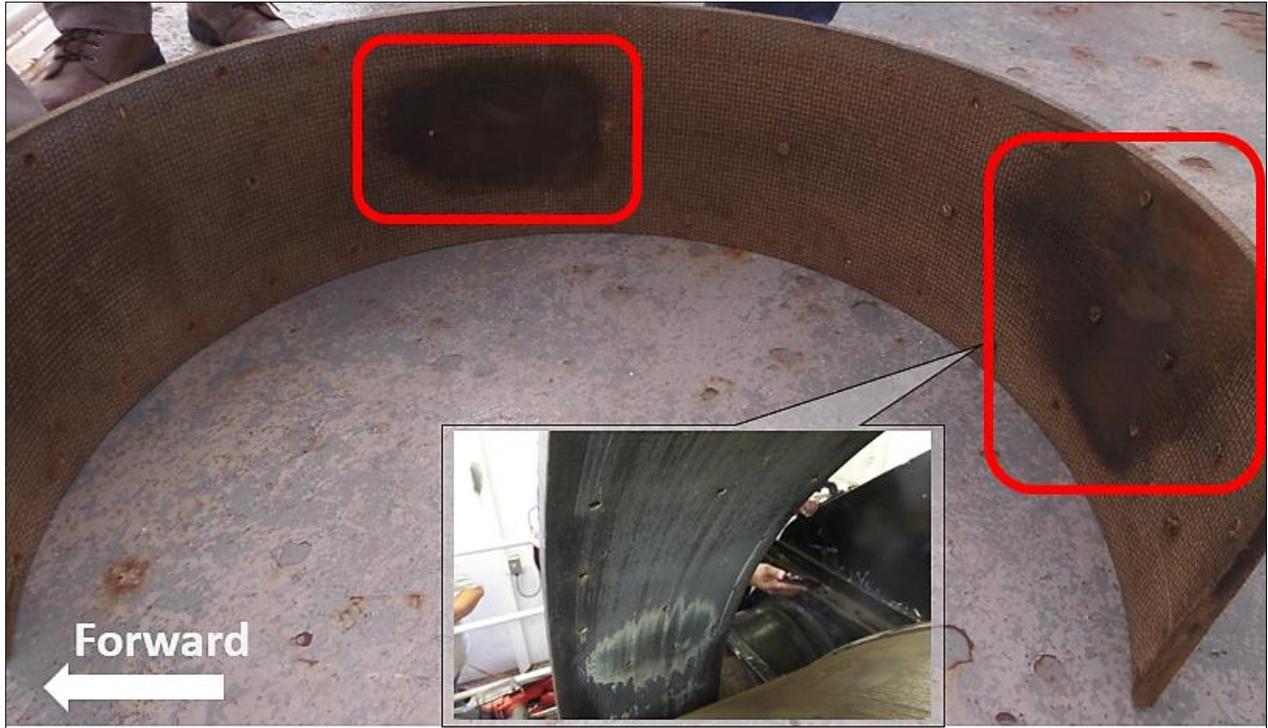
On May 4, in the port of Toledo, Ohio, investigators and party representatives witnessed the disassembly and replacement of both the upper and lower section of the starboard anchor brake band liners. At the request of the vessel owner, an attending technician from CME supervised the process. The lower brake band liner appeared to have been in place for the life of the vessel, and frictional wear was uniform along the surface. When the upper brake band liner was removed, it had only minimal wear due to its new condition, and much of the liner surface had no visible friction or notable surface contact. However, near the top of the liner and at the aft end were notable uneven friction marks. Friction marks also appeared at the forward end of the liner near the edge and on the brake band inner surface. In addition, paint was burned from the surface in both places as well as at the forward end.

Photo of the upper brake band liner for the starboard anchor. Highlighted in red are the friction marks on the liner. The inset shows the paint worn from heat accumulation through the liner aft section of the upper band.

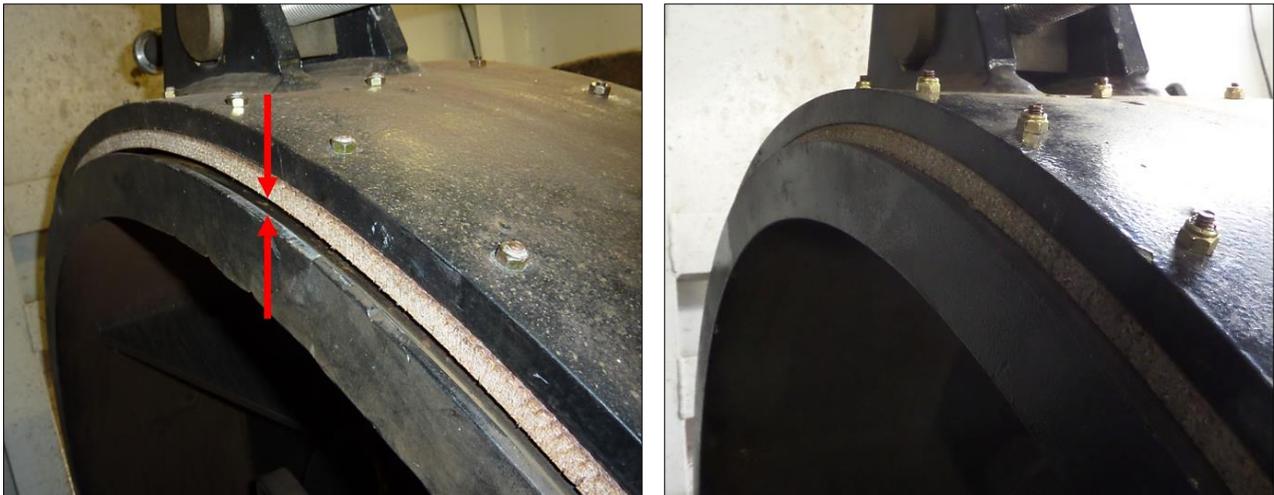
On April 9 in Silver Bay, investigators boarded the vessel and visually examined the starboard anchor assembly. When the brake was applied, a noticeable gap—about 0.3-inch wide—was observed at the top section of the brake band. The pawl, devil’s claw, brake, wildcat, handwheel, and main shaft on the starboard windlass had no visible signs of damage.

According to CME’s field service report, “upon inspection at winch, noticed brake band was out of adjustment.” CME noted no problems with the anchor windlass assembly and, after the adjustment, the anchor was tested with satisfactory results.

Left: Postaccident photo of the starboard anchor windlass’ upper brake band liner with the brake closed. The red arrows highlight the gap at the top between the drum and liner. Right: Photo of the upper brake band liner with the brake closed after the CME technician supervised the installation and adjustment. Note the lack of gap between the brake band liner and the drum.

Although anchor windlass brakes are not intended to hold an anchor and chain indefinitely during the dynamic conditions that vessels typically encounter on voyages, a properly adjusted brake should have had ample holding capacity for the weight of the *Erie Trader's* anchor and chain. However, during the postaccident teardown and replacement of the *Erie Trader's* starboard anchor windlass brake-band liners, the brake band had to be adjusted to ensure proper contact between the liner and drum with the brake activated. Based on the friction contact pattern on the upper liner, it is likely that the chief engineer and crew who replaced the top liner did not properly adjust the brake band. The brake band liner and hardware were replaced without the training, supervision, or instructions to properly carry out the task and ensure appropriate adjustments. Aside from the improperly adjusted band, investigators found no other defects in the anchor assembly.
