National Transportation Safety Board

Marine Accident Brief

Contact of Bulk Carrier *Shandong Fu En* with Ergon-St. James Terminal Wharf

Accident type	Contact	No. DCA18FM020
Vessel name	<i>Shandong Fu En</i>	
Location	Lower Mississippi River near mile 161, Convent, Louisiana 30°01.82' N, 090°50.40' W	
Date	April 6, 2018	
Time	0637 central daylight time (coordinated universal time – 5 hours)	
Injuries	None	
Property damage	\$6.25 million est.	
Environmental damage	None	
Weather	Visibility 10 miles, mostly cloudy, winds south-southeast 11 knots; air temperature 70°F; morning twilight 0621, sunrise 0645, evening sunset 1723, evening twilight ends 1947	
Waterway information	Lower Mississippi River has a project depth of 45 feet at the accident location; high-water conditions were in effect, with the current about 5.4 mph (4.7 knots). The distance between the north end of the Ergon-St. James Terminal and the south end of the Convent Marine Terminal wharves is 1,479 feet (451 meters).

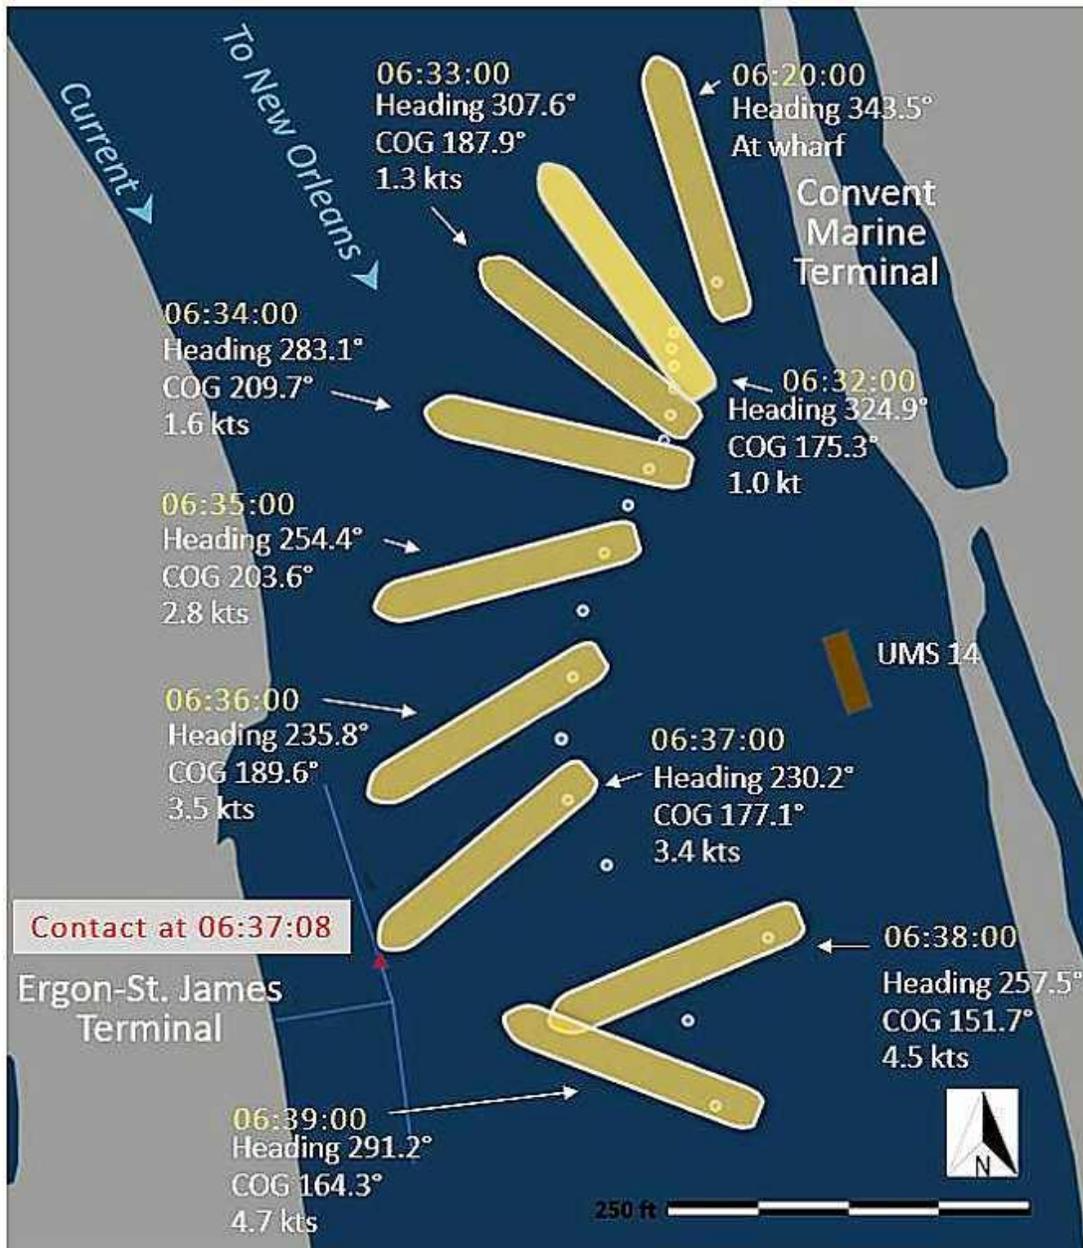
Trackline of the *Shandong Fu En* from 0620 to 0639, showing the vessel's heading and course over ground (COG). (Map data by Google Maps)

Voyage data recorder data showed that maneuvering began at 0629:17 as the bulker's heading slowly started moving to port (from 340 degrees) at a rate of turn of less than 5 degrees per minute. About 5 minutes later at 0634:08, the rate of turn momentarily reached as high as 37 degrees per minute. At 0634:56, the pilot ordered dead slow astern, the first of four astern engine orders before the accident. At 0635:09, the vessel's rate of turn had slowed to 22 degrees per minute and its course was 201 degrees, moving slowly across and down the river nearly broadside to the current. At 0635:17, the pilot ordered slow astern; 18 seconds later half astern; and 14 seconds after that, full astern. At 0636:26, thirty-seven seconds after the full-astern order, the *Admiral Jackson* captain radioed, "83 [the pilot], you're pretty close right here." The pilot responded, "I am backing all I got." Less than 15 seconds later, the bow of the *Shandong Fu En* struck the Ergon-St. James Terminal wharf. After a quick assessment of the damage, at 0637:13 the *Admiral Jackson* captain radioed that the ship had hit a mooring dolphin.

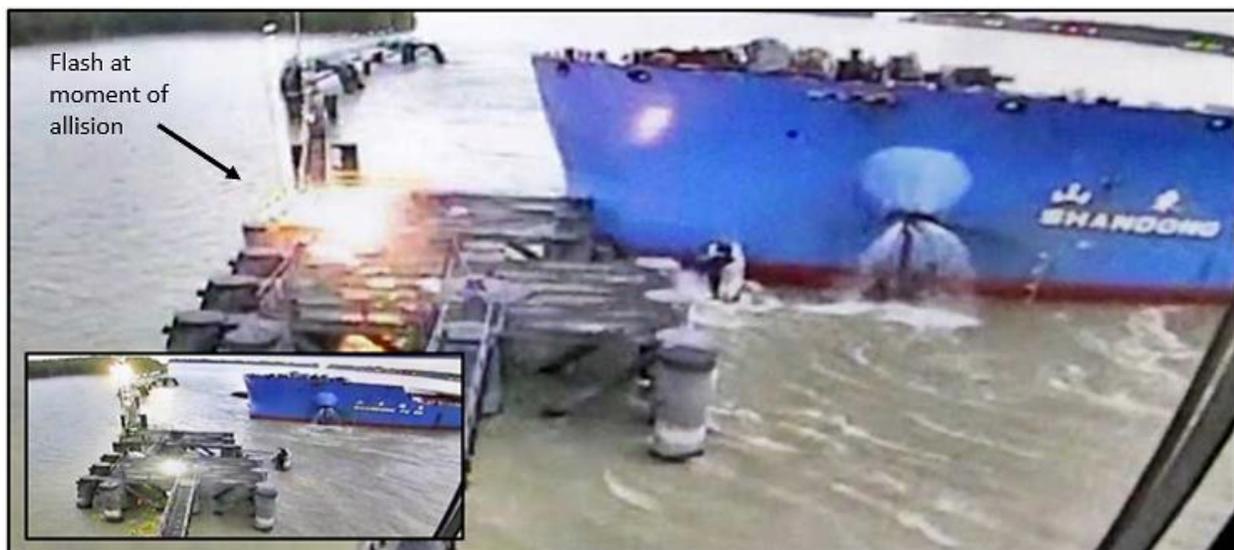
Initial impact of the *Shandong Fu En* bow swinging into the Ergon-St. James Terminal wharf at 0637:08. Inset: Screenshot of the *Shandong Fu En* 20 seconds earlier. A crack and three other holes were found in the bulk carrier's shell plate below the waterline. (Video by Ergon-St. James Terminal)

found the forepeak flooded from four penetrations of the shell plate below the waterline—a 6.6-foot-by-2.1-foot crack and three 5.9-inch diameter holes. The initial estimate to repair the damage to the bulk carrier was \$250,000. The Ergon-St. James Terminal sustained about \$6 million in damage to mooring dolphins and walkways.

The National Transportation Safety Board determines that the probable cause of the contact of bulk carrier *Shandong Fu En* with the Ergon-St. James Terminal wharf was the fatigued pilot's misjudgment of a downstream turning maneuver during high-water conditions.

Pilot organizations have recognized that even for experienced pilots, fatigue can degrade performance especially in challenging conditions aboard deep-draft vessels. Since the accident, the NOBRA Board of Examiners instituted new procedures to mitigate the risk associated with operating deep-draft vessels in high-water conditions on the Mississippi River. These procedures include increasing the sleep opportunity for pilots by 1) lengthening the time between turns from 8 to 12 hours, and 2) reducing the work hours for attended moored vessels from 8 to a maximum of 6 hours per shift. They also include limiting pilot transits and mooring operations to daylight hours.

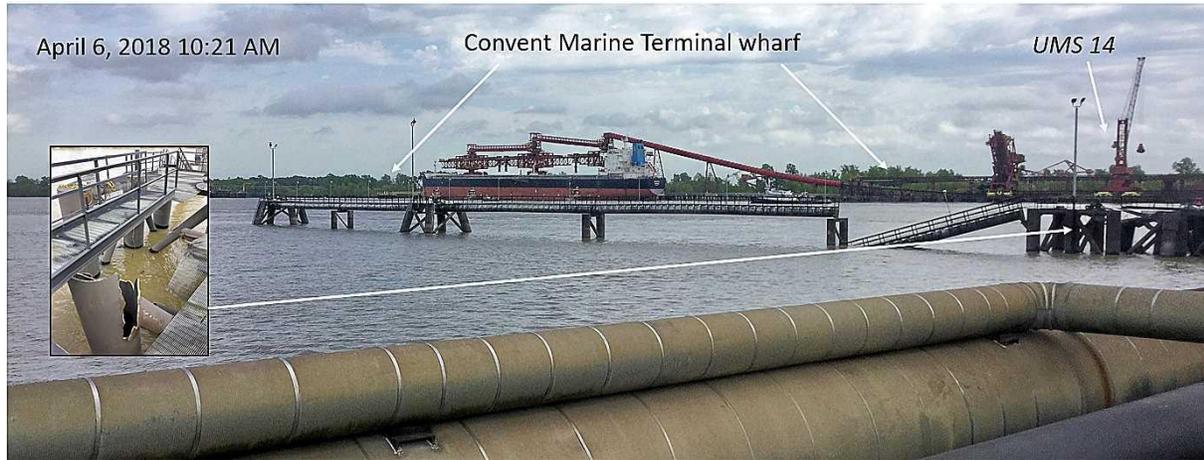
Damaged walkway at the Ergon-St. James Terminal about 4 hours after the accident. Inset: Damaged dolphin. (Photo by Coast Guard)
