National Transportation Safety Board

Marine Accident Brief

Contact of Towing Vessel *Steve Richoux* With Mardi Gras World Pier

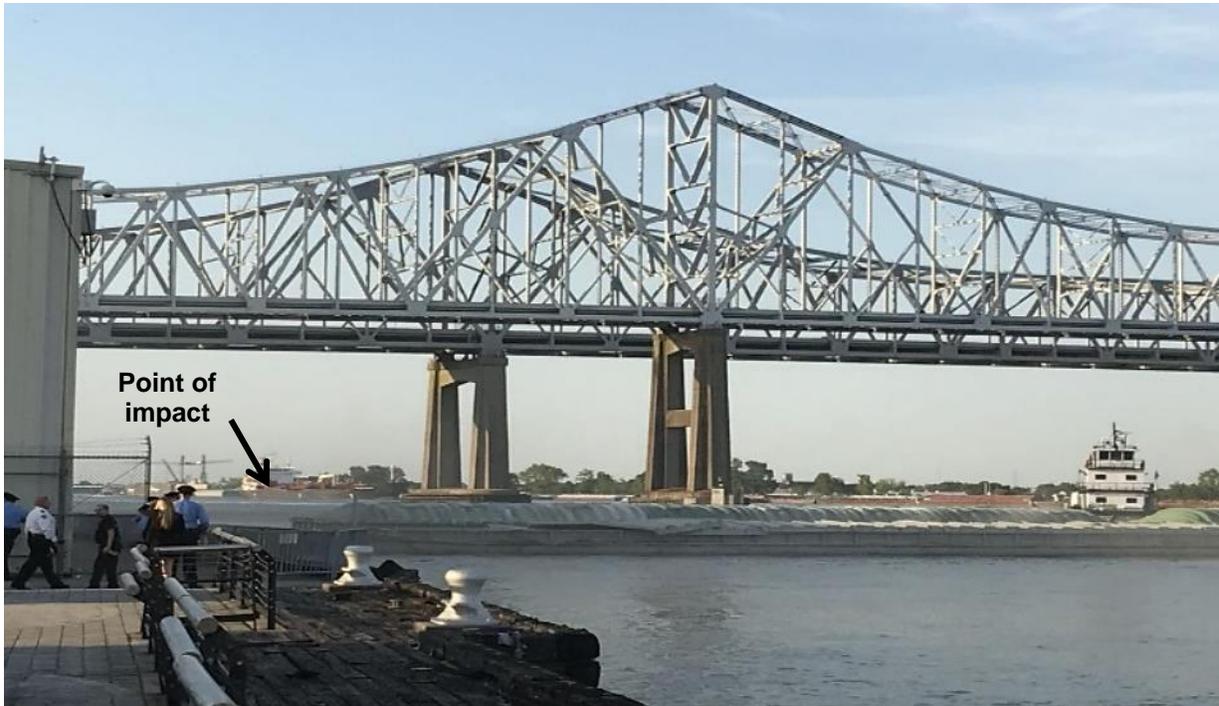
Before any assistance could arrive, the lead two barges of the tow struck the wharf at about 4 mph, causing significant damage to both the wharf and the Mardi Gras World warehouse. Two forward barges sustained minor damage; the *Steve Richoux* itself was not damaged.

Steve Richoux and barges after the accident (view downriver with the Crescent City Connection Bridges in the background). (Source: Mardi Gras World)

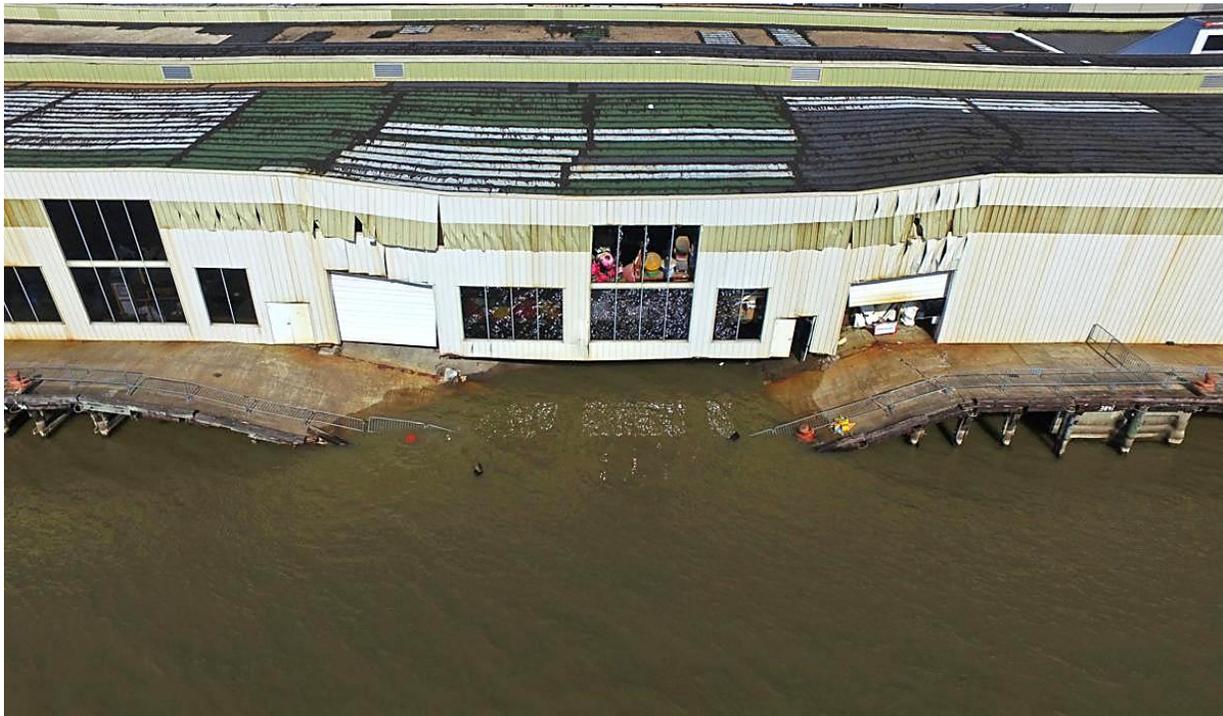
Damage to the Mardi Gras World warehouse and wharf. (Source: Coast Guard)

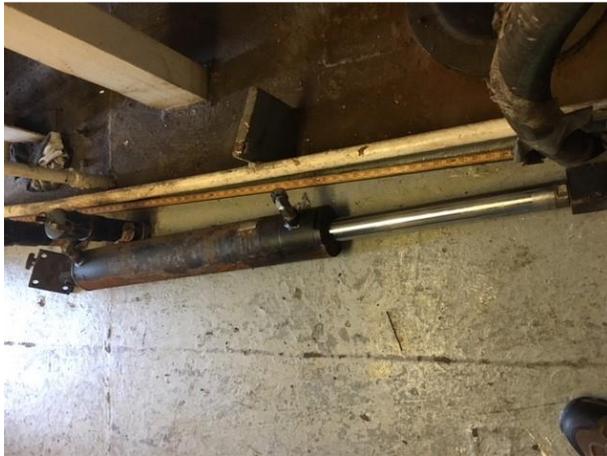
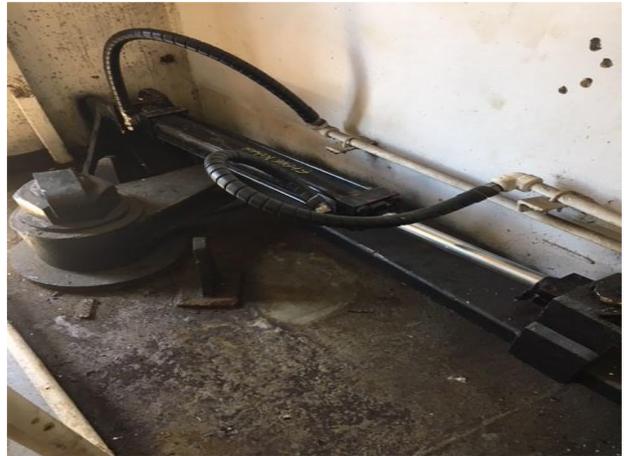
The service technician who tested and repaired the steering system postaccident found that the port flanking rudder actuating ram piston traveled an inch too far to the end of the ram, allowing the rudder to press up against the deck stops. This happened because the piston could extend farther than the distance the rudder could turn. Also, the limit cams that prevented the piston from traveling too far were not properly adjusted due to wear and did not stop the hydraulic supply when the rudder was in the hard-to-port position. This issue would have caused the system to over-pressurize if the flanking rudders were placed hard to port, as the hydraulic pump remained on-stroke and continued to generate hydraulic pressure.

Left, the port flanking rudder steering hydraulic ram that was removed after the incident. Right, the port flanking rudder steering system with the original steering ram in place.

The operational testing of the steering gear system following the 2017 drydock period would not have discovered the over-travel by the port flanking rudder's hydraulic ram piston, because the testing did not place the rams in the hard-to-port position long enough to over-pressurize the hydraulic system. In addition, the maintenance program and reporting system for the vessel was not effective because the crewmembers who had direct experience with the flanking rudder steering issue prior to the accident did not report related alarms to the company's maintenance personnel for repair.

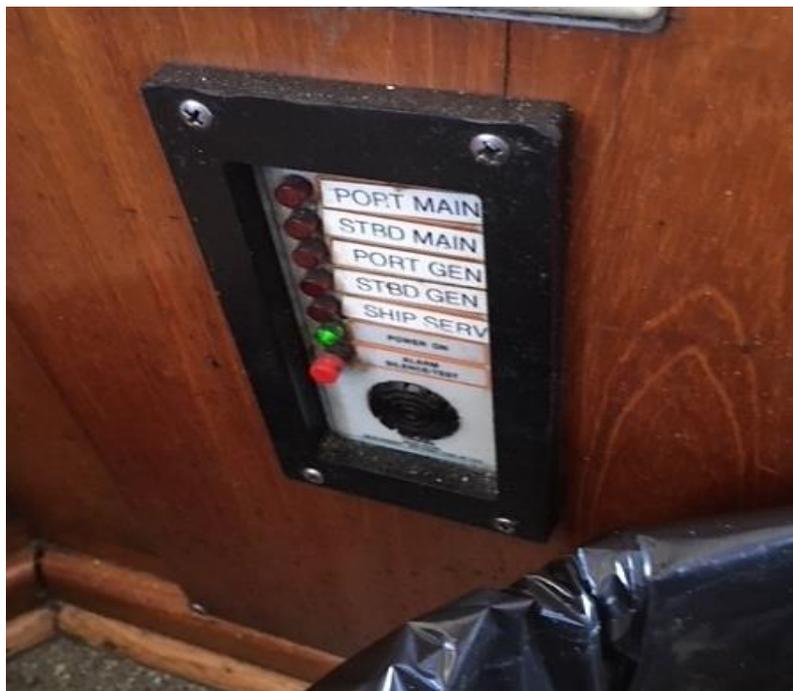
The system was designed so that, if over-pressure occurred, a hydraulic pressure relief valve would lift, protecting the fittings, piping, hoses, and pumps. The “SHIP SERV” alarm would also sound and illuminate in the wheelhouse. The service technician told investigators that this alarm indicated high hydraulic system pressure.

Alarm panel located on the starboard side of the wheelhouse near the deck. The alarm labeled “SHIP SERV” indicated that the steering system was over-pressurized.

who was in the wheelhouse cycled the steering levers for the flanking rudders hard to port several times in an effort to counteract the effect of the current as it moved the vessel from the river's right descending bank toward the left descending bank. Although the alarm listed as "SHIP SERV" activated and was silenced in the wheelhouse, neither the captain nor the pilot realized that its activation meant that the steering system was over-pressurized. Had the alarm been labeled as such, they would have known that the system had a problem.

Towing vessel regulations that took effect after the accident (on July 20, 2018) contain rules for alarms and monitoring. They include that towing vessels "must have a reliable means to provide notification when an emergency condition exists or an essential system develops problems that require attention." The regulations also state that summary alarms at operating stations are permitted, but the specific alarms must then be indicated at the machinery. Aboard the *Steve Richoux*, the over-pressurization alarm was a specific-condition alarm indicated at the operating station (wheelhouse).

Accurate labeling of alarms pertaining to critical machinery and essential systems is crucial so that vessel operators understand the nature of problems or failures. Quickly understanding what specific condition exists allows crewmembers and/or the operating company to take timely and appropriate action to mitigate or correct the condition.

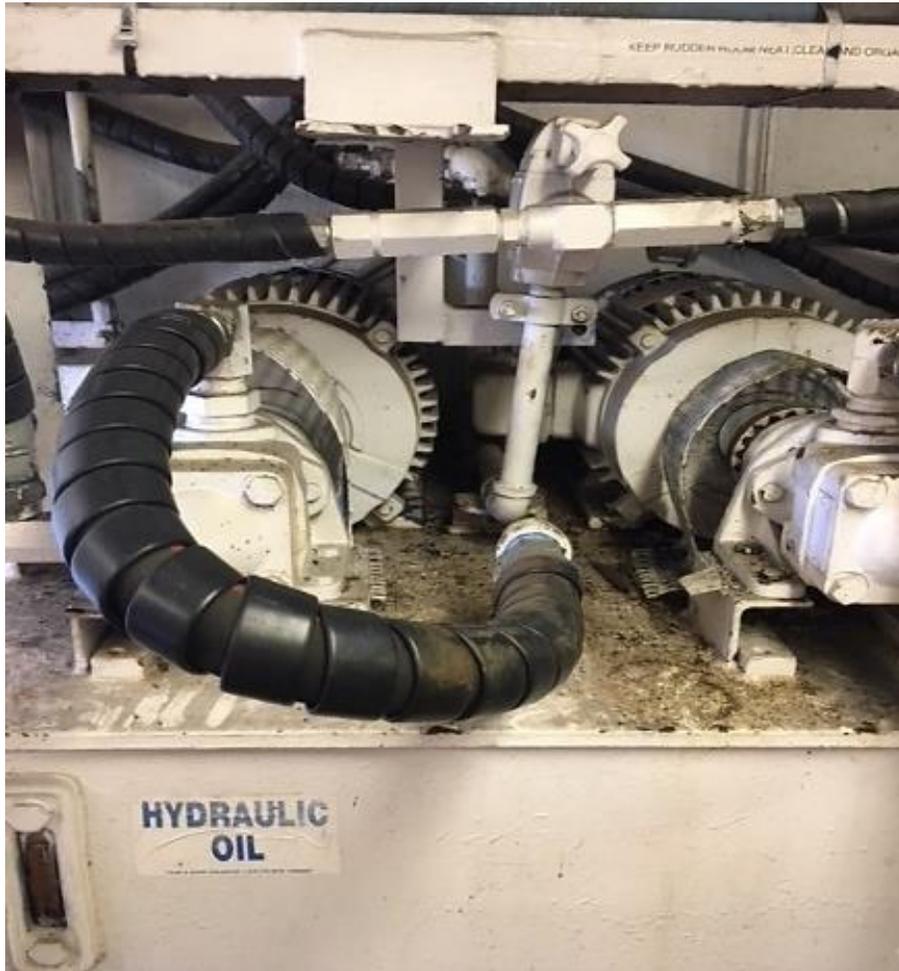
Because the actuating rams for the flanking rudders and main rudders operated off the same hydraulic system, if the port flanking rudder remained in the hard-to-port position and the relief valve continued to lift, the system would not hold normal operating pressure for the rams. Therefore, even if an operator switched between the two hydraulic pumps to maintain system pressure, the rudders would not respond to any additional commands because the relief valve was located on the

discharge side of the pump, preventing adequate oil flow from reaching the hydraulic pistons and developing the required pressure to move the rams.

Steering hydraulic pump motors that operated the flanking and main rudders.

The pilot and the captain tried switching the steering gear pumps to regain control of the vessel but doing so had no effect because the steering loss was caused not by the failure of a steering gear pump but by over-pressurization of the hydraulic system. Steering could not have been restored until the system pressure returned to normal. In an effort to control the vessel, the pilot's rudder commands included placing the flanking rudders hard to port, which unbeknownst to the pilot and captain was the source for the continued over-pressurized condition and subsequent continued lifting of the relief valve, which prevented normal system operating pressure from being restored. Had the captain or the pilot understood the cause of the steering failure, they would only have had to move the flanking rudders off the hard-to-port position to regain steering.
