National Transportation Safety Board

Marine Accident Brief

Fire aboard Fish Tender *Logger*

Accident type	Fire/Explosion	No.	DCA18FM030
Vessel name	<i>Logger</i>		
Location	Bering Sea, about 55 miles west of Port Moller, Alaska 55°54.10' N, 162°10.59' W		
Date	July 28, 2018		
Time	0500 Alaska daylight time (coordinated universal time – 8 hours)		
Injuries	None		
Property damage	\$450,000 est.		
Environmental damage	None reported		
Weather	Visibility 10 miles, light rain, winds west-southwest 17 knots, seas 6–8 feet, air temperature 54°F, water temperature 51°F, sunrise 0646		
Waterway information	The Bering Sea is north of the Alaska Peninsula and the Aleutian Islands, which form an island chain in the north Pacific Ocean.

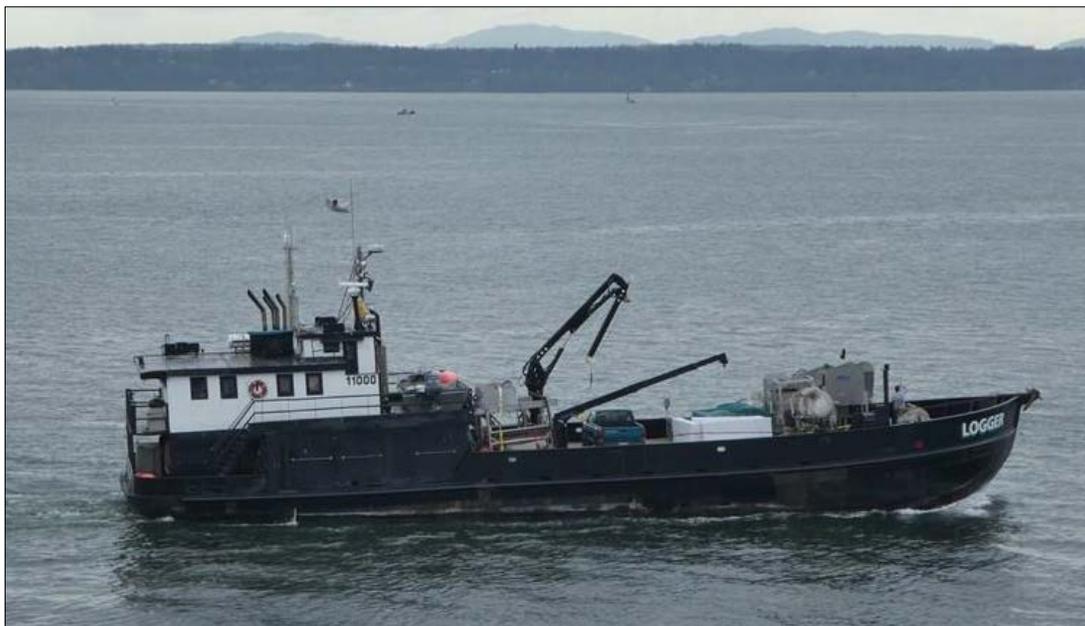
Logger before accident. (Photo by Charlie Allen, MarineTraffic.com)

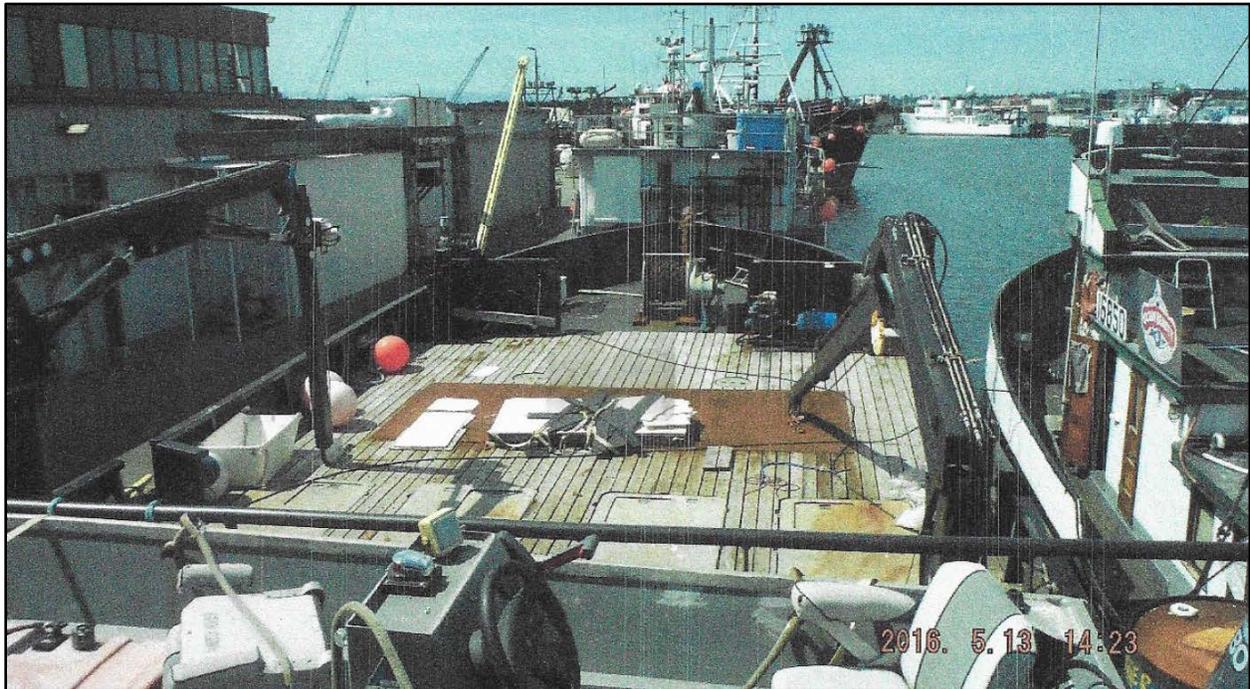
As the heat and smoke continued to fill the deckhouse and wheelhouse the captain and deckhands exited to the main deck and made their way forward to the bow. When the captain looked back, the wheelhouse, galley, and lower deck were engulfed in flames. He recalled that smoke was emanating from wooden planks fitted onto the main deck (which he referred to as the false deck) forward of the house, an indicator that the fire was in the space below the main deck

Photo from 2016 survey report documenting condition of *Logger* shows wooden deck boards (false deck) on the main deck, from where captain saw smoke emanating.

When the captain was asked by investigators where the fire started and what may have ignited it, he surmised that it may have been wiring that led to the forepeak for the fish hold pumps. His reasoning for that potential source was based on the smoke he saw emanating from the main deck and the wooden planks of the false deck, which indicated to him that there may have been a fire below the deck. He noted that the fire had to be substantial in size for smoke to penetrate the deck. However, he stated that the propagation of the fire was so rapid that he could not confirm this possibility with certainty.
