National Transportation Safety Board

Marine Accident Brief

Boom Failure aboard Crane Barge *Atlantic Giant II*

Accident type	Hull/Machinery/Equipment Damage	No. DCA18FM032
Vessel name	<i>Atlantic Giant II</i>	
Location	Brownsville Ship Channel, Brownsville, Texas 25°57.86' N, 097°21.99' W	
Date	August 9, 2018	
Time	2030 central daylight time (coordinated universal time – 5 hours)	
Injuries	3	
Property damage	\$6.4 million est.	
Environmental damage	None	
Weather	Visibility 10 miles, winds southeast 10 mph, seas calm, air temperature 85°F, water temperature 86°F	
Waterway information	In the 14.5-mile-long Brownsville Ship Channel, the section from Goose Island to the Brownsville Turning Basin is 250 feet wide with a controlling depth of 36–39 feet. ¹

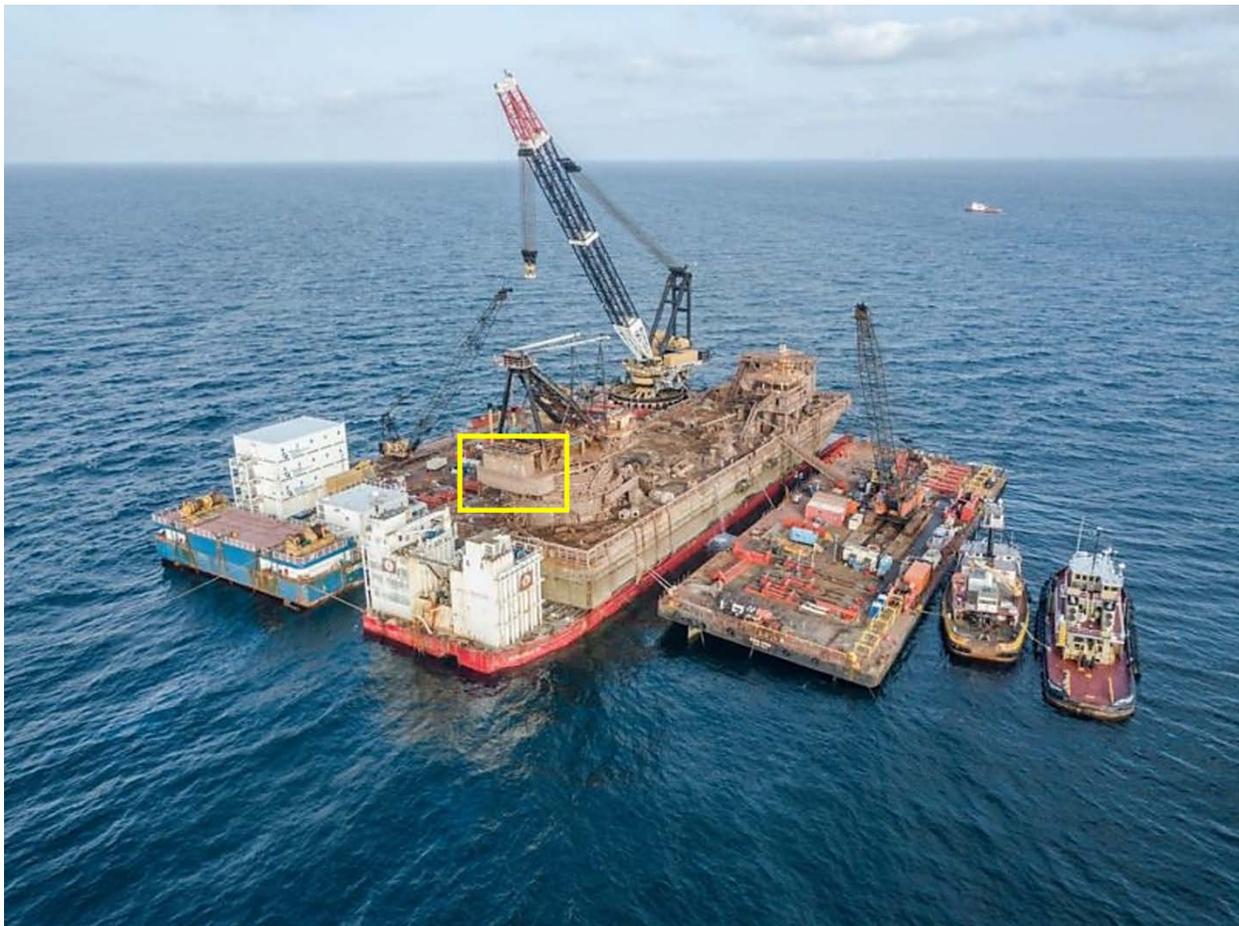
Derrick barge *TOPS DB1* loaded on *BOABARGE 29* during offshore salvage operations in early 2018. Yellow rectangle highlights counterweight lifted by *Atlantic Giant II*. (Photo courtesy of Resolve Marine Group)

Next, tugboats moved the *Atlantic Giant II* into position for the counterweight, and the spuds were lowered. In the pre-job meeting, SteelCoast had stated that the *TOPS DBI*'s crane counterweight weighed 350 tons, which correlated with the original work order from SteelCoast dated August 1.⁸ By 1500, the lift was rigged using a four-part sling, along with four 200-ton chains and 200-ton shackles (the written lift plan called for four 20-foot, 130-ton slings rather than 200-ton chains). According to the crane operator, it was initially rigged for a 550-ton lift at a 60-degree boom angle. Following the lift plan, Keppel AmFELS instructed the crane to take up 350 tons of tension with the main hoist while crews cut the lift free of the *TOPS DBI*. By 1645, after the lift was cut free, the crane was ordered to take up 400 tons, but the lift did not move. All parties then agreed to take up 500 tons of tension.

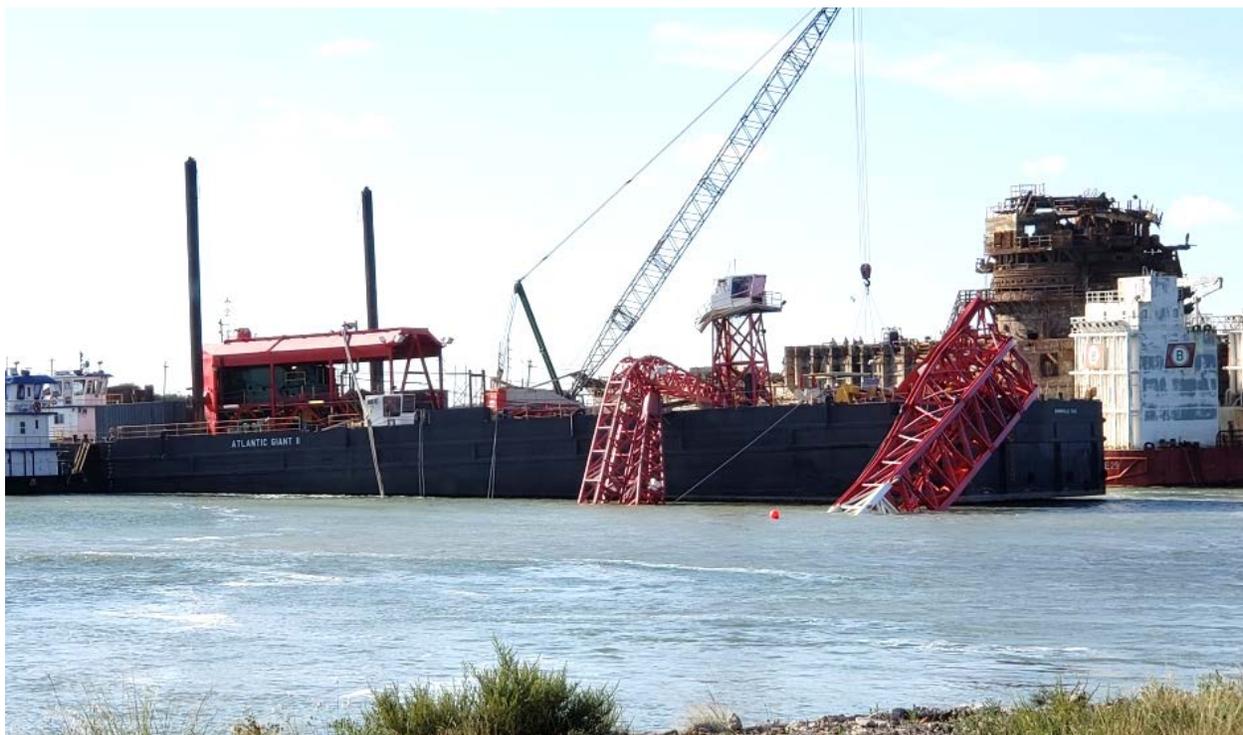
Two tugboats were used to rotate and move the *Atlantic Giant II* and the counterweight toward the dock. Before they rotated the barge from facing east to southeast, the port spud was raised. After it was lowered, one of the tugboats repositioned. The port spud was then raised again, followed by the starboard spud. However, at about 2030, shortly after the starboard spud was raised, the barge heeled to starboard and the crane's boom collapsed. The port stay failed first, dropping the load into the channel.⁹

Collapsed crane boom on *Atlantic Giant II*. In background are *TOPS DB1* and *BOABARGE 29*. (Photo by Coast Guard)

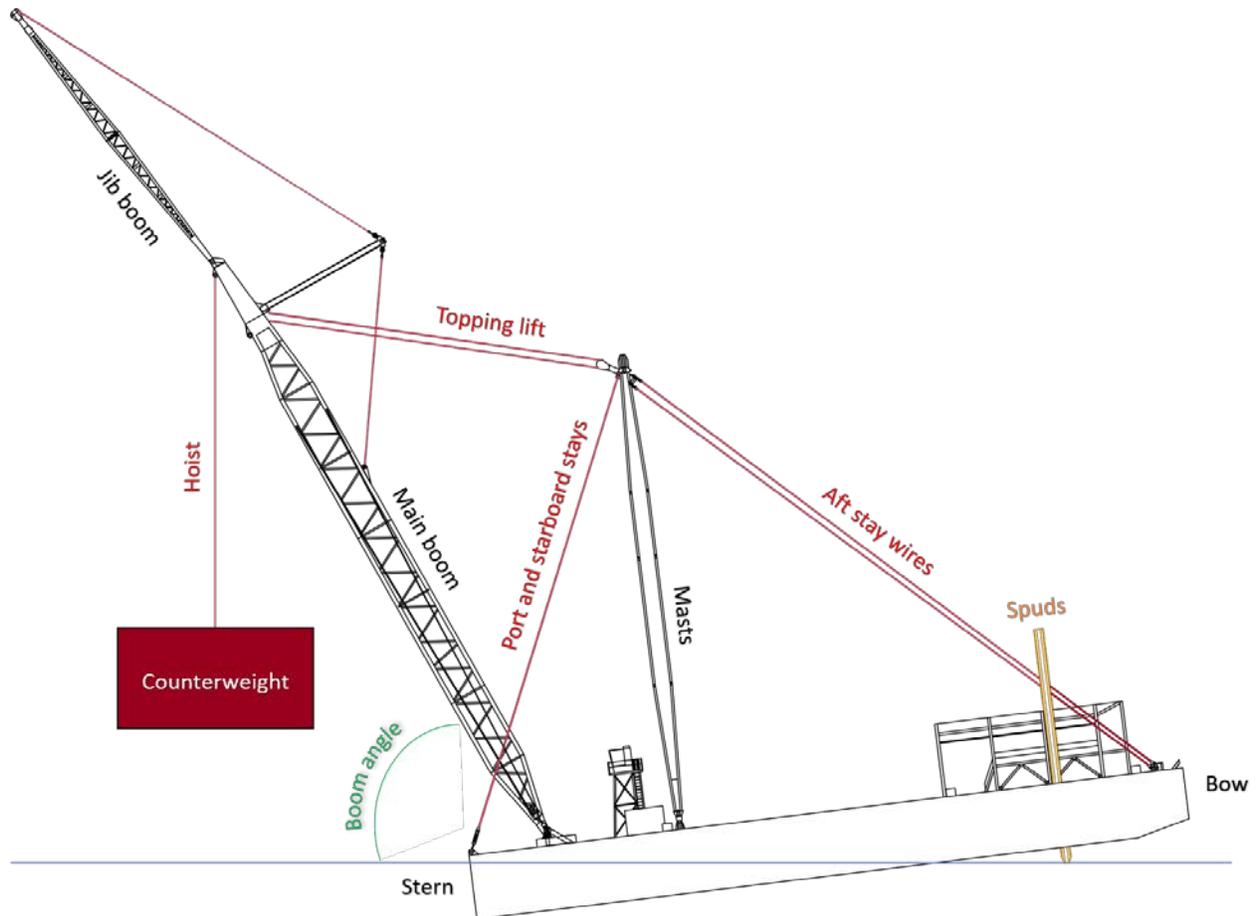
Simplified diagram of *Atlantic Giant II* illustrates barge's trim and boom angle relative to sea level, as crane hoists *TOPS DB1*'s counterweight. (Dimensions and angles not drawn to scale.)

Typically, load chart ratings are based on the crane being perfectly level in all directions. A crane that is not level due to a list causes sidelading of the boom, thus reducing the rated capacity. The crane operator stated that he boomed up to 69 or 70 degrees; the Keppel AmFELS' incident report stated 68 degrees. Therefore, the vessel would have trimmed at least 7 degrees by the stern—hence the 1.5 foot of air gap the tugboat captains witnessed at the barge's end opposite of the crane—for the boom angle to read 60.7 degrees when the weight was suspended. At 60.7 degrees of boom angle, the maximum capacity of 645 tons was exceeded by 26 tons. The trim

likely contributed to the crane being overloaded by reducing the boom angle relative to the water. After the accident, SCM issued additional internal guidelines for crane barge lifting operations that call for more detailed weight, structural, and stress information from clients.

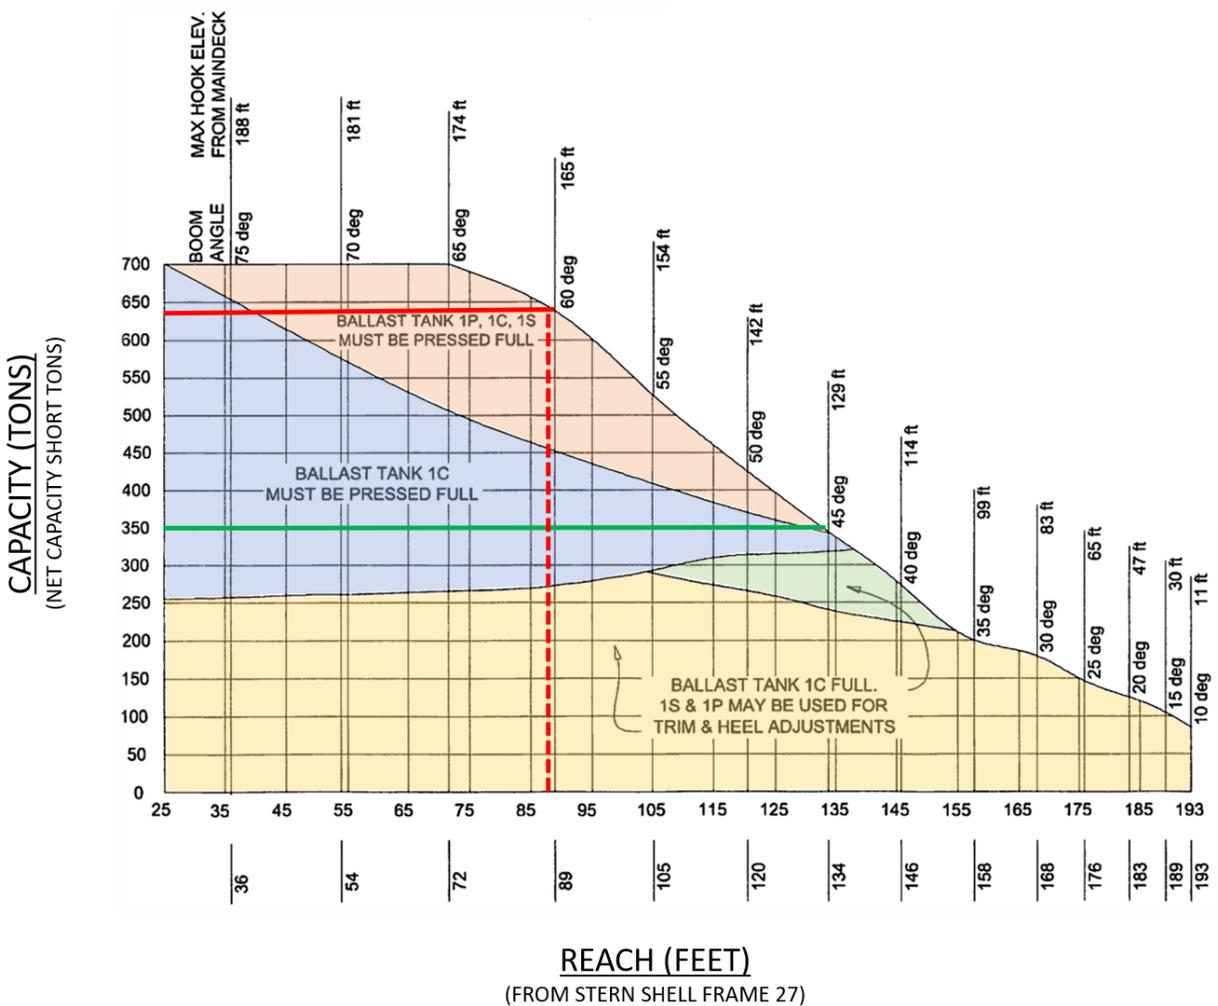
Crane capacity chart for *Atlantic Giant II*. Solid red line overlaid onto chart indicates maximum weight of 645 tons for a 60.7-degree boom angle (dashed red line). Green line indicates planned lift of 350-ton counterweight. (Colors added to distinguish between ballast tank requirements)

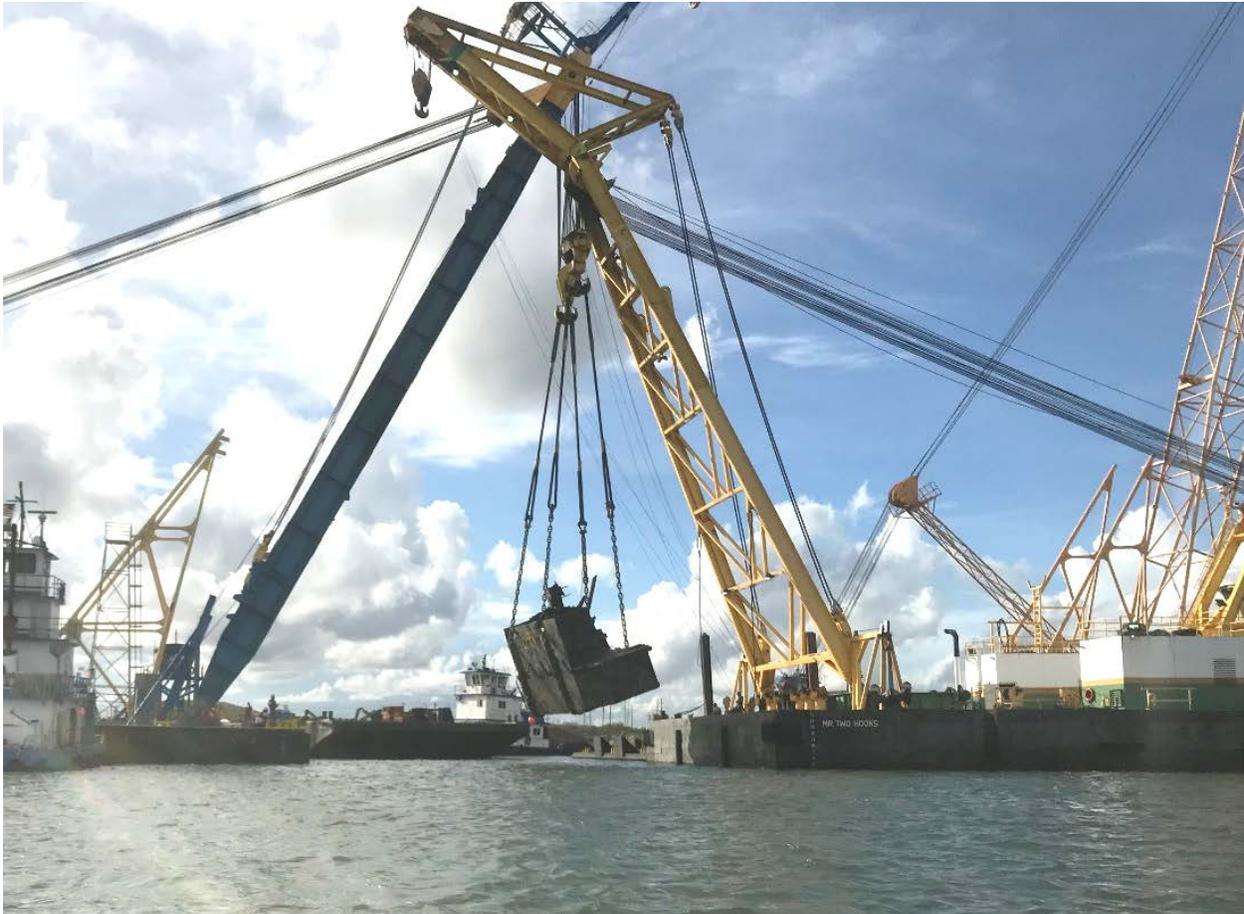
When the counterweight was later recovered from the water, salvors reported the lift weighed 671 tons.

Counterweight being recovered from harbor. (Photo by Coast Guard)
