National Transportation Safety Board

Marine Accident Brief

Collision between Fishing Vessels *Got 'M On* and *Lady Toni*, and Subsequent Sinking of *Got 'M On*

Accident type	Collision	No. DCA18FM031
Vessel names	<i>Got 'M On</i> and <i>Lady Toni</i>	
Location	Gulf of Mexico, near Port O'Connor, Texas 27°53.3' N, 095°41.5' W	
Date	July 28, 2018	
Time	1548 central daylight time (coordinated universal time – 5 hours)	
Injuries	Minor	
Property damage	\$1.45 million est.	
Environmental damage	None reported	
Weather	Visibility 10 miles, winds calm, seas 1–2 feet, air temperature 90°F, water temperature 87°F	
Waterway information	Open waters of the Gulf of Mexico, at a water depth of about 200 feet, approximately 105 miles east of Corpus Christi, Texas

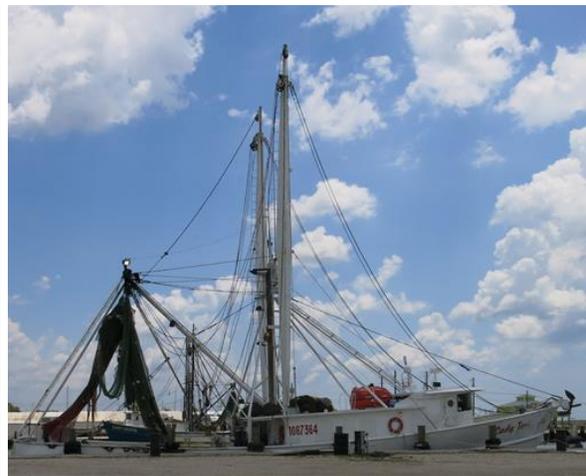
On the afternoon of July 28, 2018, the sport-fishing vessel *Got 'M On* collided with the commercial fishing vessel *Lady Toni* about 105 miles east of Corpus Christi, Texas. The *Got 'M On* began flooding and all eight persons aboard disembarked to a Good Samaritan vessel before the sport-fishing boat sank. No pollution or injuries were reported. The value of the *Got 'M On* was \$1.2 million and damage to the *Lady Toni* was about \$250,000.

Left: *Got 'M On*, pre-accident. (Photo by Clay Voss) Right: *Lady Toni* dockside, postaccident.

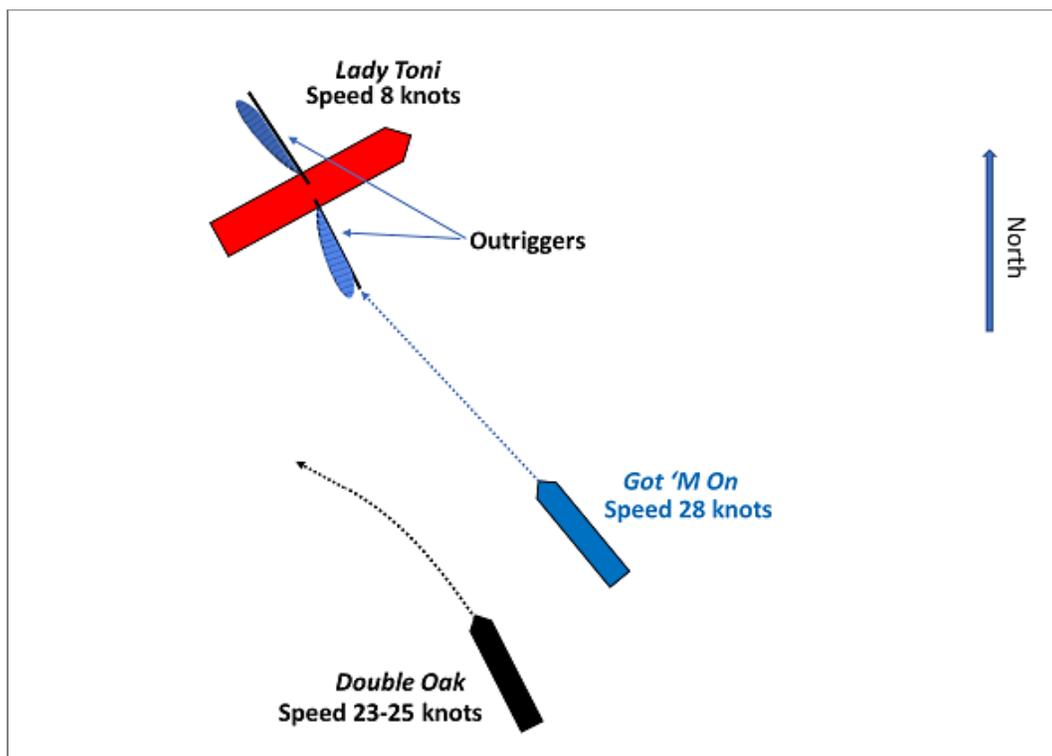
The *Double Oak* was under way at 23–25 knots, heading in a northwesterly direction (somewhat parallel to the *Got 'M On*) back to Port O'Connor and, according to two deckhands on the flying bridge of the vessel, were overtaken on their starboard side by the *Got 'M On*. The deckhands estimated that the *Got 'M On* overtook the *Double Oak* at a distance of between 400 yards and half a mile. The deckhand steering the *Double Oak*, who had previously captained other sport-fishing vessels, said he maneuvered the boat to port about 2–3 minutes before the collision to avoid the *Lady Toni* just before the *Got 'M On* overtook the *Double Oak*. Both of the *Double Oak* deckhands told investigators that, prior to the collision, they saw no one on the decks or at the conning stations of either vessel, that neither the *Got 'M On* nor the *Lady Toni* changed course or speed, and that they heard no radio transmission from either vessel.

Approximate positions of vessels prior to collision. (Not to scale)

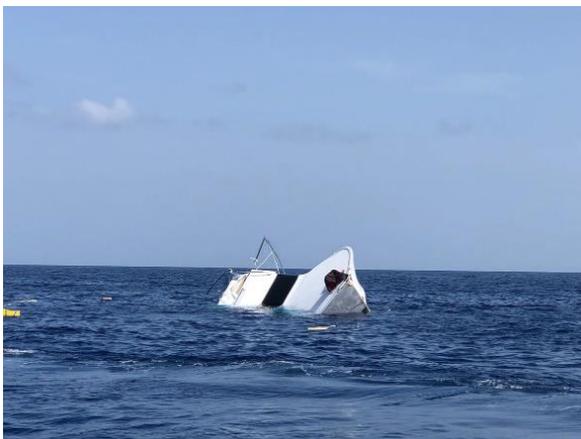
Both *Double Oak* deckhands stated that they saw the outrigger of the shrimp boat strike the flying bridge of the *Got 'M On*, which caused the *Got 'M On* to pivot and the starboard bow of the *Got 'M On* to strike the starboard quarter of the fishing vessel. According to the deckhand steering *Double Oak*, the force of the *Got 'M On* striking the *Lady Toni* lifted the sport-fishing vessel about 3–4 feet into the air.

Left: *Got 'M On* shortly after the collision. (Photo by John Hafernick) Right: The starboard (damaged) side of *Lady Toni*.
