National Transportation Safety Board

Marine Accident Brief

Grounding and Sinking of Fishing Vessel *Capt. M&M*

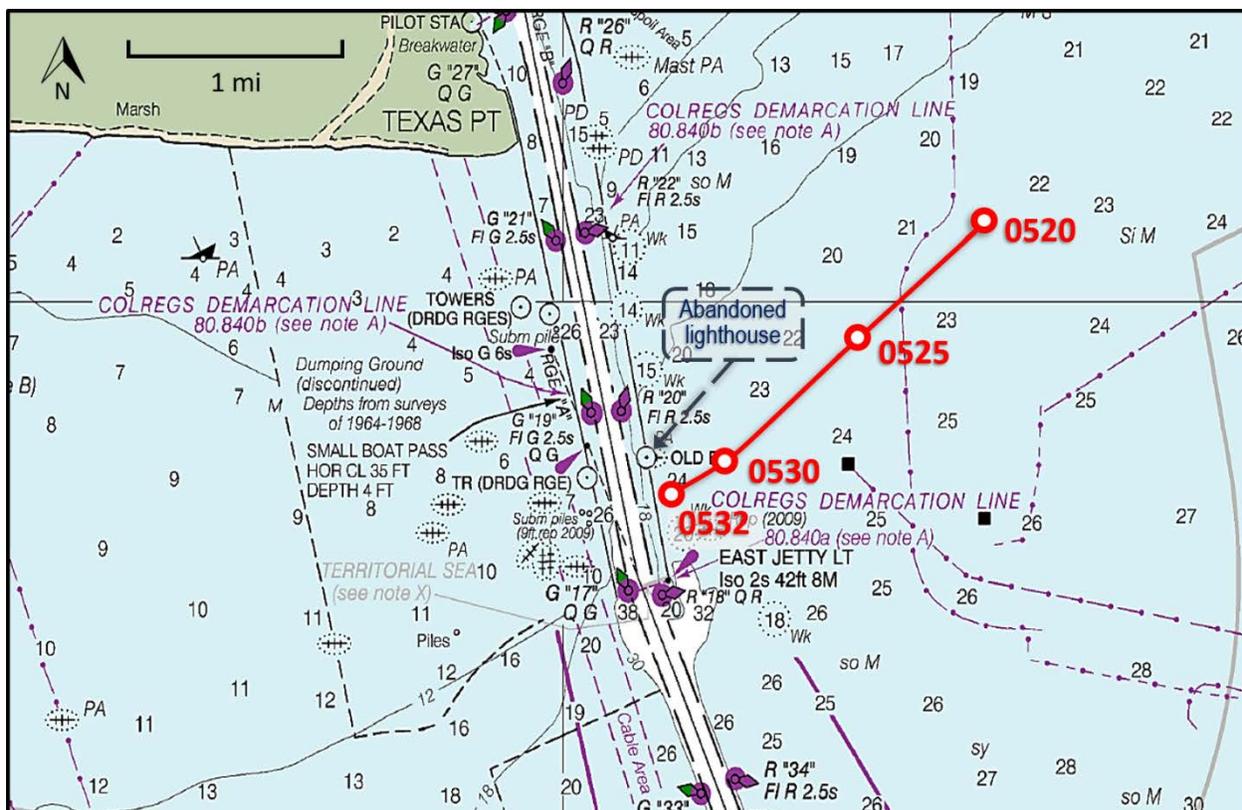
About 0520 on September 18, about half an hour before sunrise, the *Capt. M&M* was approaching the channel from the east on a steady course of 227 degrees true at 8 knots, according to a replay of Port Arthur Vessel Traffic Service's (VTS) display.³ Approximately 10 minutes later, the radar target on the display reached the east jetty 0.6 mile north of the jetty's end. At 0532, the *Capt. M&M*'s starboard bow struck the jetty.⁴ Located nearby was an abandoned lighthouse on the jetty and lighted red buoy "20," 0.2 mile north and inside of the jetty.

Trackline of the *Capt. M&M* before grounding on the jetty. (Source: NOAA chart 11332)

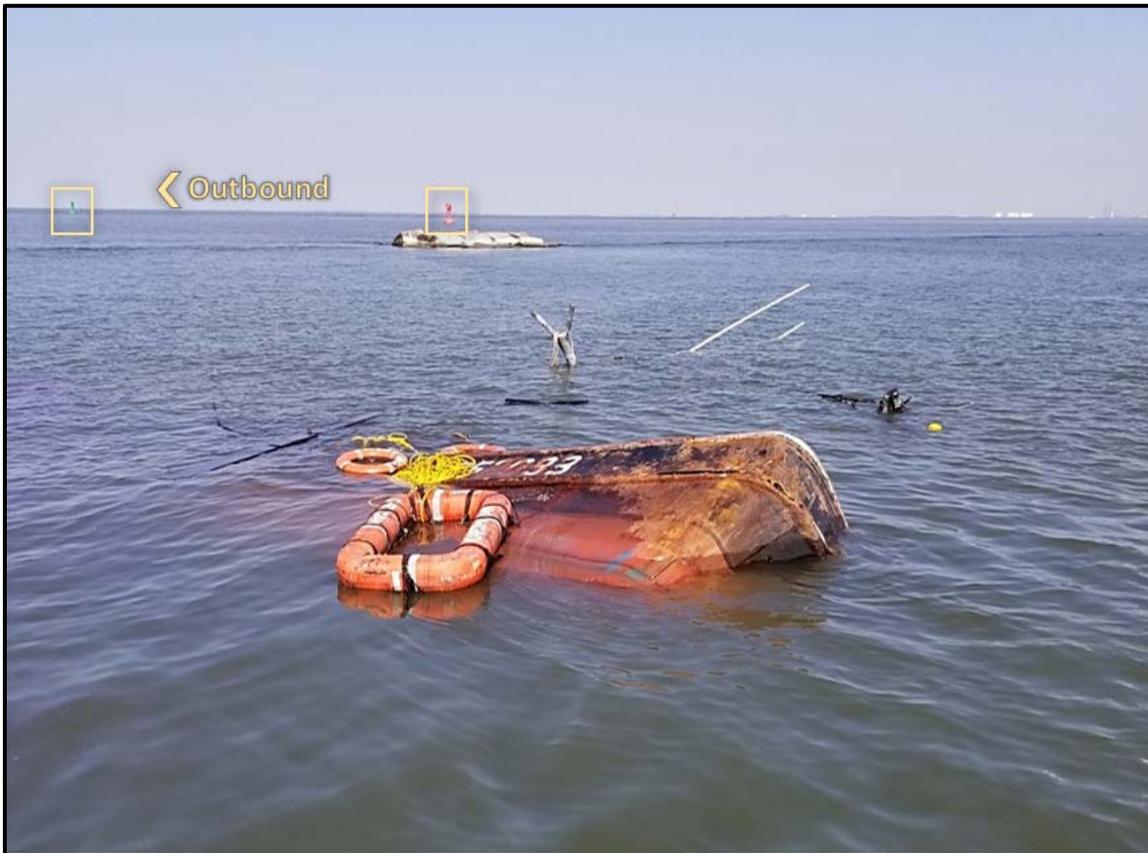
The impact from the grounding awoke the sleeping crew and caused a hole in the forepeak through which water began entering the vessel. The engine room also began flooding through a cutout in the collision bulkhead that separated the engine room from the forepeak.

After capsizing, the vessel sank several days later near the site of the grounding. The MH-65 crew reported seeing a 1.5-by-1.0-mile oil sheen afterward. At the time of the accident, the *Capt. M&M* had 3,500 gallons on board, just under half of its fuel capacity. None of the fuel was recovered.

Starboard quarter of the *Capt. M&M* wreckage. Sabine Pass Jetty Channel buoys "19" (green) and "20" (red) appear in the background. (Source: Coast Guard)

The crew stated in interviews that the vessel flooded from a holed forepeak below the waterline, which allowed progressive flooding into the engine room via a cutout in the collision bulkhead. According to Coast Guard personnel and Vermillion Gulf Seafood staff, it is a common practice in the local shrimp fleet to modify the bulkhead with a cutout to allow access to the forepeak from the engine room. However, modifying this bulkhead on the *Capt. M&M* defeated the purpose of a watertight collision bulkhead, which is to limit flooding to the forward compartment of a vessel following a collision. Once flooding reached the engine room, the vessel likely lost stability and capsized. Although regulations regarding the integrity of collision bulkheads exist for inspected vessels, they do not apply to fishing vessels the size and age of the *Capt. M&M*; therefore, the Coast Guard did not require repair of the cutout in the bulkhead.

The National Transportation Safety Board determines that the probable cause of the grounding of the fishing vessel *Capt. M&M* was the failure of the wheelhouse watchstander to keep a proper navigation watch. Contributing to the sinking was a modification to the watertight collision bulkhead that allowed progressive flooding.

Collision bulkheads—the first transverse watertight bulkhead aft of a vessel's stem—are designed to prevent progressive flooding when the bow is compromised in a collision. Cutting holes in these bulkheads for ease of access to adjacent spaces defeats the designed intent of the bulkhead. Vessel owners, operators, and crews should ensure the integrity of their vessels' watertight subdivision is maintained.
