# National Transportation Safety Board

## Marine Accident Brief

### Engine Room Fire aboard Towing Vessel *Jacob Kyle Rusthoven*

<b>Accident type</b>	Fire/Explosion	<b>No.</b> DCA18FM038
<b>Vessel name</b>	<i>Jacob Kyle Rusthoven</i>	
<b>Location</b>	Lower Mississippi River, mile 673.8; near West Helena, Arkansas <sup>1</sup> 34°38.77' N, 090°35.12' W	
<b>Date</b>	September 12, 2018	
<b>Time</b>	1005 central daylight time (coordinated universal time – 5 hours)	
<b>Injuries</b>	None	
<b>Property damage</b>	\$1.5 million est.	
<b>Environmental damage</b>	None reported	
<b>Weather</b>	Clear, visibility 10 miles, winds light and variable, air temperature 70°F	
<b>Waterway information</b>	According to the Helena Gage at mile 663.1, located 10 miles south of the accident, the river height was 19.1 feet and rising.

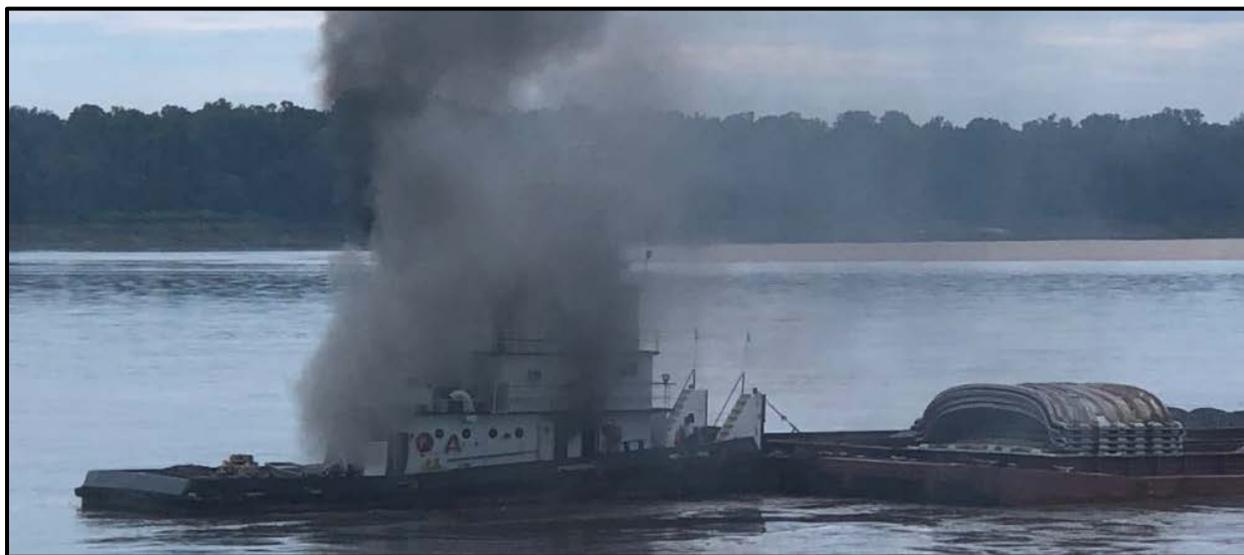
As the *Jacob Kyle Rusthoven* passed the *Bill Atkinson*, the captain of the *Bill Atkinson* noticed smoke coming from the open starboard-side engine room door of the *Jacob Kyle Rusthoven* when the vessel was about abeam of his wheelhouse. The captain of the *Jacob Kyle Rusthoven* then broadcasted on the radio that his vessel was on fire and adrift.

Smoke emanating from the open starboard-side and aft engine room doors on the main deck. (Source: *Bill Atkinson* captain)

**Fire Investigation.** The *Jacob Kyle Rusthoven* was destroyed in the fire with only its forward and aft open decks left unburned. All documents and records kept on board the vessel burned in the fire, and the vessel was declared to be a total loss. The emergency fuel oil shutoffs on both the port and starboard sides were found to have not been activated. Based on witness photos and video, all main deck access doors were open before and during the fire.

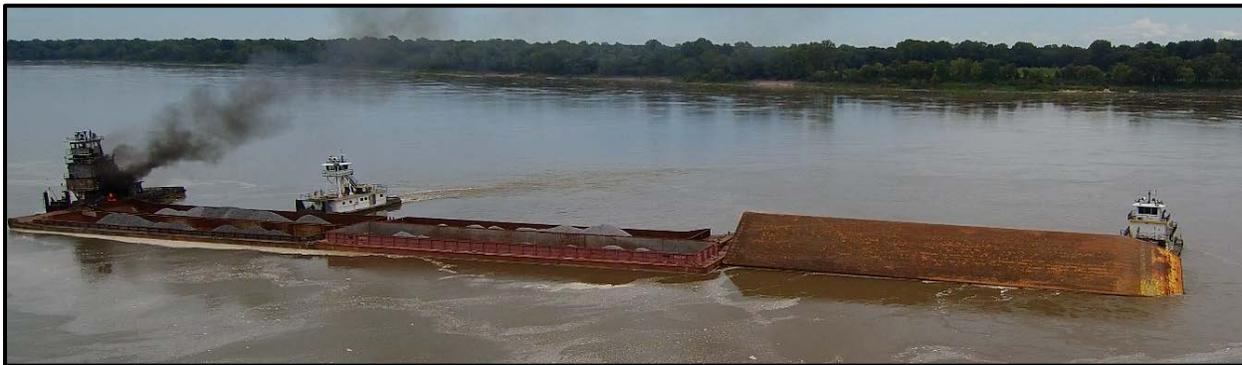
According to the mate on the *Jacob Kyle Rusthoven*, once they were in the skiff, about 200 feet away from the drifting *Jacob Kyle Rusthoven* and tow, the stern of the towboat hit the bank and the tow wires started to part. The center head deck barge, *GD 953*, flipped over, dumped its load of limestone, and settled upside down on top of barge *GD 952*. Three of the barges in the starboard string broke out of the tow. Towing vessels from West Helena arrived on scene to assist in gathering the *Jacob Kyle Rusthoven* and its barges, eventually pushing them up against the right descending bank.

Two towing vessels push toward the bank the remaining barges as the *Jacob Kyle Rusthoven* burns. Barge *GD 953*, which had turned over, sits on top of barge *GD 952*. (Source: Coast Guard)

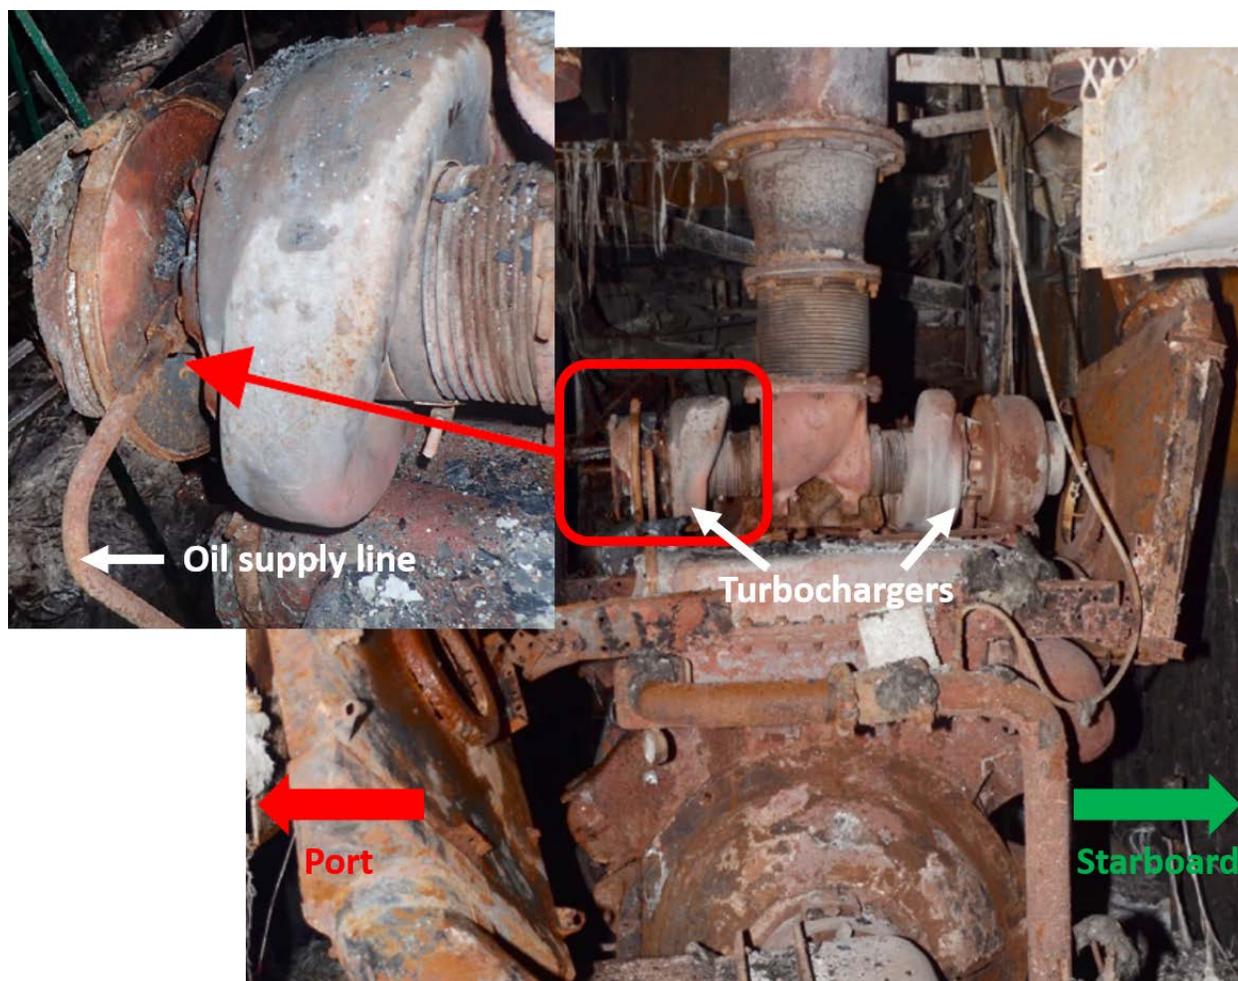
A commercial forensic science firm contracted by the vessel's insurer conducted an examination of the vessel at the shipyard. According to the firm's representative, fire damage to the starboard main engine was greater than the port main engine. The inboard turbocharger assembly on the starboard main engine had significantly more fire and heat damage than anywhere else. The wires that secured the insulation around the engine's high-temperature exhaust piping and turbocharger components burned away, and the metal components of the casing and compressor wheel of the inboard turbocharger melted. The fitting on the lube oil supply line to the starboard-side turbocharger was found to be loose enough that it could be moved on its threads by a finger. There was no fire damage beneath the engine or in the bilge.

Fire-damaged starboard main engine, while looking forward. The red box highlights the inboard turbocharger with its casing and compressor missing due to the damage. The inset shows the lube oil supply line fitting that was found to be loose. (Source: SEA Limited)

The fire was determined to have originated at or near the inboard turbocharger on the starboard-side main engine based on the heat damage at that location. A commercial forensics science firm found that a loose fitting on the lube oil supply line was a likely fuel source. Considering witness accounts of the captain operating the vessel at full power (maximum engine rpm), it was likely that when smoke first appeared, the lube oil in the line to the turbocharger was at or near its maximum operating pressure. The pressurized lube oil could have atomized from the loosened fitting and consequently come into contact with a hot surface on the starboard engine near the turbocharger. The atomized oil would have likely ignited and eventually spread the fire to adjacent combustible materials in the engine compartment, before spreading to the upper level. As the engines and generator(s) continued to run until they failed, they would have continued to supply lube oil and eventually fuel from any of the non-metallic fuel hoses and filters that failed as a result of fire exposure. It could not be determined how the lube oil pipe fitting loosened or when it was last serviced, or if the correct torque for that connection was applied.

The National Transportation Safety Board determines that the probable cause of the engine room fire on board the towing vessel *Jacob Kyle Rusthoven* was an engine lube oil leak that ignited off a hot surface near the starboard main engine turbocharger. Contributing to the severity of the fire was the lack of crew measures to activate the engine fuel supply shutoffs and secure open doors ventilating the engine room.
