# National Transportation Safety Board

## Marine Accident Brief

### Contact of Cruise Ship *Carnival Horizon* with Manhattan Cruise Terminal Pier 90

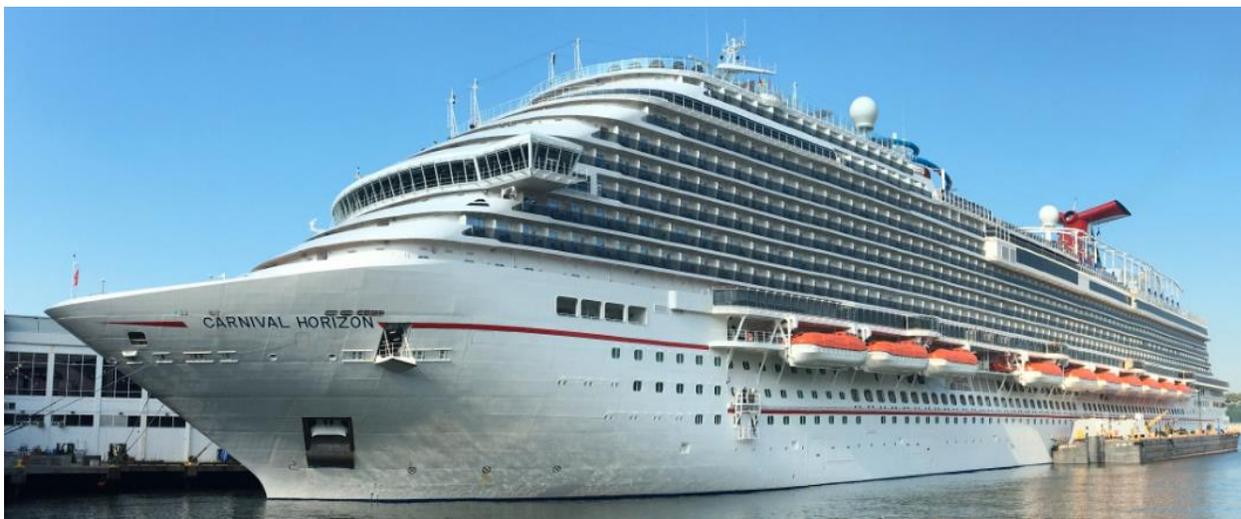
On the morning of August 28, 2018, the cruise ship *Carnival Horizon*, with a total of 6,361 people on board, was maneuvering to berth no. 2 at Manhattan Cruise Terminal's Pier 88 in New York City, New York, when its bow struck the southwest corner of adjacent Pier 90. No one was injured and no pollution occurred, but Pier 90's walkway, roof parking garage, and facilities suffered extensive structural damage, and the ship sustained minor damage above the waterline, totaling about \$2.5 million in cumulative damage.

***Carnival Horizon* at the Manhattan Cruise Terminal after the accident.**

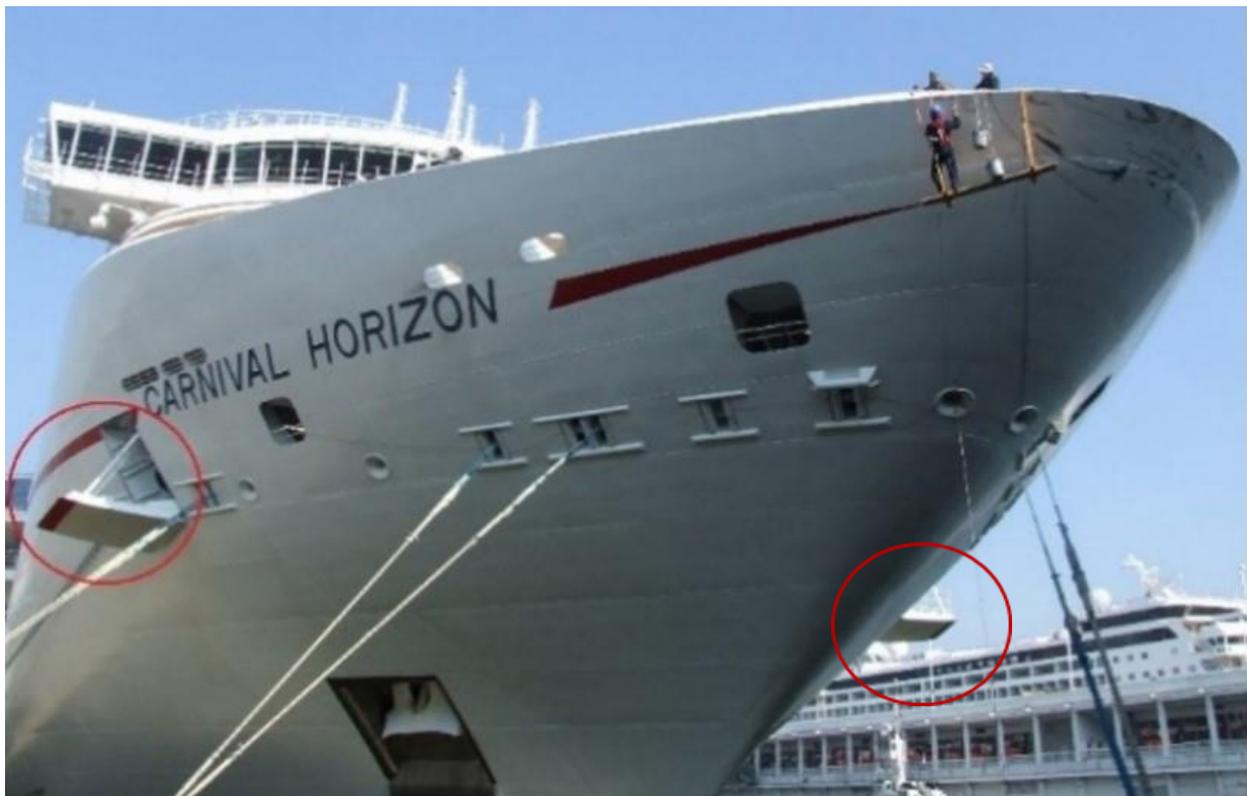
***Carnival Horizon's* bow after the accident. The forward mooring platforms where the lookout was stationed (about a 100 feet aft from the tip of the bow) are circled in red. (Source: Coast Guard)**

During interviews with the master, the staff captain, and the third officer, investigators inquired about the position of the forward lookout. The third officer stated that he went back and forth between the port- and starboard-side mooring platforms to estimate the distance from the bow to Pier 90 by line of sight. When switching position between the port and starboard mooring platforms, he would have to walk about 15 meters across the mooring deck. No crewmember was positioned on the tip of the bow to observe the clearing distances. The master and the staff captain both stated that, in the future, they would place a crewmember on the tip of the bow (one deck higher and farther forward than during the accident) for docking maneuvers. In a subsequent interview, the master told investigators that during the ship's next return trip to Pier 88 on September 5, 2018, a crewmember was placed at the tip of the bow. In fact, the ship's standard operating procedures were revised to include the addition of a crewmember on the bow specifically for maneuvers where the bow is expected to come in close proximity of objects while maneuvering in and out of port.

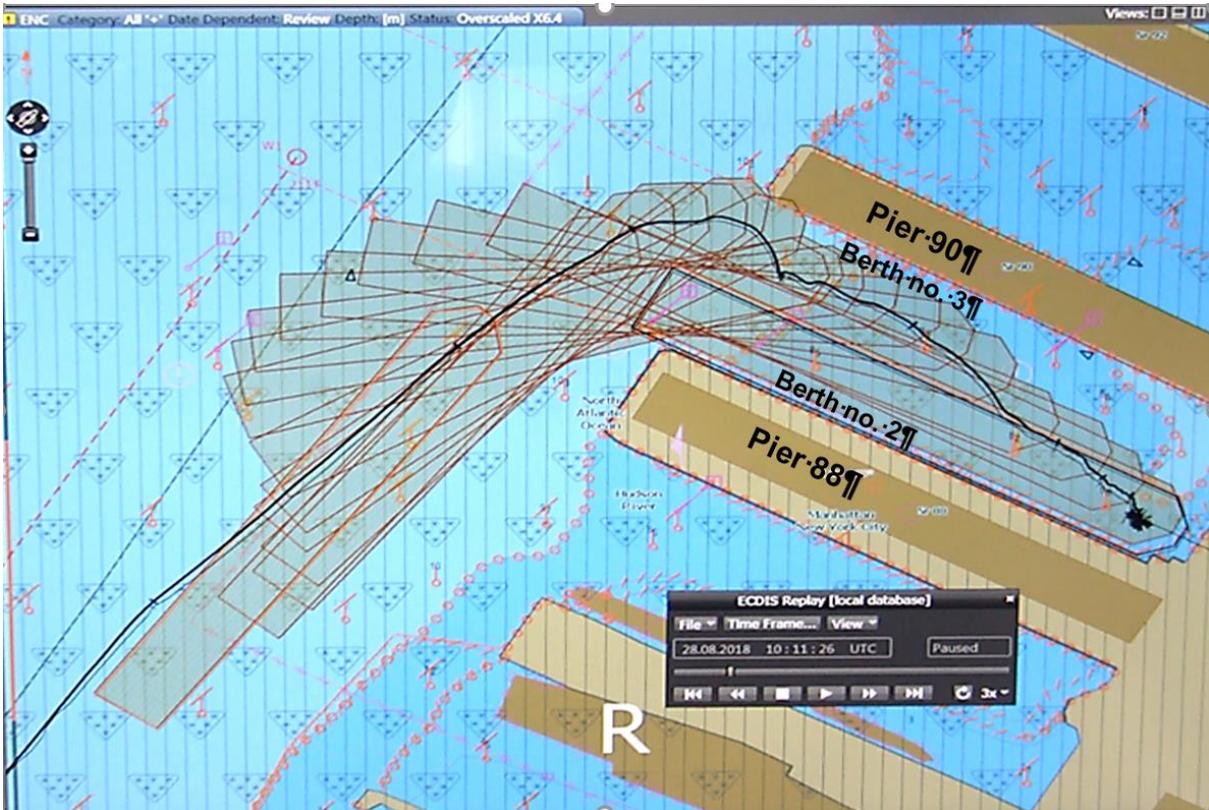
Screenshot from the *Carnival Horizon*'s ECDIS, showing the vessel's track beginning at 0539 and ending at 0611.

In response to the pilot's heading orders, the master moved the azipod control levers individually to adjust the thrust angle and rpm (thrust amount) for each azipod to bring the ship to that course. At 0541, the rpm on both azipods were increased from 50 to 60. Between 0545 and 0548, at a speed over ground of about 1.3 knots, the ship's bow began to clear the corner of Pier 88 where the ship was to dock starboard side to. The pilot gave a series of thruster orders.

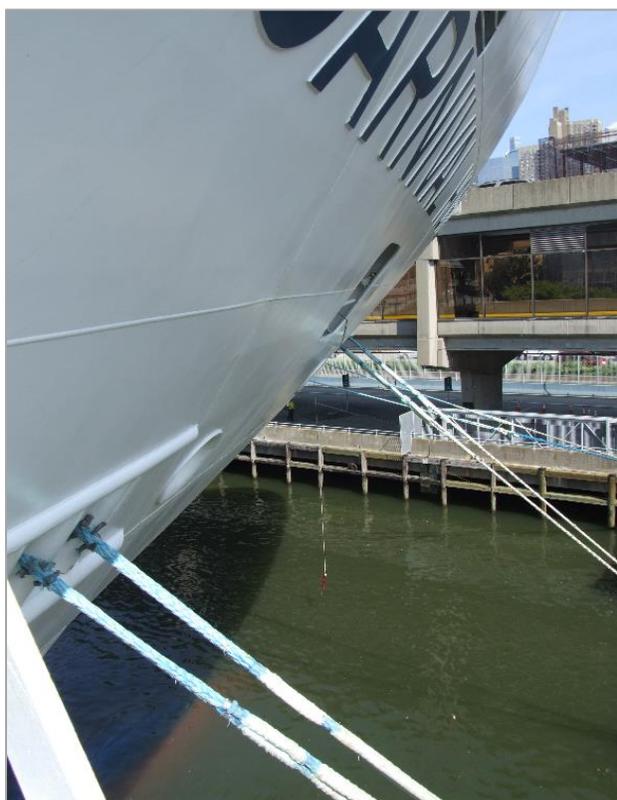
View from *Carnival Horizon*'s starboard mooring platform looking forward toward the bow.

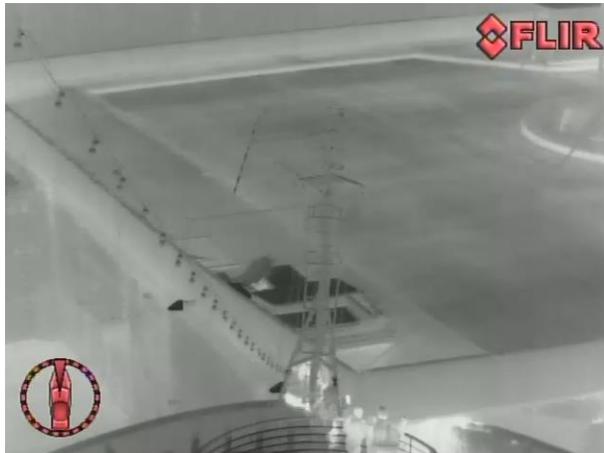
Left, screenshot from *Carnival Horizon*'s thermal night-vision bow camera at the time of impact with Pier 90. Right, *Carnival Horizon*'s damaged forward mast and support structure.

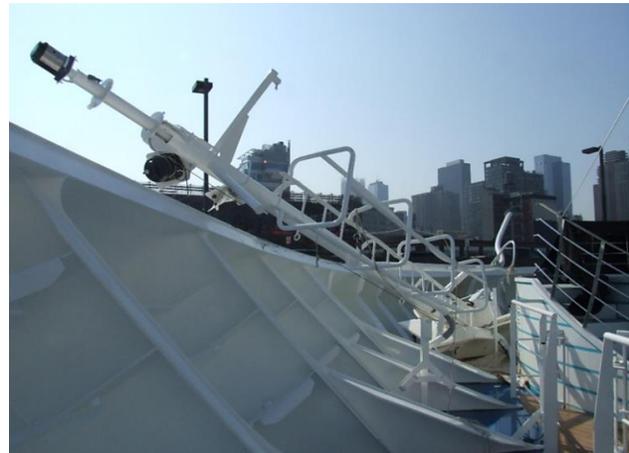
The southwest corner of Pier 90 sustained structural, electrical, and concrete slab damage to the second and third levels. Three metal support beams and parking level concrete slabs totaling 250 cubic feet needed short-term repairs. On the *Carnival Horizon* a forward mast light on deck 4 was struck down, one of its posts ripped off from the main deck, and the three other posts completely buckled at the base. Also, an associated approximately 8-inch-by-8-inch hole was found in the deck plating; the plating had ripped out and was attached to the dislodged post of the light mast. The top plate of the bulwark on deck 4 between frames 409 and 410 was indented downward, and the associated center bulwark and horizontal stiffeners were found slightly bent as well. The total cumulative damage resulting from the accident was about \$2.5 million.

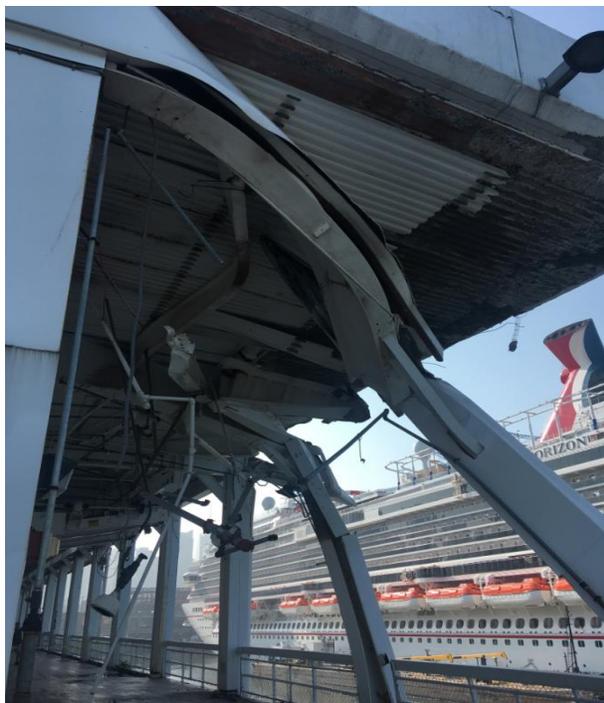
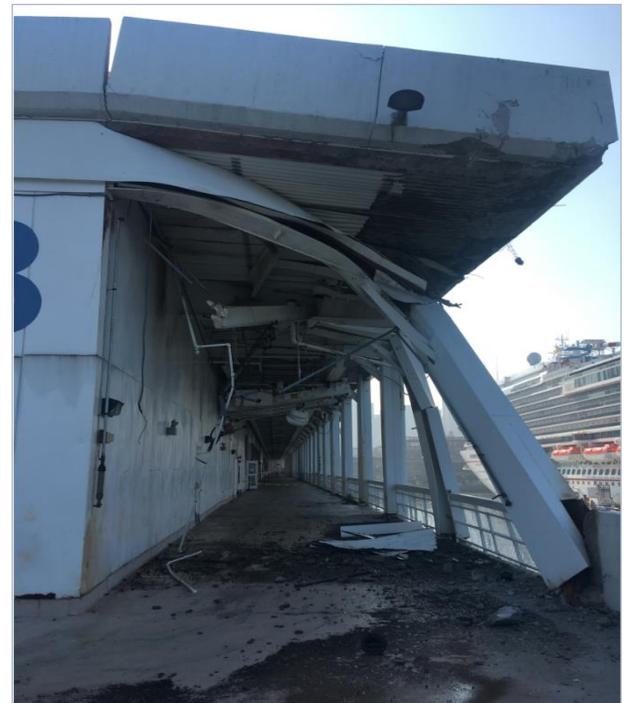
Left, structural damage to Pier 90's parking garage. Right, passenger embarkation walkway among damaged and sagging concrete slabs and metal debris. (Source: US Coast Guard)
