National Transportation Safety Board

Marine Accident Brief

Fire and Sinking of Fishing Vessel *Jeanette*

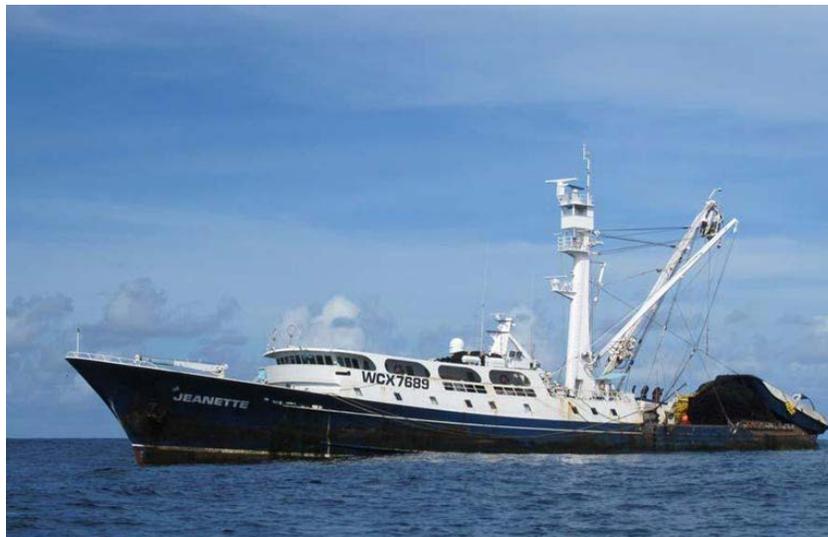
The fishing vessel *Jeanette* prior to the fire.

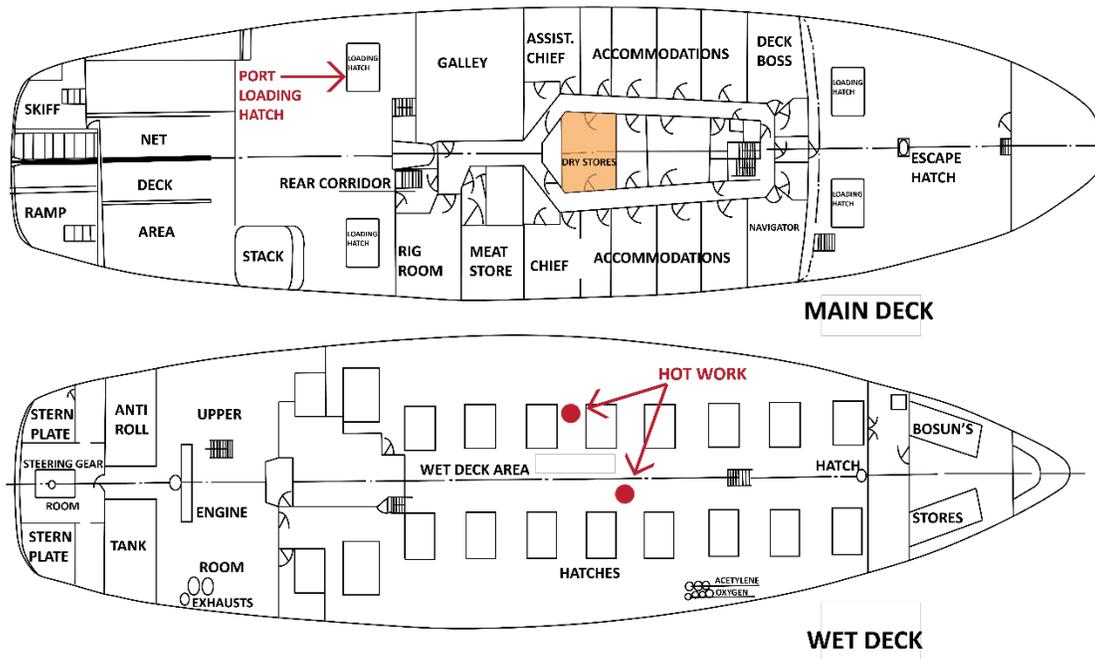
At 1055, the crewmembers stopped working to clean up for lunch. Shortly afterwards, a smoke detector located in the cabin across from the dry stores locker began to alarm. When the crew investigated the cause of the alarm, they observed smoke emitting from the dry stores locker, and the cook was called to unlock the door so they could investigate the source.

Vessel deck plans modified for clarity and to show the location where the hot work occurred on the wet deck (represented by red circles) and the location of the dry stores locker where the fire was discovered (shaded in orange). Note the port loading hatch on the main deck, where water entered and caused listing.

Upon opening the door to the locker, the crewmembers saw that the items stored in the space were on fire. The crew responded by utilizing handheld dry chemical extinguishers to try to put out the fire. Initially, the crew was successful in their effort to extinguish the fire, but the smoke soon began to overwhelm them, so they retreated from the interior of the vessel. The door to the dry stores locker was left open, which allowed the fire to re-ignite and spread.

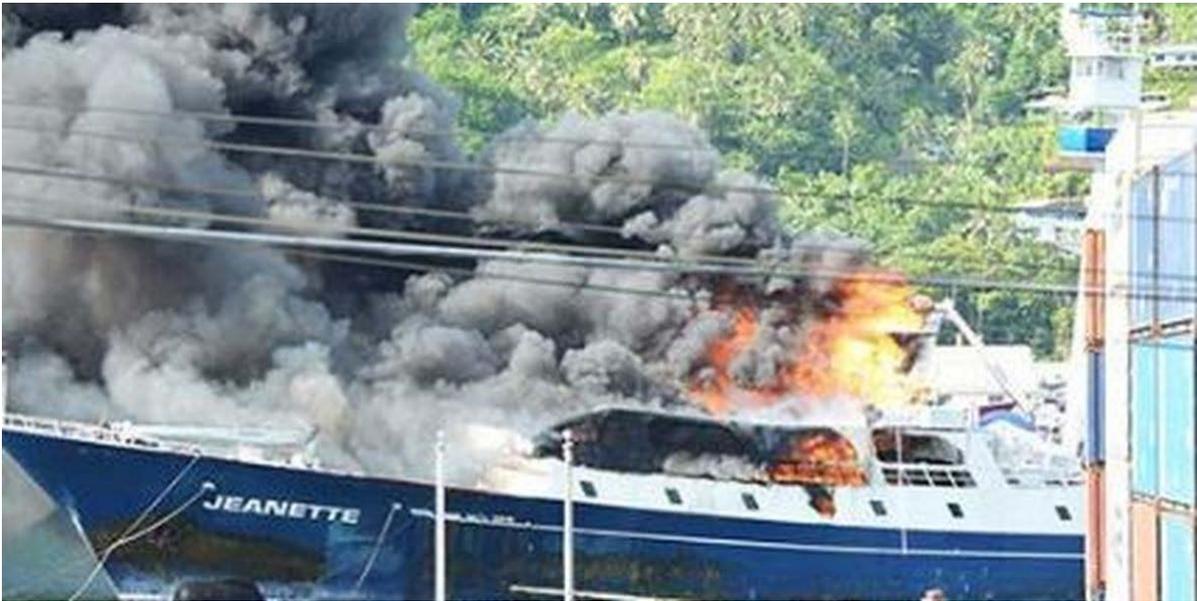
the fire at approximately 1122, and while the first fire truck arrived on scene at 1136, the firefighters were not equipped with self-contained breathing apparatus (SCBA) to enter the smoke-filled vessel. One of the vessel's crew donned an SCBA from the aft fire equipment locker, but since the crewmember was not wearing a firefighting suit, he was unable to approach and attempt to extinguish the growing fire due to its heat.

The bridge of the *Jeanette* engulfed in fire. (Source: US Coast Guard)

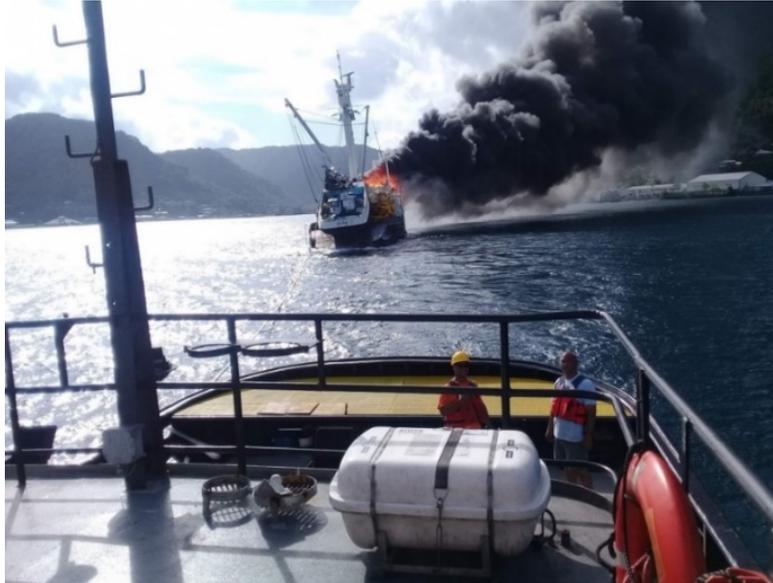
The fishing vessel *Jeanette* being towed by the tugboat *Iseula* while on fire. (Source: US Coast Guard)

On December 6 at 0102, while the *Jeanette* was still on fire and under tow, the purse seine netting burned away underneath the skiff, and the skiff slid off the stern of the vessel, causing the fishing vessel's crane boom and power block to swing to port and rest on the port side bulwark, and the vessel listed to port. Over the next nine hours, the vessel's port list increased as water entered the open 8-by-8-foot port loading deck hatch. At 1032, the *Iseula* released the tow line as the *Jeanette* listed further to port, and at 1039, almost twenty-three hours after the fire was discovered, the fishing vessel sank in open water about 15 miles offshore. A slight oil sheen was observed in the area following the sinking.
