National Transportation Safety Board

Marine Accident Brief

Accident No.: DCA-97-MM-033
Vessel No. 1: Panamanian Container Ship *Ever Grade*, Lloyds Register No. 1392784, 757 feet long, 37,042 gross tons, built in 1984
Vessel No. 2: U.S. Coast Guard buoy tender *Cowslip* (WLB-277), 180 feet long, 790 gross tons, built in 1942
Accident Type: Collision
Location: Columbia River near Astoria, Oregon
Date: May 14, 1997
Time: 2125 (local)
Owner/Operator: *Ever Grade*: Evergreen International S.A., Panama
Cowslip: U.S. Coast Guard, Washington, D.C.
Property Damage: \$1.2 million
Injuries: *Ever Grade* - 0
Cowslip - 1
Complement: *Ever Grade* - 18
Cowslip - 51

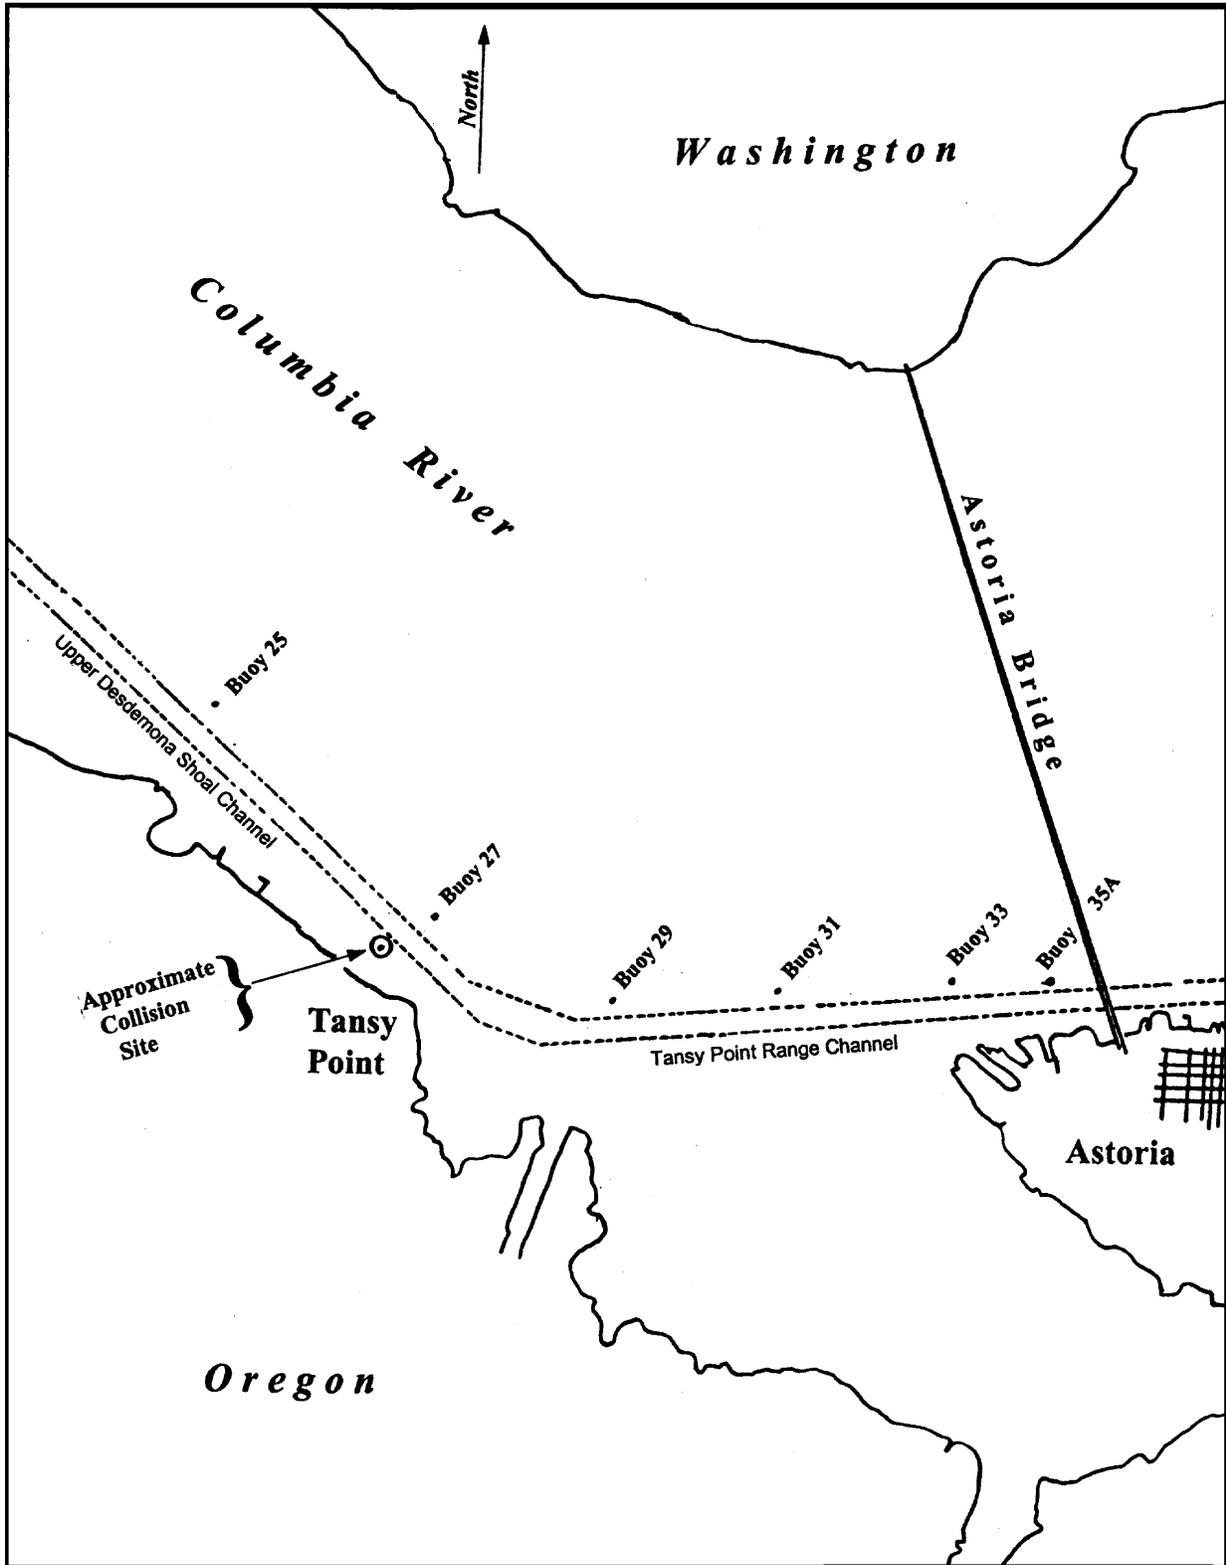
At 2101, the pilot ordered the *Ever Grade*'s engine first to "slow ahead," and then, in the same minute, to "half ahead," as he maneuvered the ship toward the Astoria Bridge. (See figure 1.) At 2107, the *Ever Grade* passed beneath the Astoria Bridge, and the pilot transmitted a security call⁵ on VHF-FM channel 13 announcing, "This is the container ship *Ever Grade* passing under the Astoria Bridge outbound with a draft of 36 1/2 feet. The container ship *Ever Grade* outbound."

Figure 1. Chart of area showing approximate collision site.

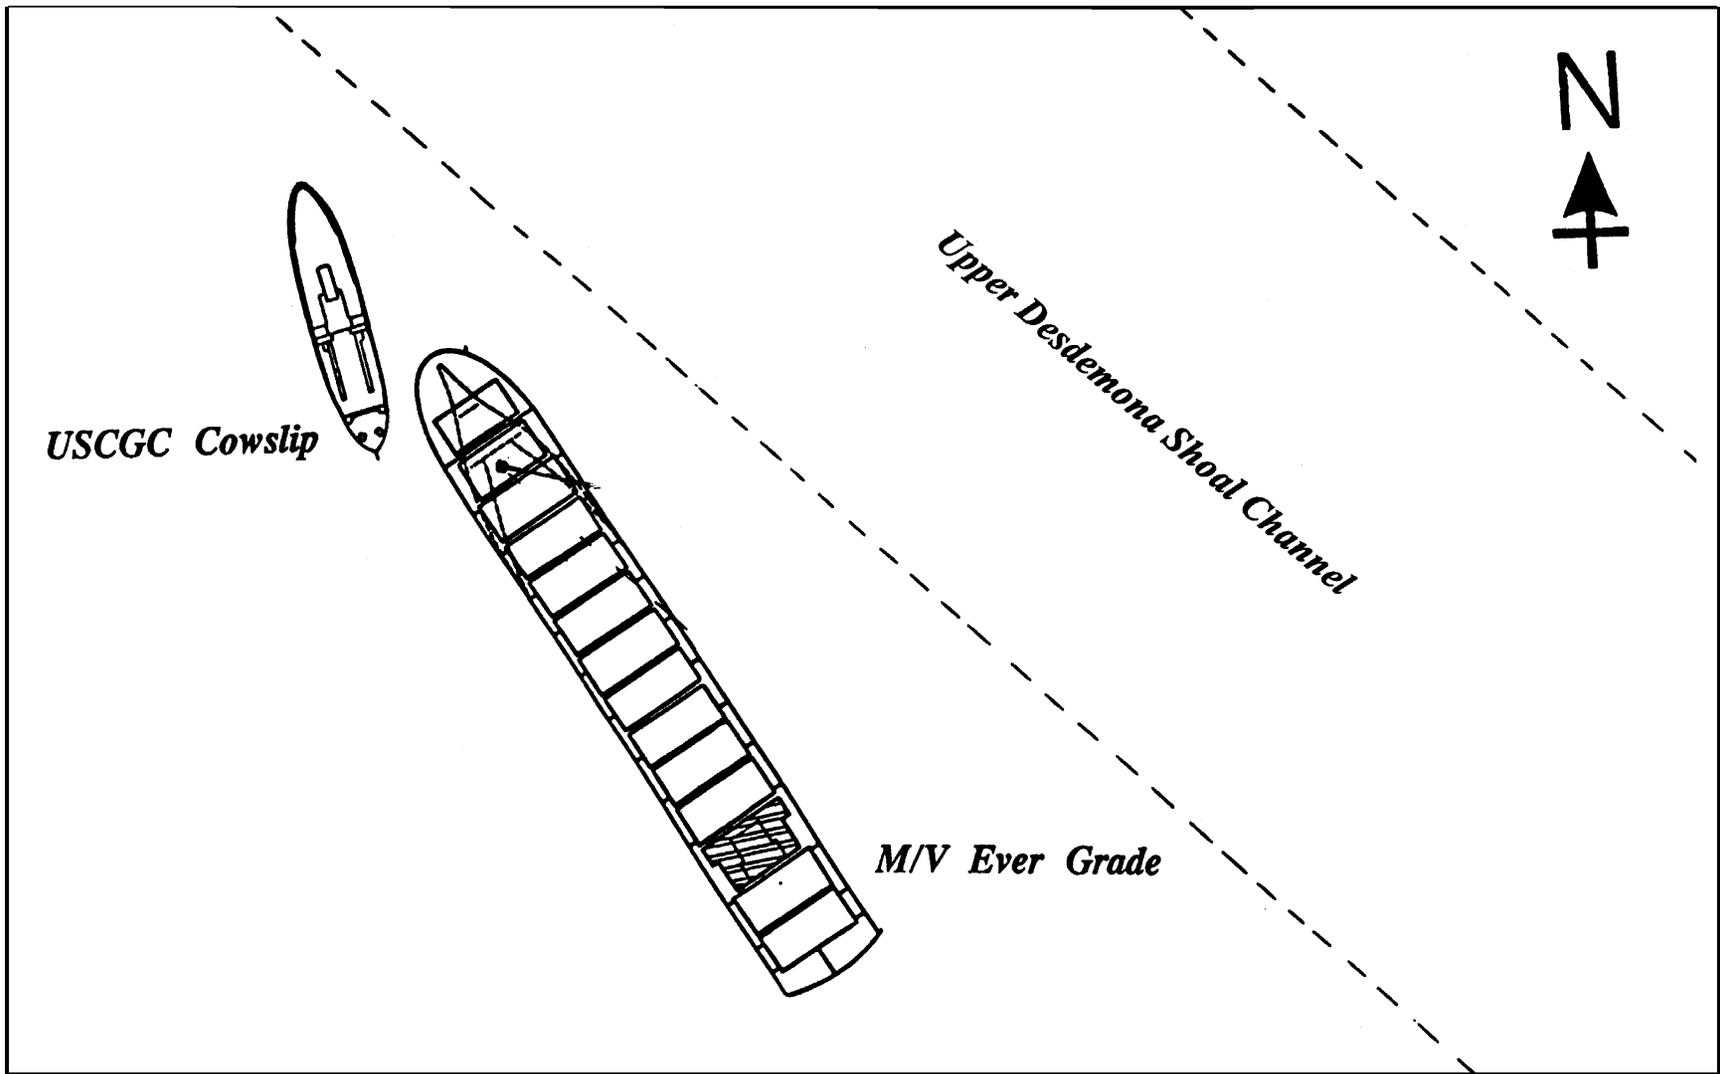
The *Cowslip* CO continued to watch the *Ever Grade* as it approached the *Cowslip*, and when he judged that its bow was past the *Cowslip*’s pivot point, he ordered “left full rudder” in an attempt to swing the *Cowslip*’s stern away from the approaching ship. At 2125, about the same time that the CO ordered “left full rudder,” the bow of the *Ever Grade* struck the port bridge wing of the *Cowslip*, crushing it inward and pinning the throttle control in the “full ahead” position. (See figure 2.) The impact heeled the *Cowslip* to starboard and knocked the CO to the deck, injuring him slightly.

Figure 2. Sketch of vessels showing approximate angle of impact (not to scale).

After the collision, the *Cowslip* bounced off the *Ever Grade* and, moments later, it was hit a second time on the port quarter, near the motor room. The two vessels then separated and moved away from each other. Both vessels were subsequently anchored, and damage assessments were conducted.
