Heeling Accident on M/V *Crown Princess*
Atlantic Ocean Off Port Canaveral, Florida
July 18, 2006

ACCIDENT REPORT

NTSB/MAR-08/01
PB2008-916401

Marine Accident Report

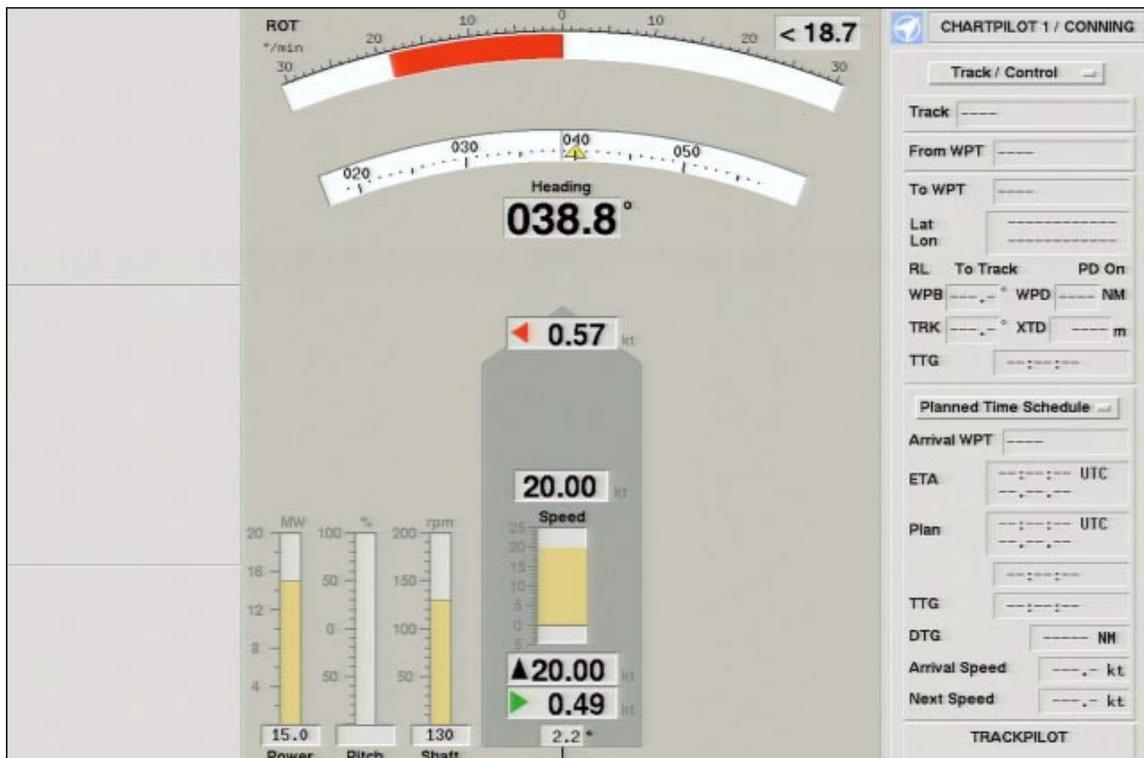
About 1523, the vessel reached a turn rate of about 10° per minute to starboard. The turn then shifted to port, and the rate of turn reached nearly 20° per minute. The rate-of-turn indicator (figure 3) displayed red for turns to port, green for turns to starboard. The indicator did not show turn rates beyond 30° per minute in either direction, although a turn rate of any size was displayed digitally next to the indicator. The second officer told investigators that shortly after he took the conn, the rate-of-turn indicator “was a bright color red . . . my eyes were instantly drawn to it.”

Figure 3. Trackpilot display on the *Crown Princess*. The rate-of-turn indicator is at the top, abbreviated ROT. The highest rate of turn displayed in either direction on that indicator was 30° per minute. The digital display on the right above the indicator could show any rate of turn. The rate of turn displayed here is 18.7° to port.

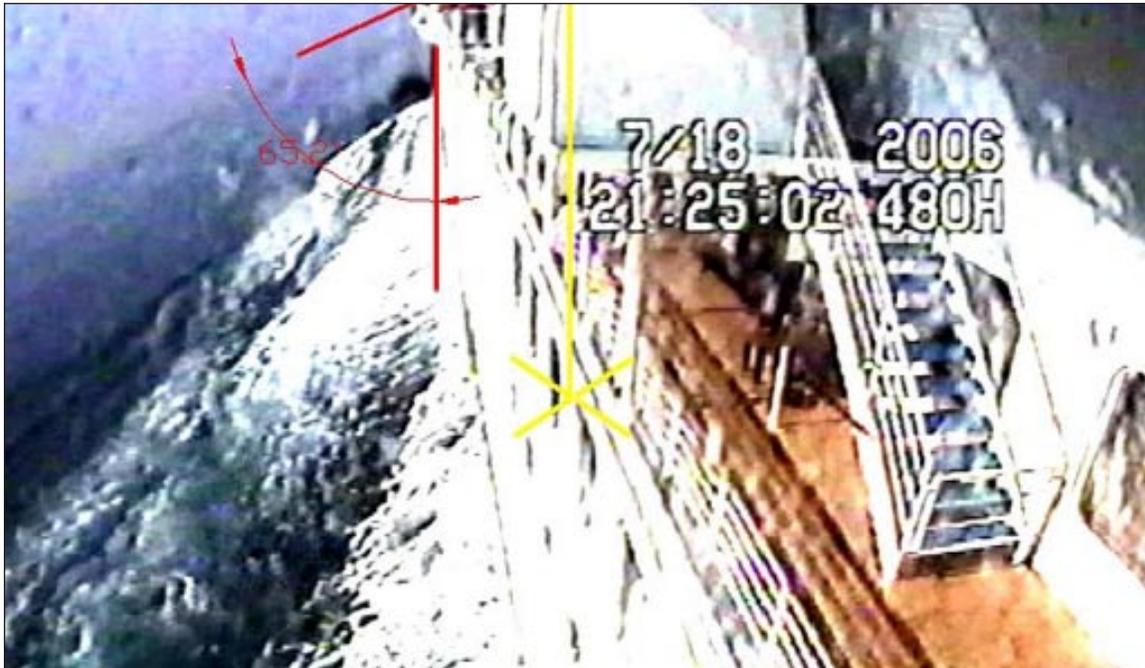
used two methods to determine the maximum angle of vessel heel from the images taken by the shipboard camera. One method was to measure the angle formed by the apparent horizon in an image and the vertical axis of the vessel, taking into account the distortion created by the camera lens (figure 5).

Figure 5. Image of the *Crown Princess* taken by a ship's videocamera at the maximum angle of heel, with reference lines added by investigators. Stamped time corresponds to 1525:02 eastern daylight time. The apparent bending of the horizon is an artifact of the wide-angle camera lens, which causes straight lines to appear curved and bow outward from the image center.

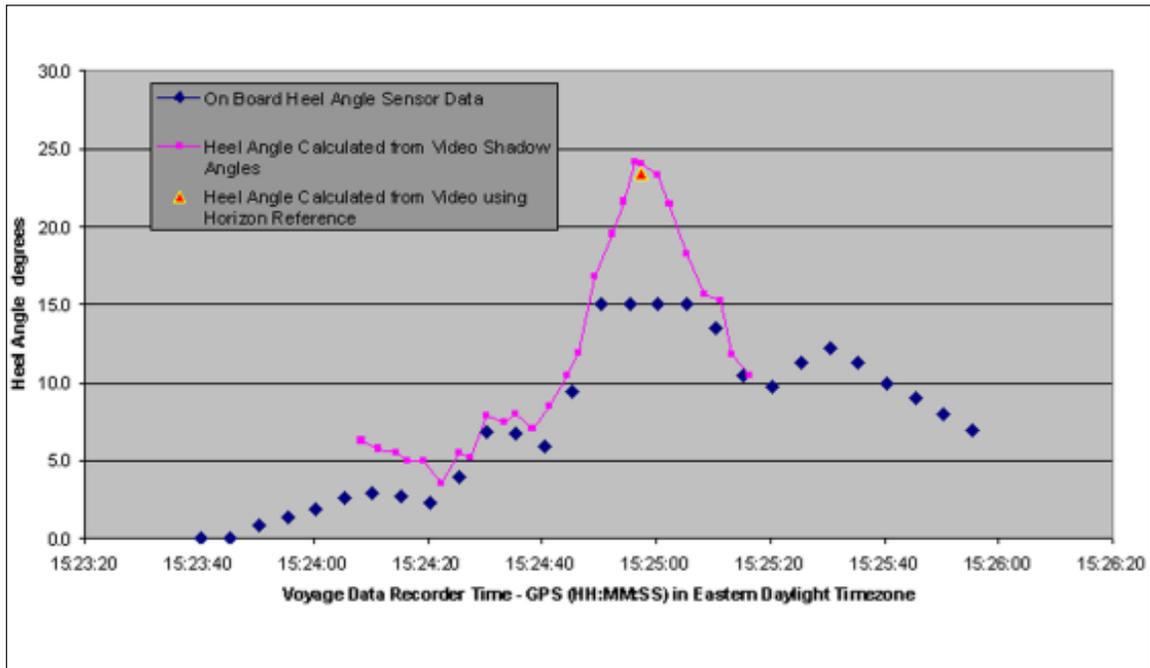
The other method was to measure the difference between the angle of the shadow created by the vessel on a reference point on the images and the angle that would have been created by the ship's orientation to the sun at that time, given the sun's angle over the horizon and the ship's orientation. Investigators obtained the sun's angle from U.S. Naval Observatory data and the ship's orientation to the sun from VDR data. The maximum angle of heel calculated from the shadow images was 24.2° to starboard at 1524:57 (figure 6).⁴⁶

Figure 6. Calculated and recorded heel angles of the *Crown Princess*. The maximum heel angle calculated from shadow images was 24.2°; that calculated from the apparent horizon line was slightly less (23.4° to 23.5°).

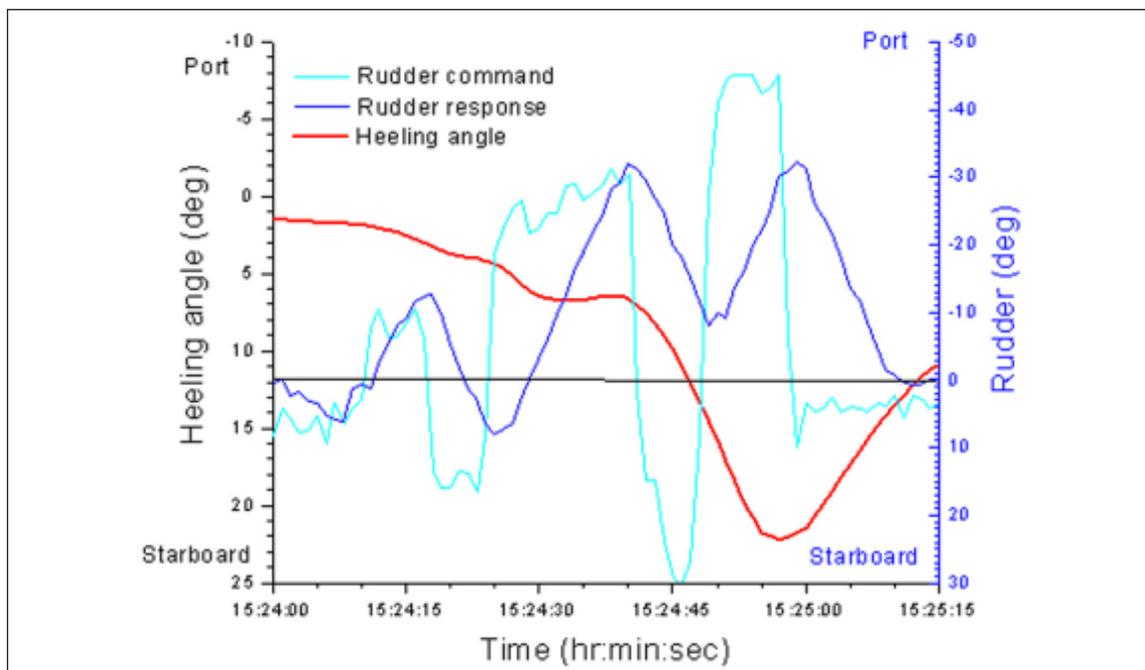
The data show that after the second officer disengaged the trackpilot at 1524:05, the vessel's rudder positions corresponded to the rudder commands for about 10 seconds. Then, at 1524:15, the rudder positions began to deviate from the wheel input as the rudders lagged the wheel commands.⁵¹ The deviation lasted until shortly after the rudders were commanded to midships (1525), after which the vessel gradually returned to even keel. The vessel's response lagged both the rudder commands and the rudder positions. From 1524:30 to 1525:10, while the rudders remained at port, the vessel's heading diverged from its direction of motion. That difference is known as the drift angle. The greater the drift angle and the greater the speed, the greater the resultant heel angle. The vessel's maximum heel occurred about 1524:57, as shown by the red line in figure 7.

Figure 7. After the second officer began steering the vessel manually, he turned the wheel faster than the rudders could follow, as shown by the divergence between the rudder commands (light blue line) and the rudder responses (dark blue line). As the vessel attempted to respond to the commands, it heeled increasingly to starboard (red line).

⁵¹ Lag results when the rate of wheel inputs exceeds the rudder response rate, which for the *Crown Princess* was 3° per second.

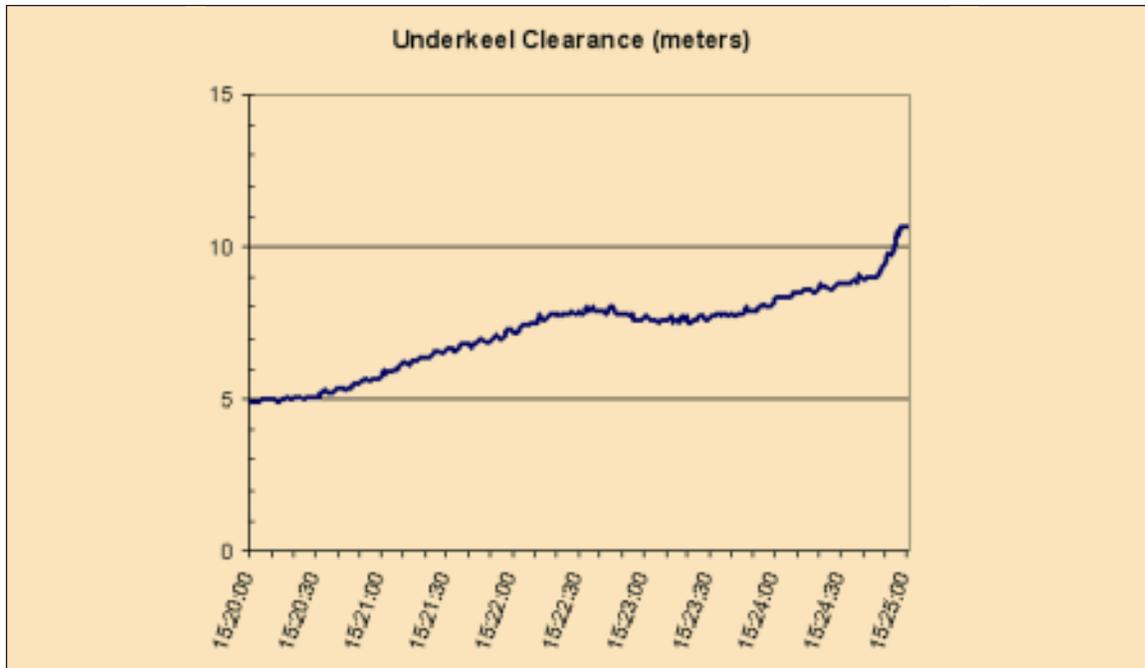
As shown in figure 8, the water depth was about 5 meters (about 16 feet) below the keel of the *Crown Princess* during the first part of the trip, gradually increasing to 8.3 meters (27.2 feet) at 1524, when the second officer assumed the conn, and reaching 10.7 meters (35.1 feet) at the end of the accident sequence.

Figure 8. Underkeel clearance of the *Crown Princess* during the accident sequence, from data recorded by the vessel's VDR.
