Allision of Bahamas-Registered Tankship
M/V *Kition* with Interstate Highway 10 Bridge Pier
Baton Rouge, Louisiana
February 10, 2007

NTSB/MAR-08/03
PB2008-916403

Marine Accident Report

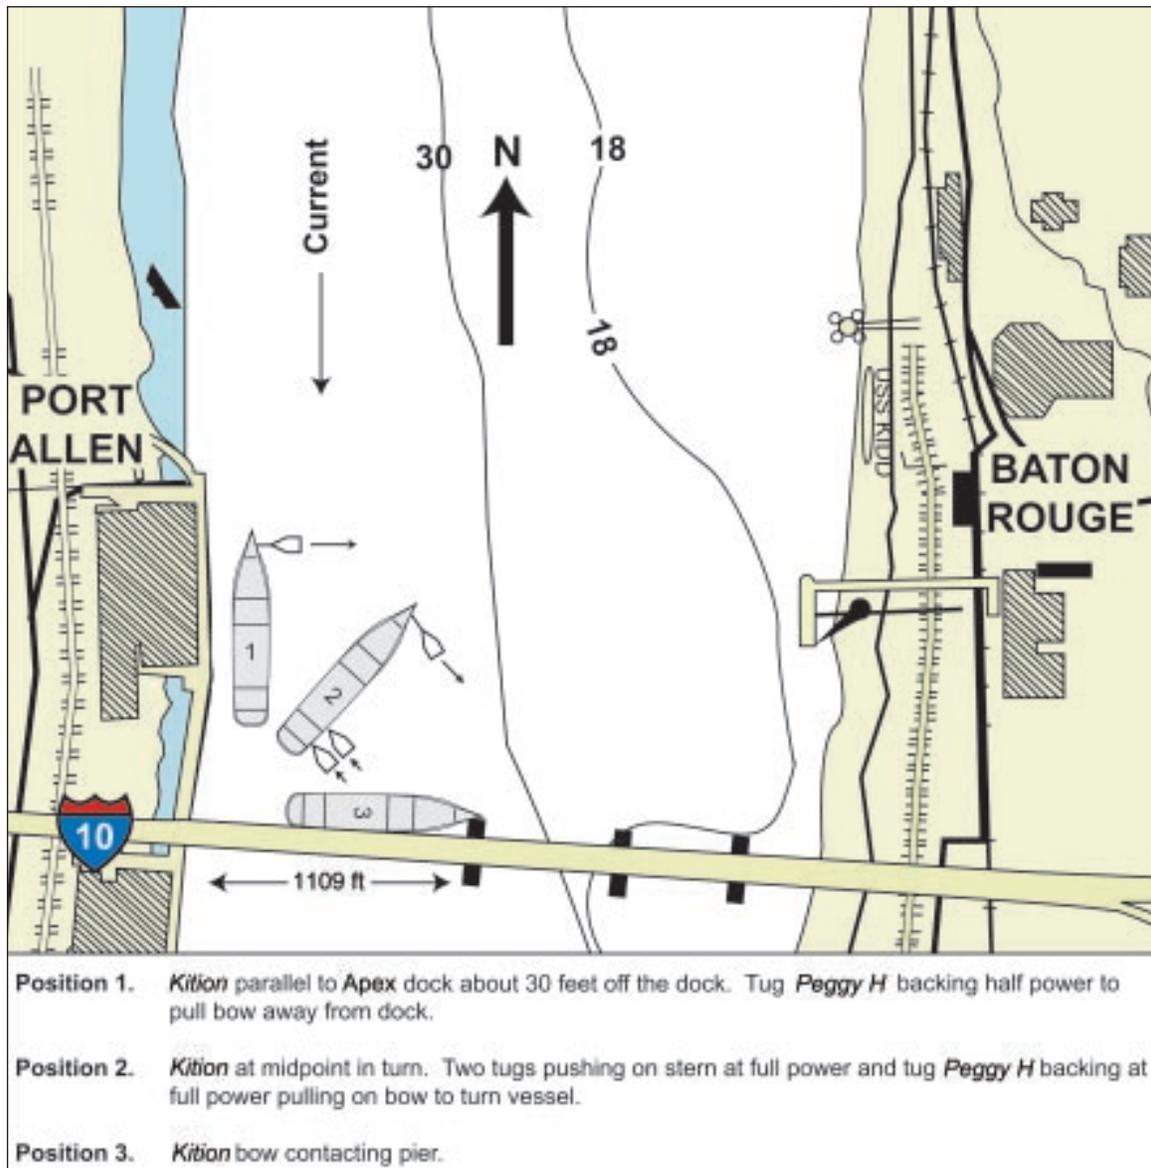
from shortly after 0729 until 0731, when the bow began to swing right (figure 2).¹⁶ At that point, the pilot ordered the engine speed increased to slow ahead and the rudder increased to hard port, which he told investigators was to control the bow swing. As the vessel swung right, its stern moved slowly away from the dock in response to the slow ahead and port rudder orders.

Figure 2. Diagram of *Kition* moving from the Apex No. 2 dock to its collision with the I-10 bridge pier.

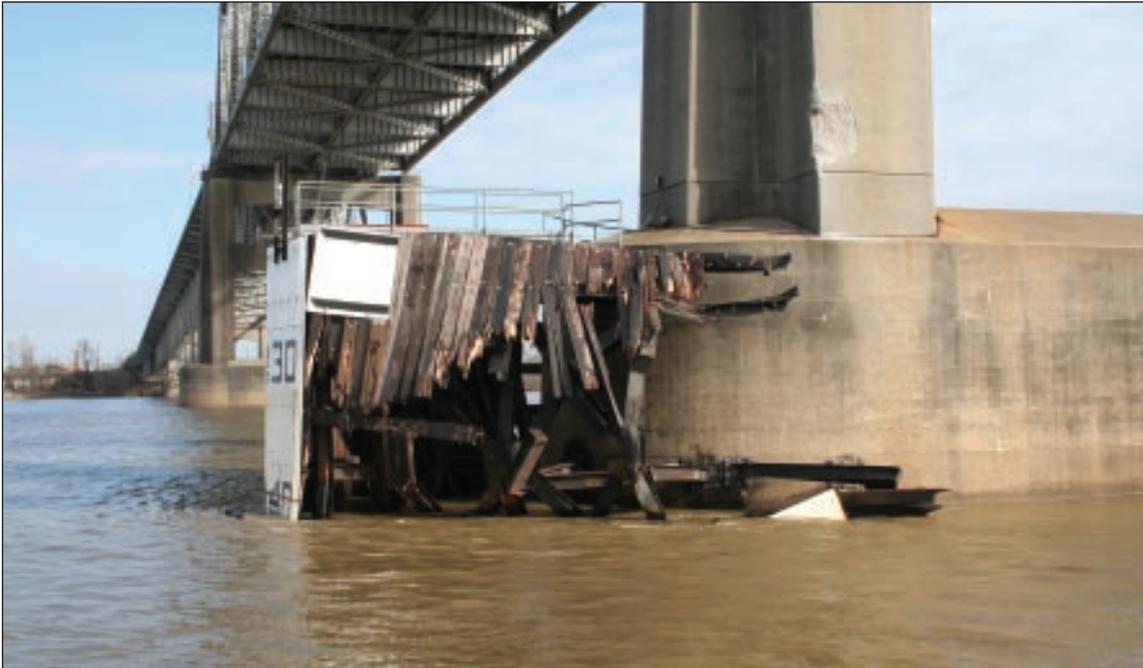
²¹ The bridge was inspected by Louisiana Department of Transportation bridge inspectors and found to be safe for use. The estimated cost of reconstructing the fendering system was \$8 million.

Figure 3. Damage to the I-10 bridge fender system and pier.

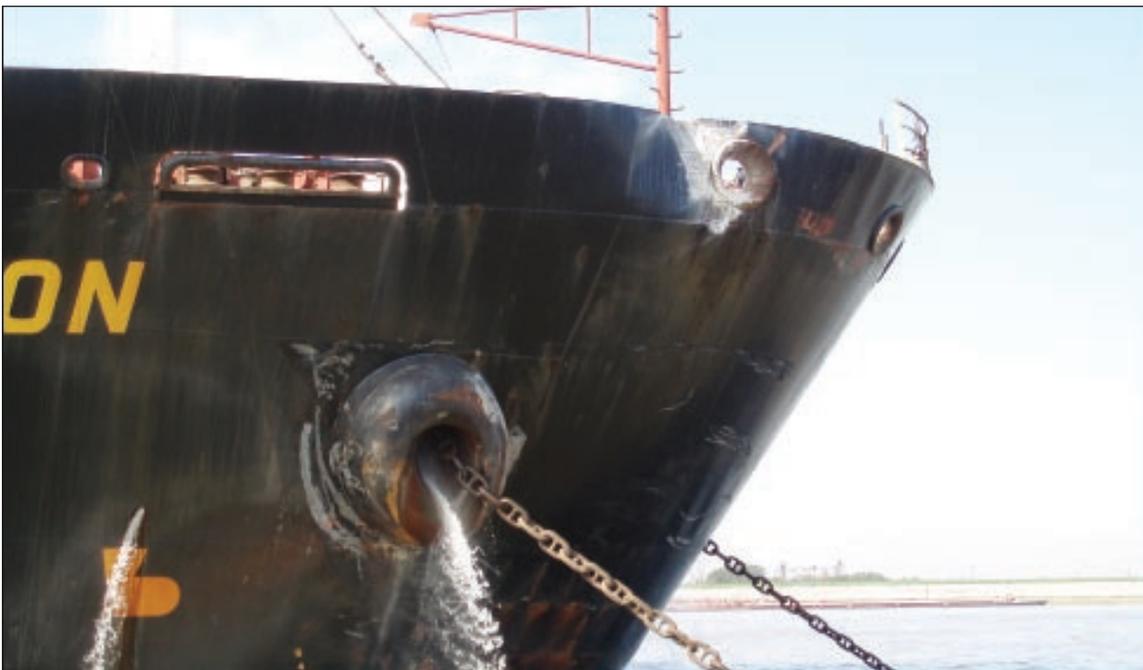
Figure 4. Damage to the bulwark on the *Kition's* starboard bow.

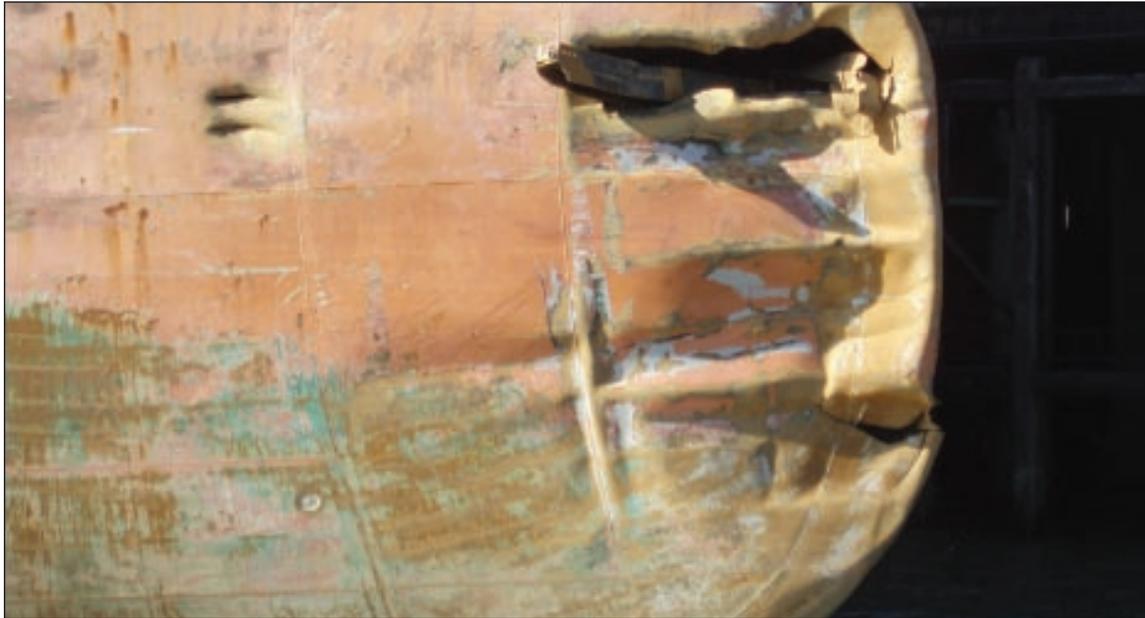
Figure 5. Holed forepeak tank and other damage to the *Kition's* bulbous bow, shown after the bow was raised out of the water by removing cargo and ballasting the aft tanks.
