Allision of the Cargo Vessel M/V *Delta Mariner* with  
Eggner's Ferry Bridge, Tennessee River  
Near Aurora, Kentucky  
January 26, 2012

**Accident Report**  
NTSB/MAR-13/02  
PB2013-106636

# Marine Accident Report

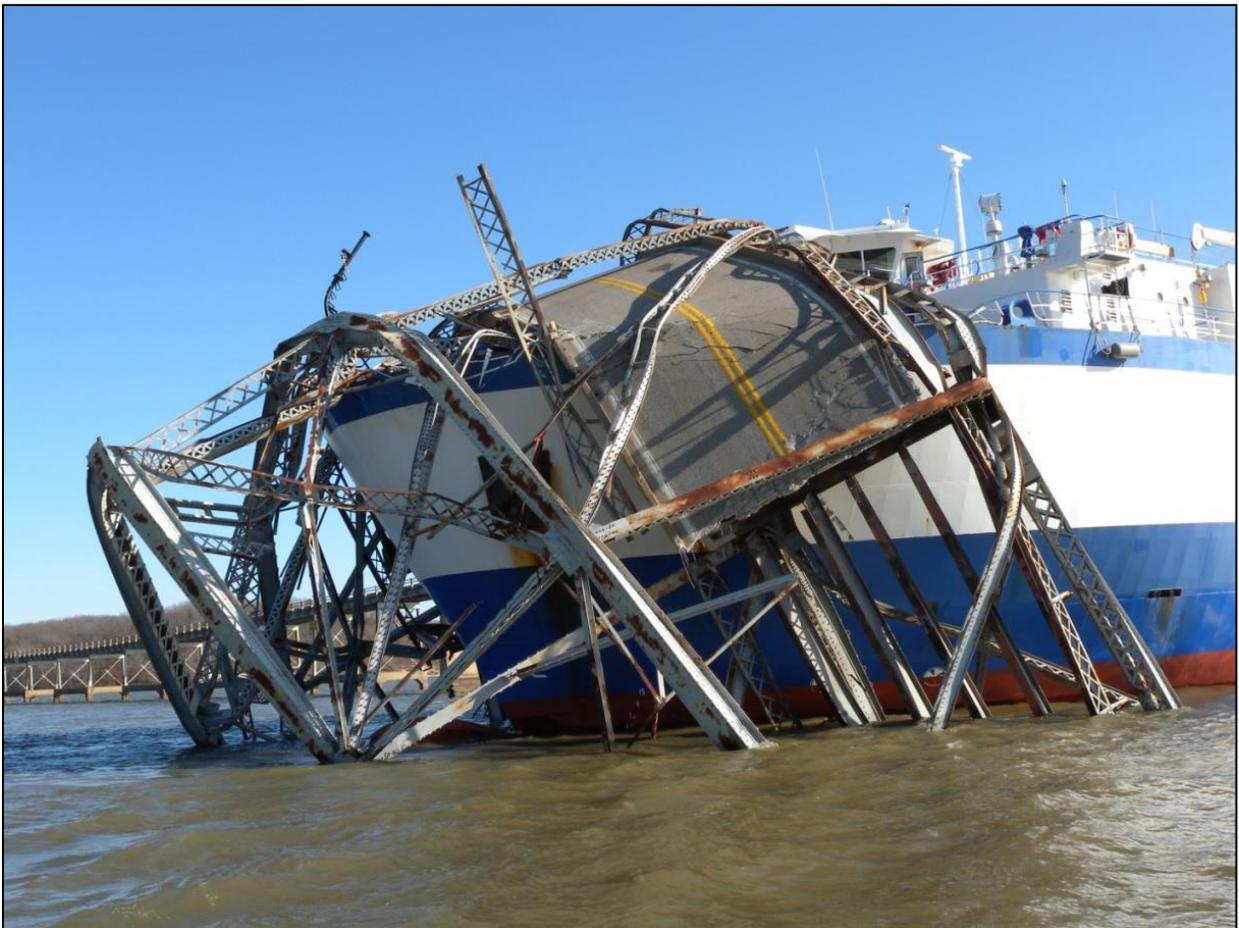
An initial postaccident survey of the *Delta Mariner*, conducted on January 27, 2012, by ABS, identified damage to the bow of the vessel: the bulwark, which normally extends above the upper side of the ship was flattened to the deck; panama chocks (casings used for line handling from one vessel to another or to the dock) were broken; and debris was resting on top of bollards (which secure ship's lines) and deck winches. After the allision, approximately 275 long tons (616,000 lbs.) of the bridge span weight was resting on the vessel. The survey also found two small puncture holes in the forecastle deck, but the vessel's hull remained watertight. Figure 5 shows the bow of the *Delta Mariner* and the section of the highway bridge that was torn away by the allision.

**Figure 5.** Postaccident photograph showing a portion of Eggner's Ferry Bridge span E and US Highway 68 resting across the bow of the *Delta Mariner*.

A dive survey conducted the next day, January 28, found no indications of damage to the hull below the waterline. The ship was repaired and returned to service on February 12, 2012.

Foss Maritime officials reported the total cost of removing bridge debris from the deck of the *Delta Mariner* and repairing the bow and pilothouse superstructure was \$2,583,750.

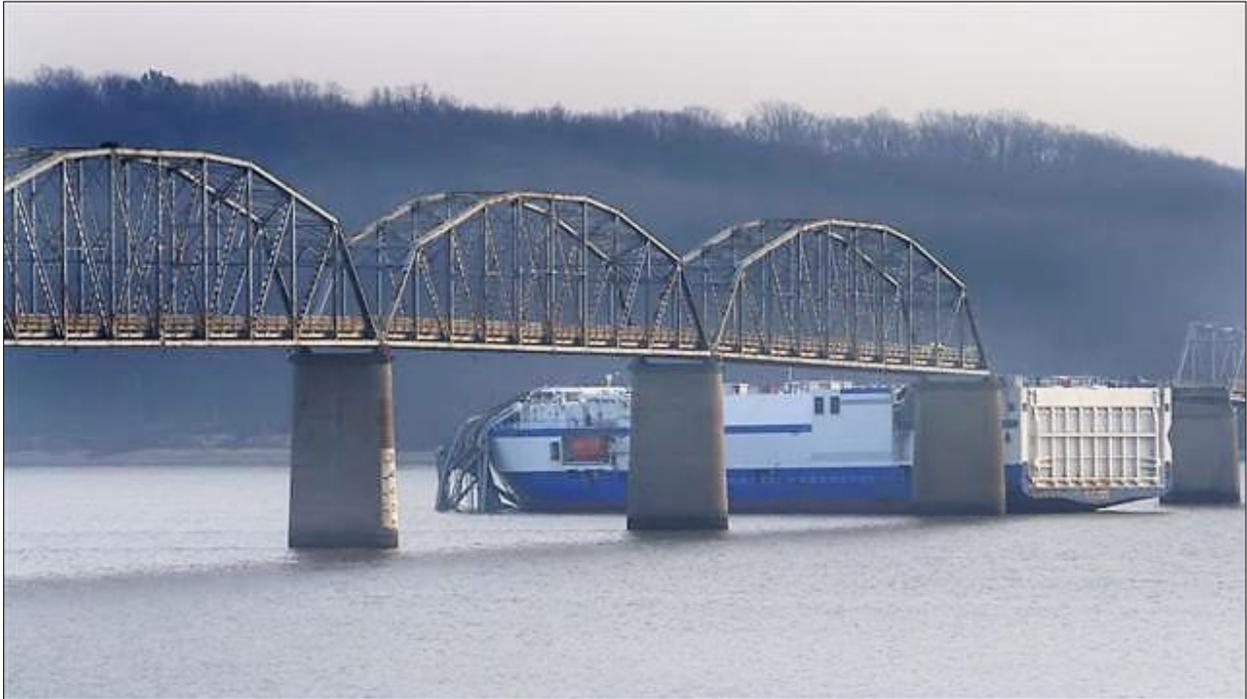
Eggner's Ferry Bridge was closed for repairs following the allision, and traffic was diverted until the bridge reopened to traffic on May 25, 2012. KYTC reported total costs of about \$7.2 million resulting from the accident. Figure 6 is a photo of the *Delta Mariner* and the bridge following the accident.

**Figure 6.** Eggner's Ferry Bridge with *Delta Mariner* anchored after striking span E. The stern of the vessel is visible between the piers of the downed span E. Photo by [www.wired2fish.com](http://www.wired2fish.com).

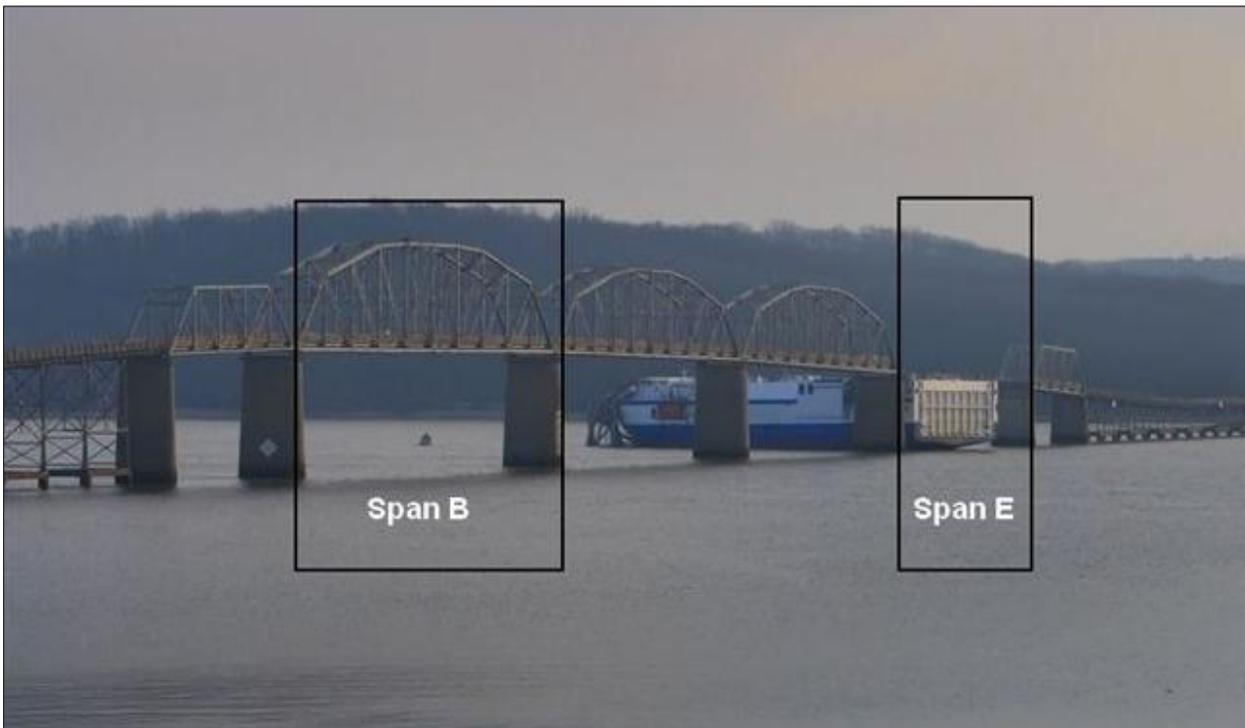
Clearance under each bridge span varied with the water level, which was largely determined by dam operations. The Army Corps of Engineers measured water elevation of the Tennessee River at Kentucky Dam at approximately 355 feet about 1800 on January 26, approximately 2 hours before the collision. The *Delta Mariner* crew had calculated an air draft of 3.57 feet between the highest point on the vessel—the automatic identification system (AIS) antenna—and span B of Eggner’s Ferry Bridge, where the vessel should have transited. Span E provided approximately 11 feet less clearance at its highest point based on field measurements taken after the accident, which was about 7.43 feet less clearance than the *Delta Mariner* needed. Bridge spans B and E are indicated in figure 7.

**Figure 7.** Eggner’s Ferry Bridge indicating span B, the main navigation span, and span E, which was struck by the *Delta Mariner*. Photo by [www.wired2fish.com](http://www.wired2fish.com).

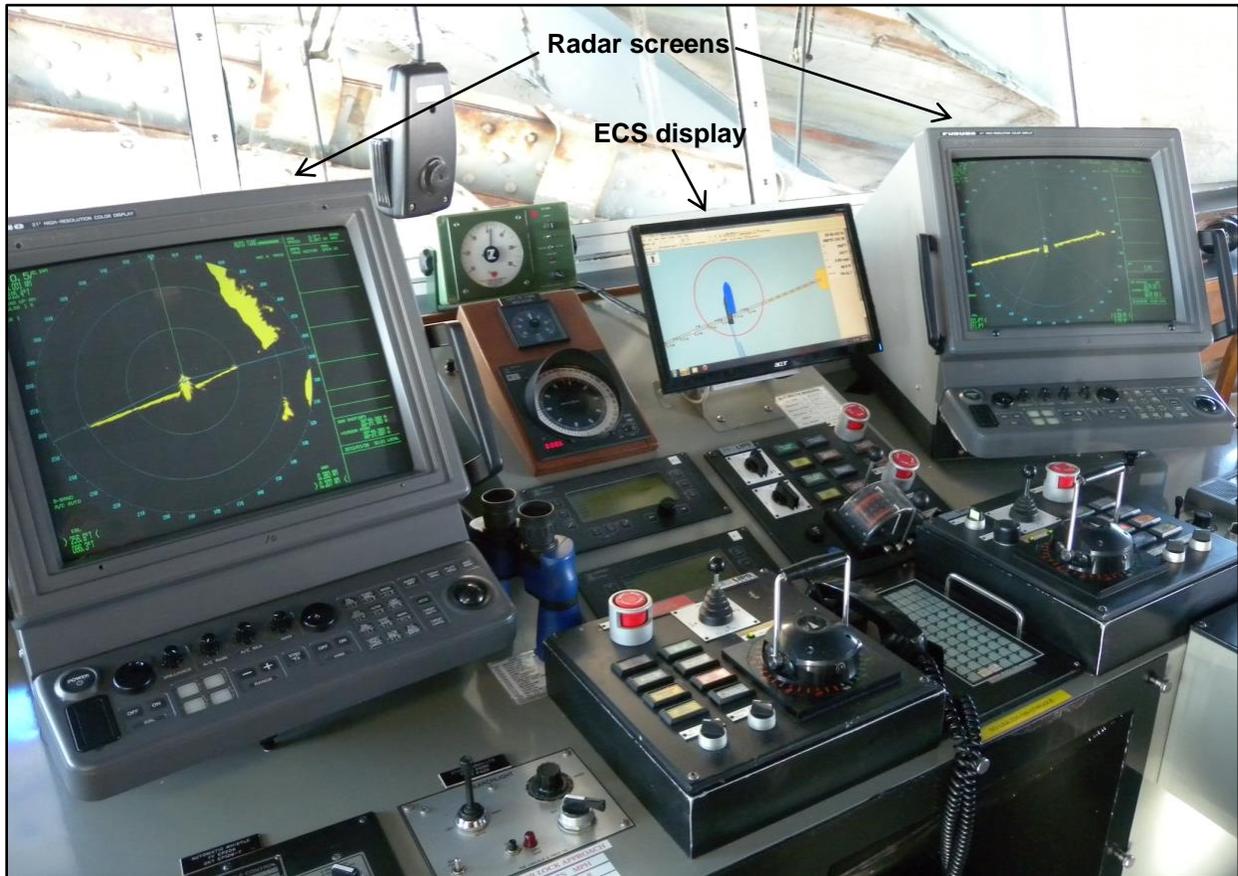
**Figure 11.** Photo of two radar screens and the ECS display located forward of the *Delta Mariner's* steering and throttle control station. The chief mate, who was acting as helmsman at the time of the accident, was facing the ECS display.

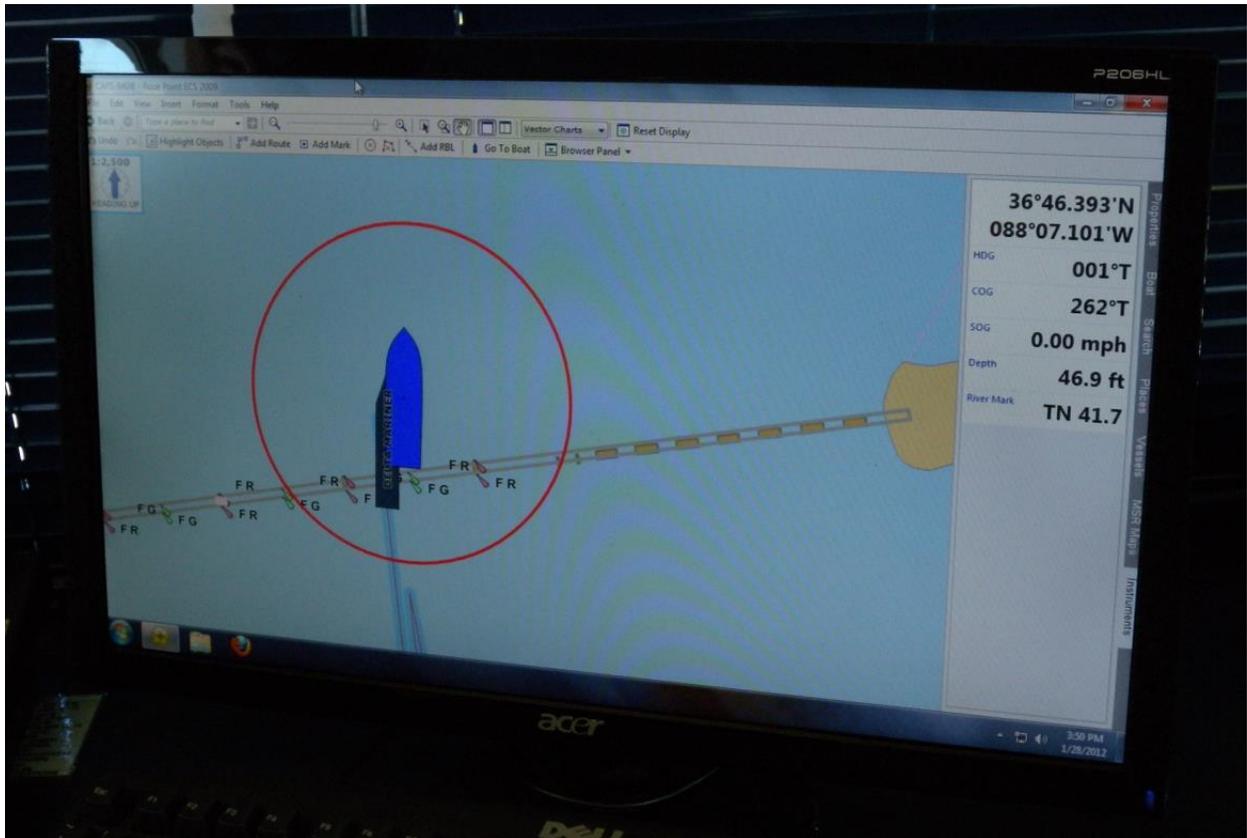
The second mate told investigators he updated the ECS vector charts “every time we reach a port or I can tie up the Internet long enough to do it.” He last updated the ECS on January 24, the day before the *Delta Mariner* departed on the accident voyage. The second mate also told investigators that ECS “has lighting schemes for bridges on it.” The lighting scheme for Eggner’s Ferry Bridge is shown on the ECS display in figure 12.

The bridge team did not attempt to verify that the lights they observed matched what the ECS displayed. The contract pilot told investigators he could not see the ECS display in front of the helm because a screen was fixed to it to dim the display for night operation. The chief mate said he was focusing on steering the vessel, and when asked how he used the electronic chart display in front of the helm position, he told investigators, “There’s no information I need there.”

**Figure 12.** ECS display on the aft chart table taken postaccident. The *Delta Mariner* can be seen anchored in position in the middle of bridge span E, and the bridge lighting scheme is visible.
