Fire On Board US Small Passenger Vessel *Island Lady*
Pithlachascotee River Near Port Richey, Florida
January 14, 2018

NTSB/MAR-18/02
PB2019-100203

Marine Accident Report

Abstract: This report discusses the fire that destroyed the small passenger vessel *Island Lady* on January 14, 2018, at the mouth of the Pithlachascotee River near Port Richey, Florida. The vessel, with 53 people on board, was on a scheduled transit to an offshore casino boat, the *Tropical Breeze I*, located about 9 miles offshore in the Gulf of Mexico.

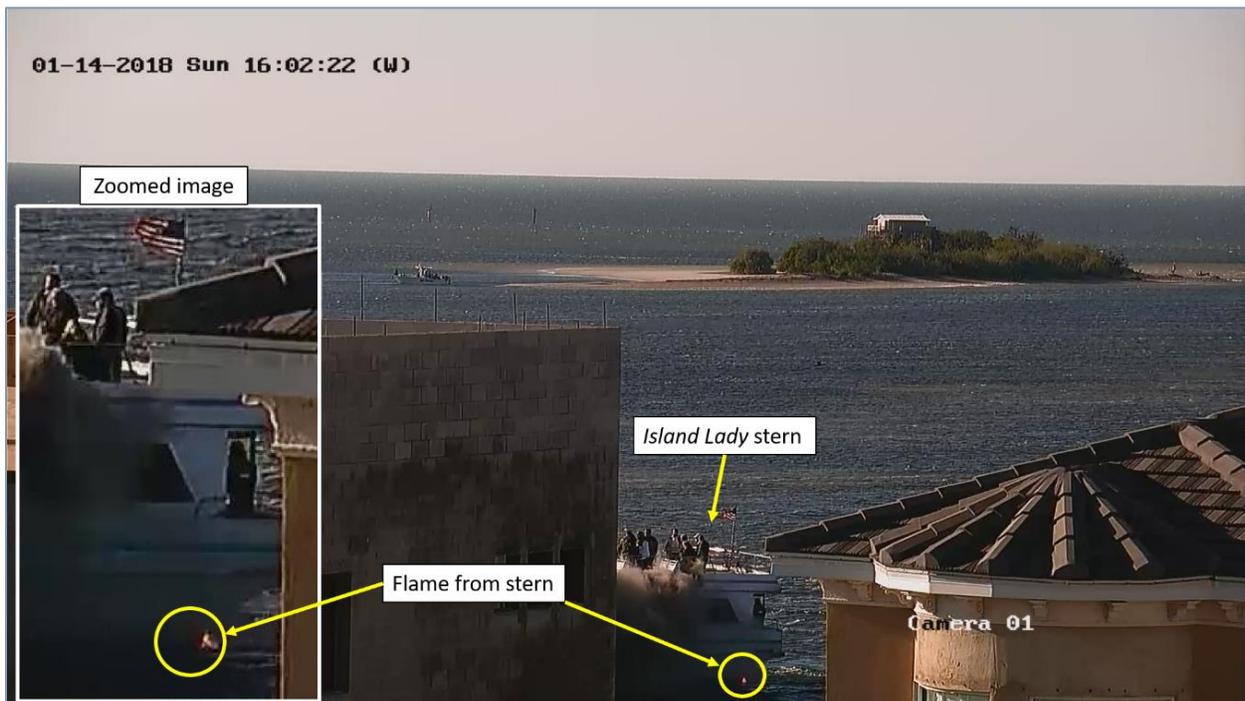
About 1553, the *Island Lady* was returning toward the harbor at a speed of about 8 knots. The captain was using the starboard engine for propulsion; the port engine remained in neutral, running at idle speed. The smoke was increasing, turning thicker and also brown/gray in color. After the vessel turned back toward the harbor and transited toward the east, the north winds blew the thickening smoke across the vessel’s beam, and the smoke billowed off the starboard side. As a result, the crewmembers were unable to pinpoint the precise location from where the smoke emanated. The shoreside video surveillance camera recorded the billowing smoke as well as flames emanating from the port exhaust opening on the stern (figure 5). At this point, no other flames were visible.

Figure 5. Still image from home surveillance video footage, with the stern of the *Island Lady* visible between two houses. Fire emanating from the port side of the stern is circled in yellow. (Video footage provided by witness)

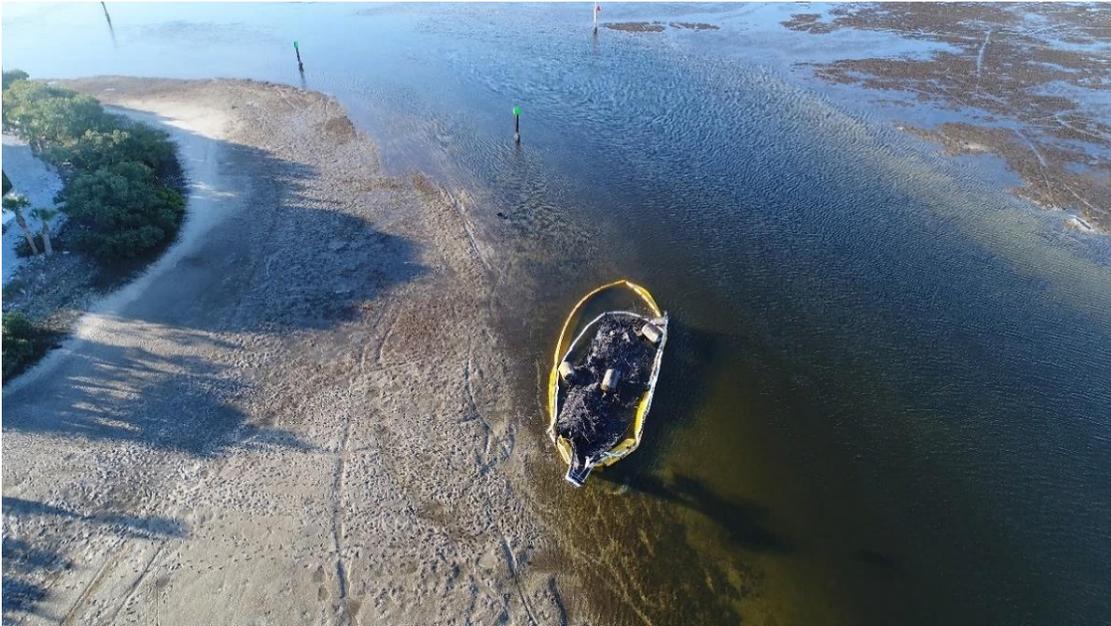
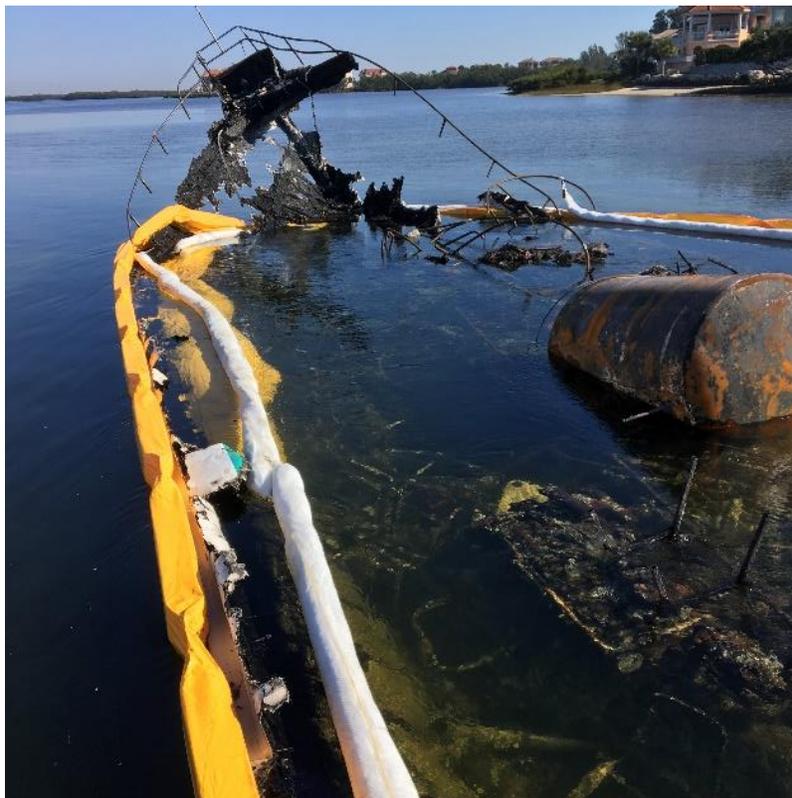
The *Island Lady*, insured for \$450,000, was declared a constructive total loss, as everything above the waterline was destroyed (figures 7 and 8). The only remains were the two fire-damaged engines, two damaged generators, remnants of various piping systems and valves, railings around the vessel, deck chairs, and three cylindrical fuel tanks.

Figure 7. Remnants of the *Island Lady* seen from above. (Photo by Titan Marine & Environmental)

Figure 8. Looking toward the *Island Lady*'s destroyed bow.

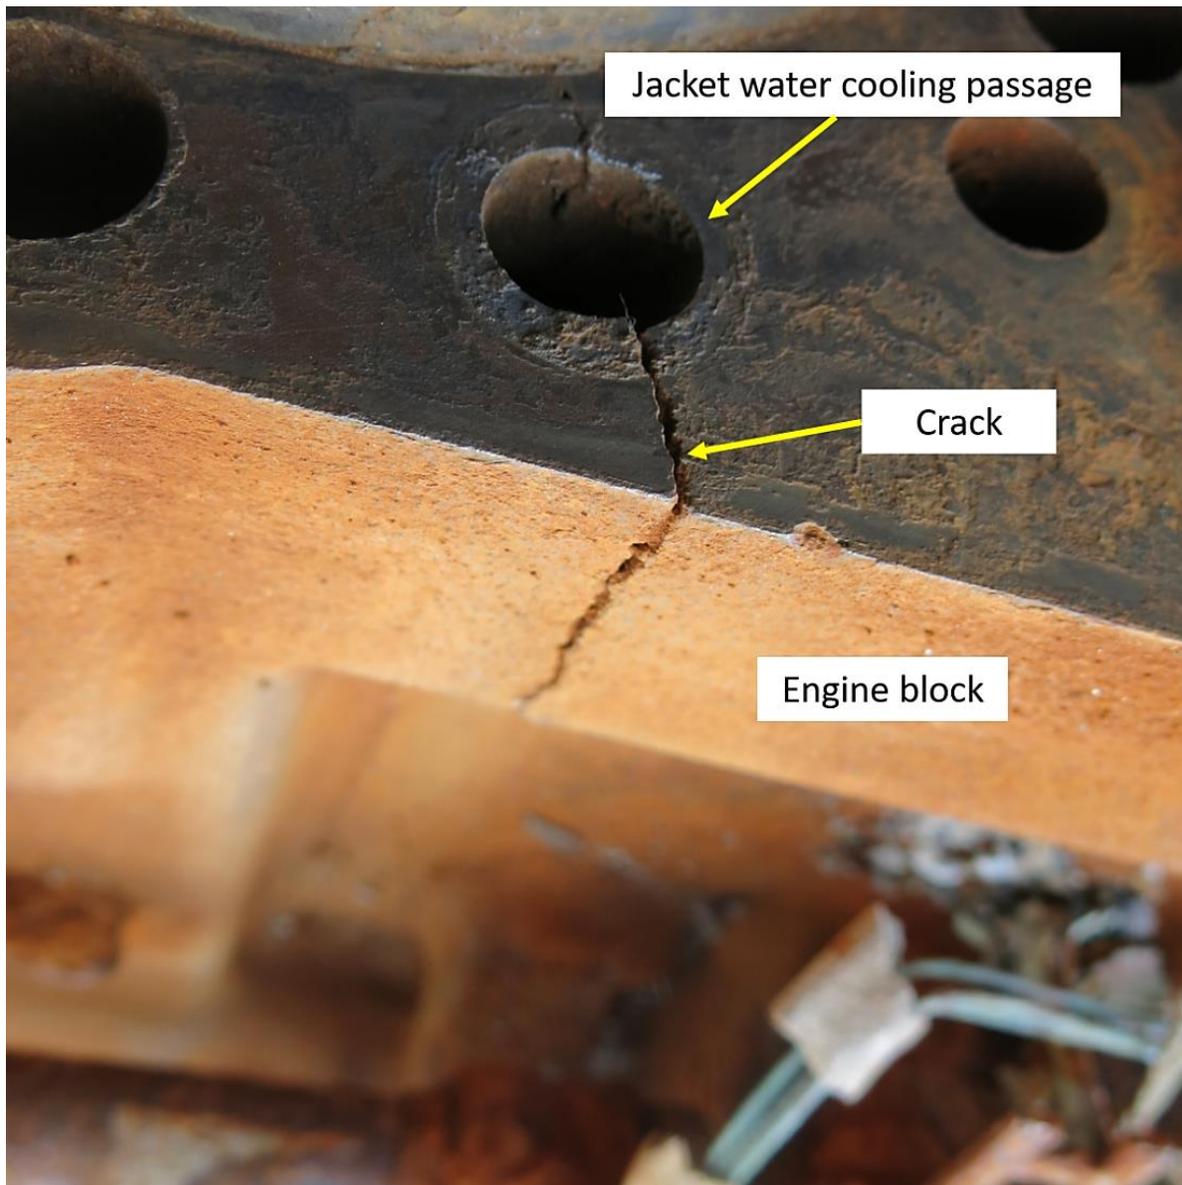
A service technician and a service manager from Ring Power—an authorized service company for Caterpillar—disassembled the port engine. A crack was discovered between the 4th and 5th cylinder on the port engine’s inboard side (figure 10). The crack was visible starting at the

no. 5 cylinder's liner through the cooling water passage and about 8 inches down the side of the block.⁸

Figure 10. Close-up of postaccident crack in the block between cylinders 4 and 5 on the *Island Lady's* port main engine.

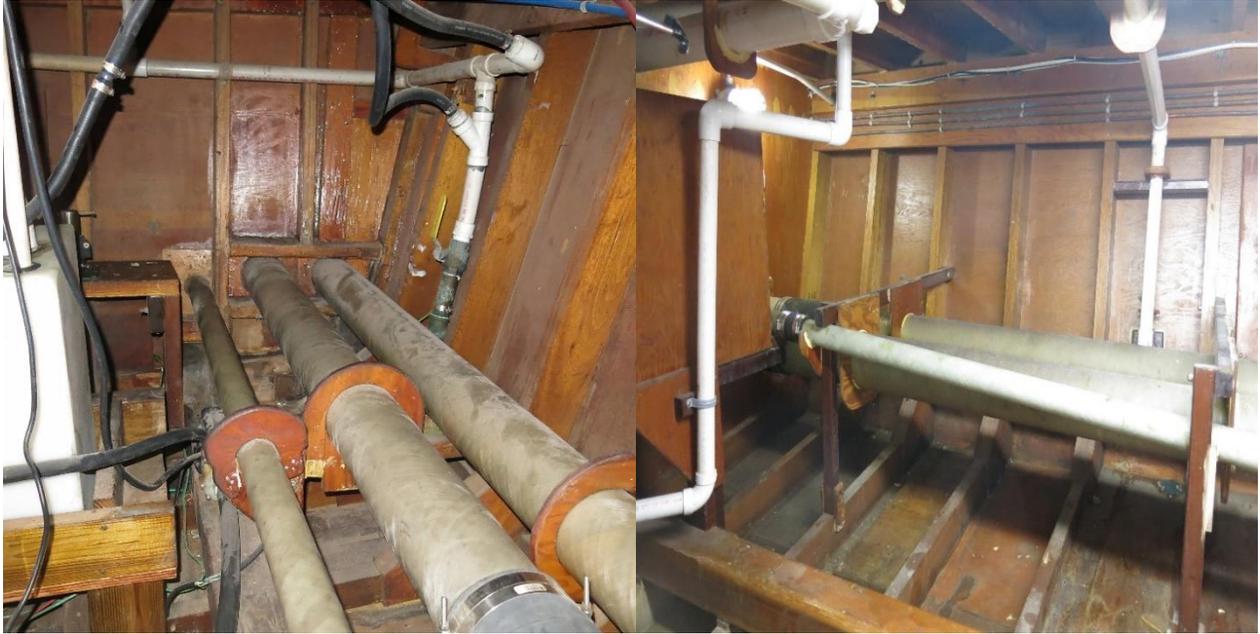
The exhaust tubes were constructed of fiberglass and connected with rubber joints. According to the vessel specifications obtained from the original owner, the original exhaust tubing was Vernatube, which was a resin-impregnated glass filament-wound tubing. The manufacturer stated that the original tubing was made exclusively with a fire-retardant resin formulated for high-temperature applications. However, Tropical Breeze Casino had since replaced some or all of this tubing: For example; according to March 2017 maintenance records, the company purchased and installed 22 feet of 8-inch exhaust tubing and 22 clamps, and the July 2017 maintenance records noted replacement of a leaking exhaust tube in the lazarette. Investigators obtained the purchase receipt to determine the properties of the replacement tubing. The tubing was Novaflex marine hard-wall water exhaust tubing, which the manufacturer stated met standards for marine wet-exhaust applications.

Figure 15. Engine exhaust tubes transiting through the lazarette spaces on board vessels constructed similarly to the *Island Lady*.

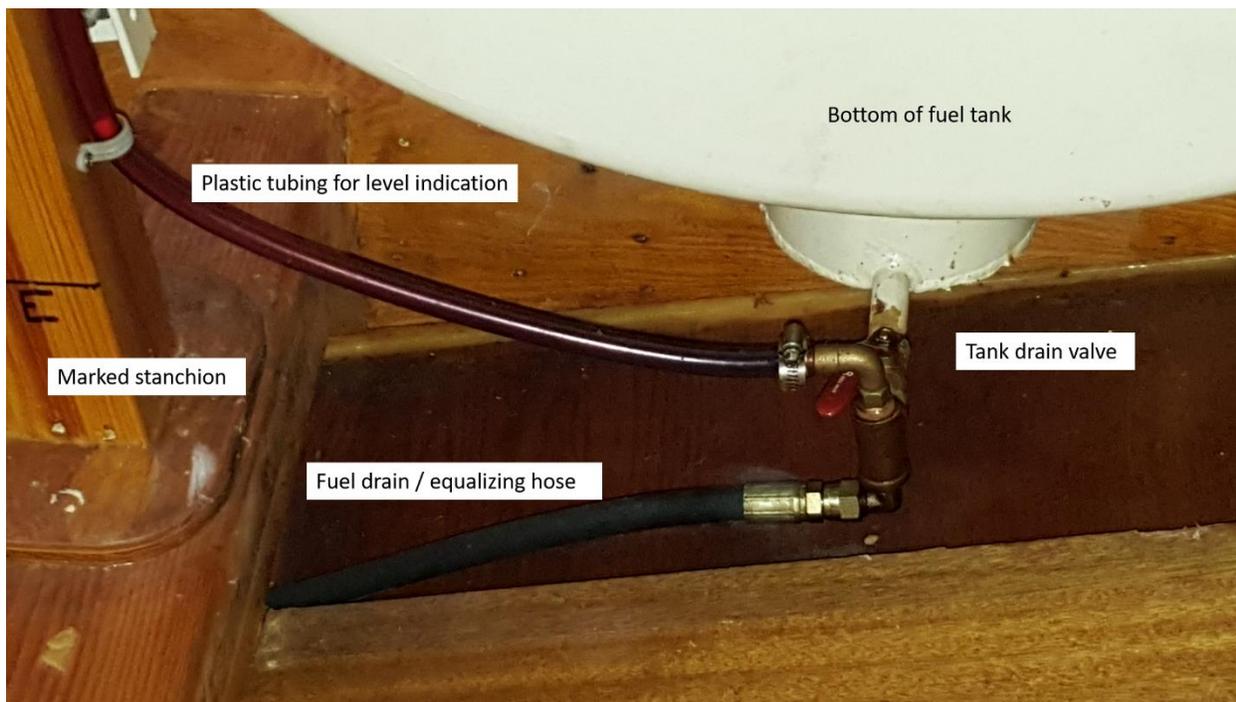
In accordance with Title 46 *CFR* 182.440 (a)(7), "tubular gauge glasses, if fitted to diesel fuel tanks, must be of heat[-]resistant materials, adequately protected from mechanical damage, and provided at the tank connections with devices that will automatically close in the event of rupture of the gauge or gauge lines." In March 2017, during a Coast Guard vessel examination of the *Island Lady*, the inspector found the fuel valves in the open position and photographed them (figure 16). The inspector told the crew to close the valves and he later looked for the regulation

about appropriate tubing material and automatic shutoff valves. He was unable to find the regulation and did not document the finding in the Coast Guard inspection report.

Figure 16. The *Island Lady's* fuel tank drain valve and plastic tubing to fuel-level indicator. (Image provided by the Coast Guard.)

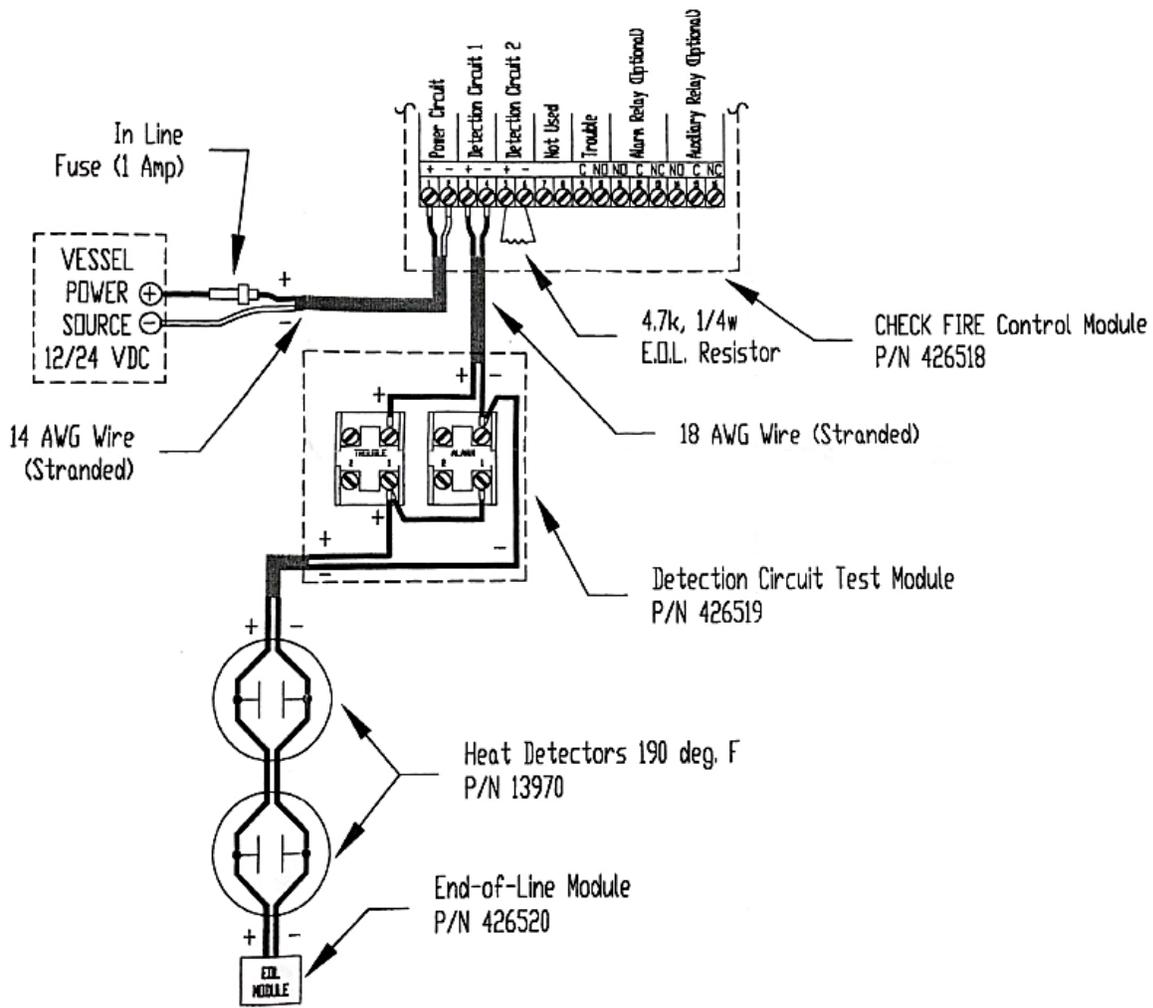
Figure 17. Drawing of the fire detection system layout. (Drawing by Checkfire, provided by the Coast Guard)

The fire detection system was to be tested annually; however, investigators could not find a record of the last test. The captain said in an interview that the heat detectors had been tested but that the records were destroyed in the fire. A Coast Guard “New to Zone” inspection of the *Island Lady* in November 2015 indicated that the overall firefighting system was inspected and found satisfactory. The Coast Guard’s most recent inspection report of the *Island Lady* (March 2017) listed the vessel’s firefighting system as “inspected with deficiencies noted,” but the deficiencies were not related to the detection system, and the owner addressed them during the inspection.¹⁴ Neither Coast Guard inspection narrative specifically mentioned testing of the fire detection system. After the fire, investigators could not locate the two heat detectors or the engine room alarm panel; they were likely destroyed in the blaze.

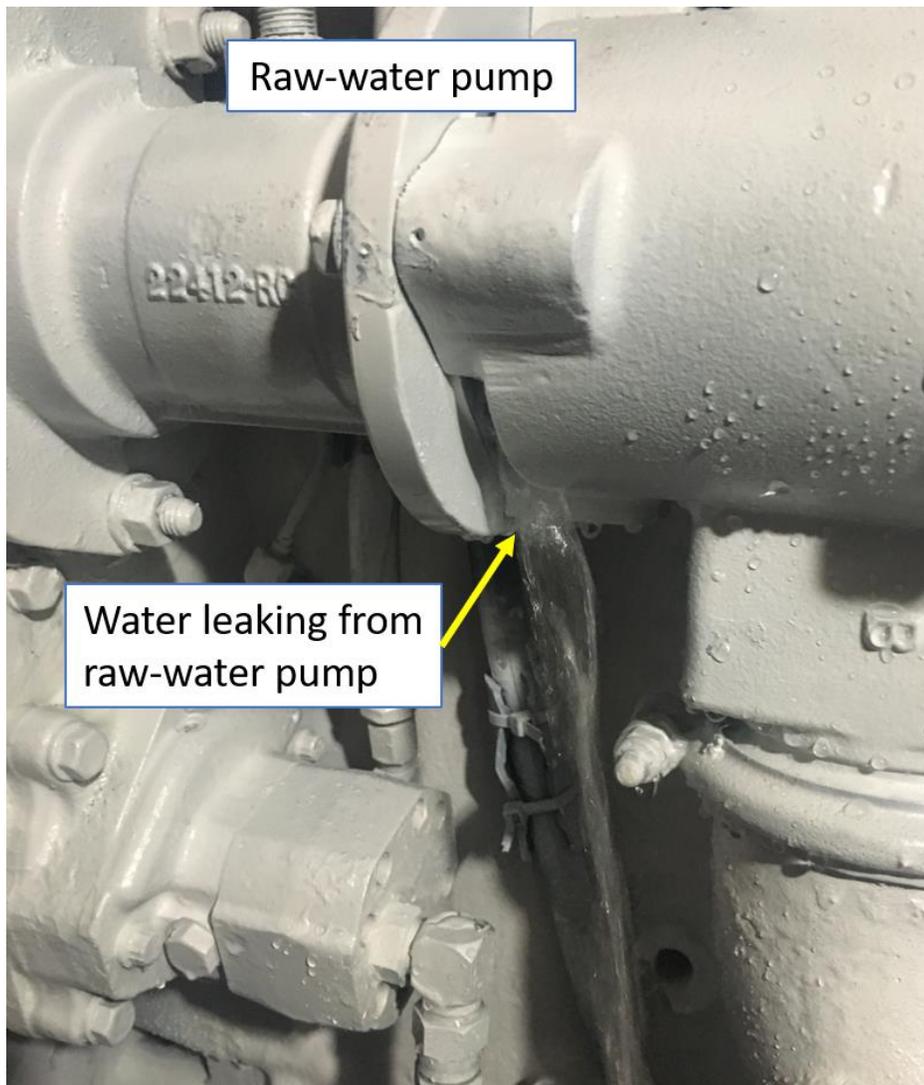
According to the monthly maintenance reports, the impellers of the raw-water pumps for both main engines were replaced in May 2017. No records were available to show the number of hours or days of operation on the impellers. Investigators obtained photos, taken by the engineer in connection with the replacement, of water leaking from the pump housing (figure 22) and of one of the old pump housings and rubber impellers before replacement (figure 23). At least six of the 12 vanes were missing from that impeller.

Figure 22. Water leaking from the *Island Lady's* raw-water pump before its May 2017 replacement, photographed by the engineer.

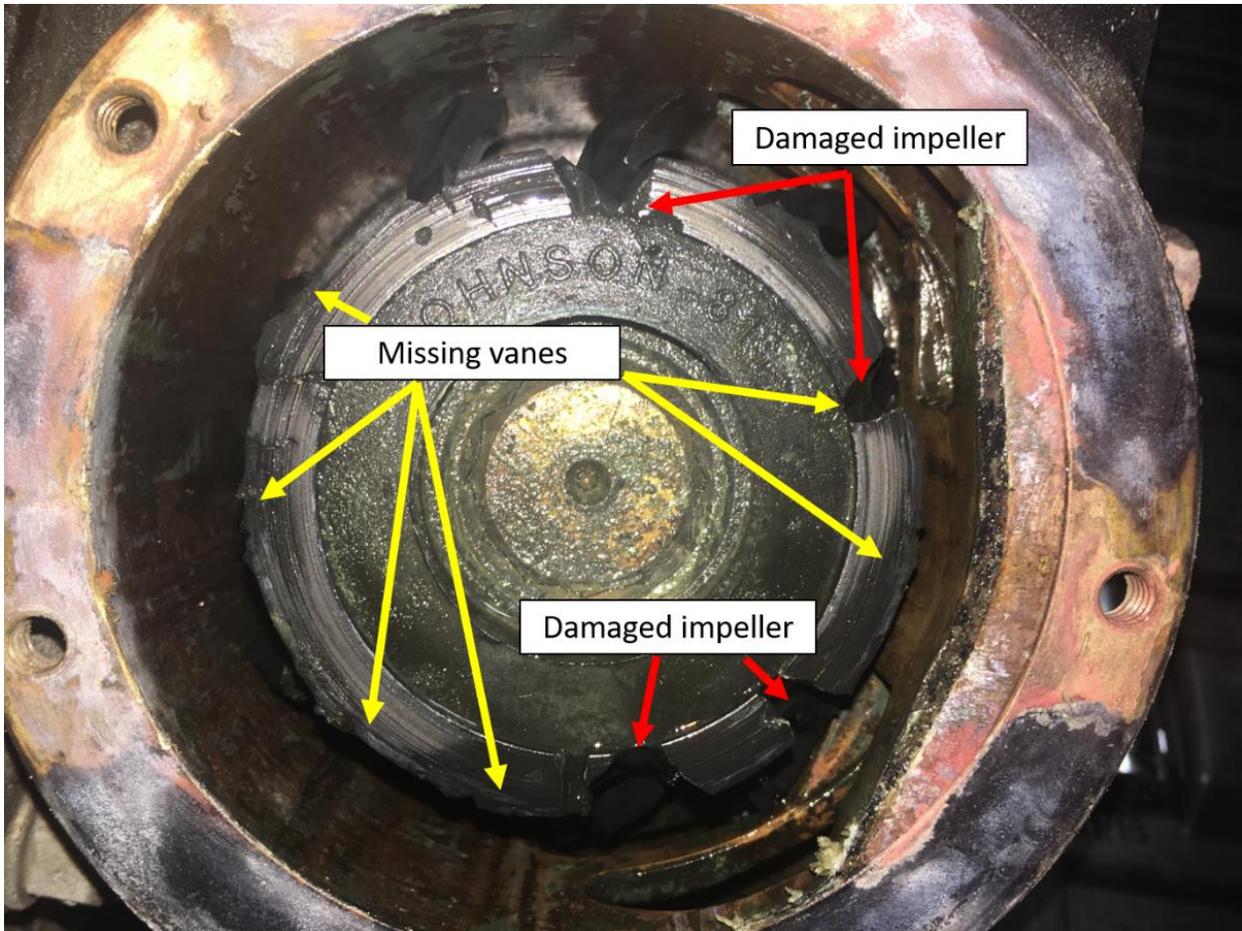
Figure 23. Raw-water pump housing and impeller from the *Island Lady* during the components' May 2017 replacement, photographed by the engineer.

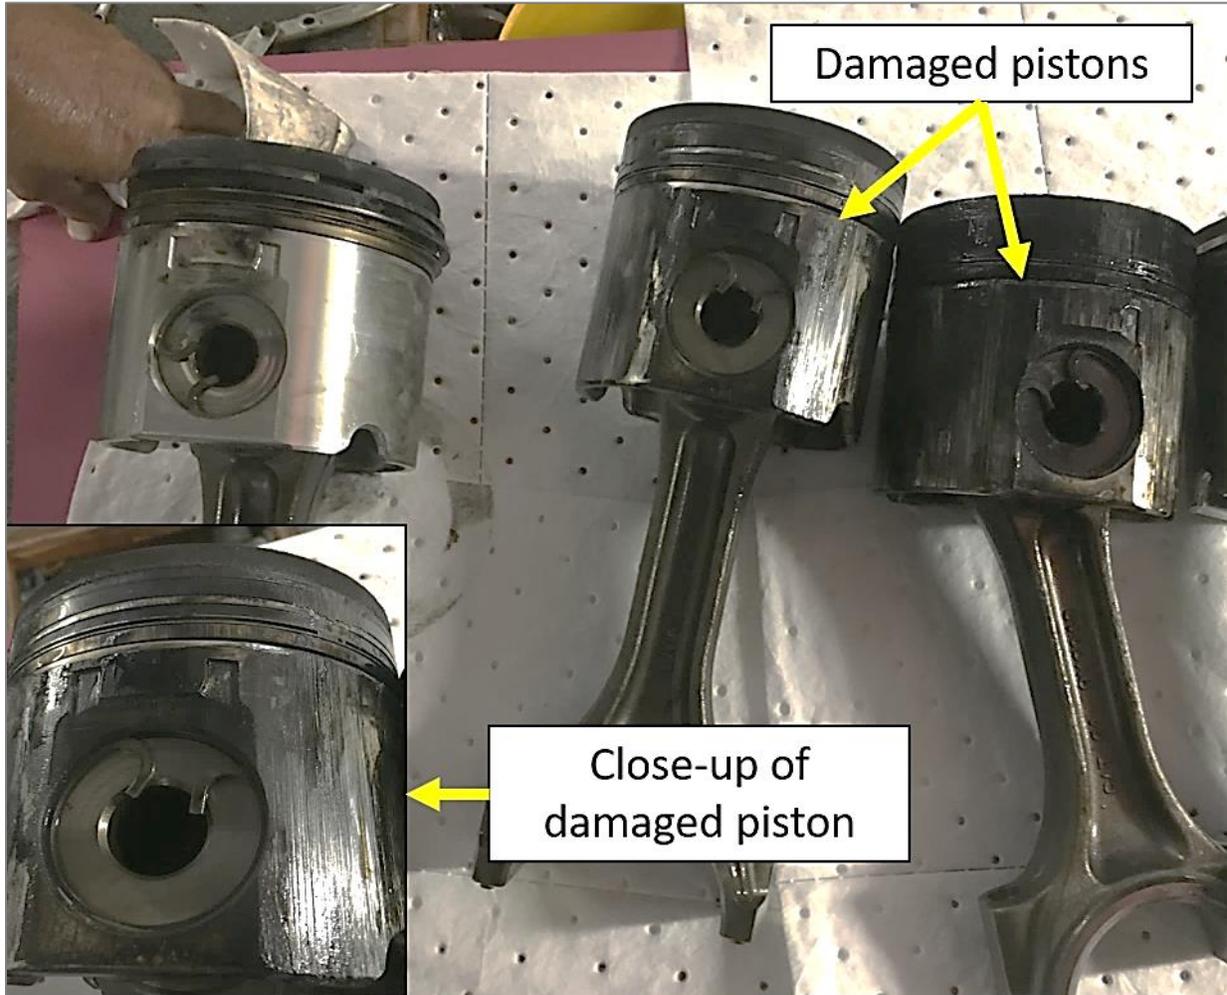
is operated with scored pistons, unburned fuel and the pressurized products of combustion are more likely to enter into the crankcase.

Figure 25. Removed pistons from the *Island Lady's* starboard engine during March 2017 overhaul, photographed by the engineer. The piston in the upper left shows no damage; the remaining pistons are scored.
