# **NATIONAL TRANSPORTATION SAFETY BOARD**

## **MARINE ACCIDENT REPORT**

**FIRE ABOARD THE  
BAHAMIAN PASSENGER SHIP  
M/V SCANDINAVIAN SUN  
PORT OF MIAMI  
MIAMI, FLORIDA  
AUGUST 20, 1984**

**NTSB/MAR-85/08**

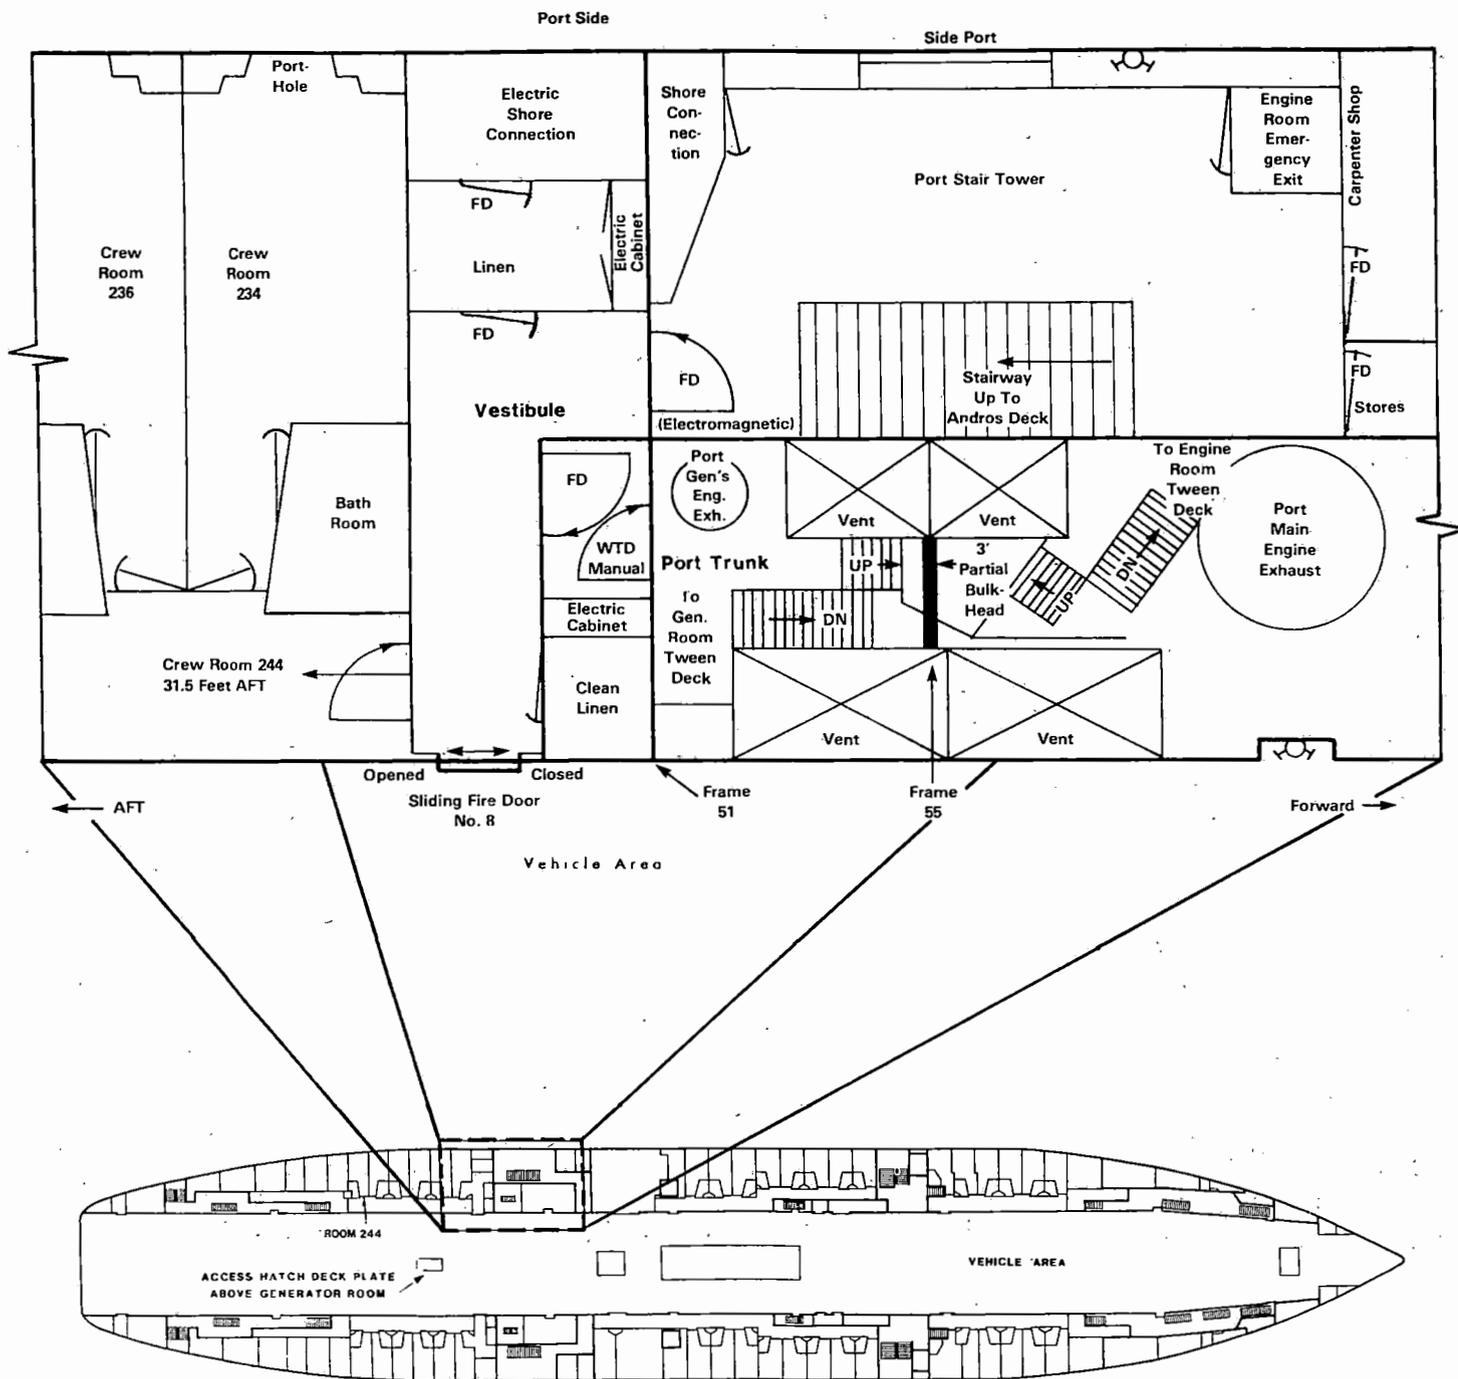
Figure 4.--Plan view of the Bimini Deck portside in the area of the stair tower.

closed sliding fire door No. 8. (See figure 4.) The staff captain, who, according to the ship's emergency plan, was in-charge of on-scene firefighting, immediately formed two firefighting teams and a backup team consisting of the crewmembers who were in the vehicle area. A firehose was rigged from the starboard side of the vehicle area and water was sprayed onto fire door No. 8 and on the fuel tank of an empty refrigerated trailer located next to the fire door. About 2315, longshoremen removed the trailer from the vehicle area and the ship's firefighters entered the vestibule through fire door No. 8. While attacking the fire in the vestibule and port passageway, the firefighters heard a banging noise from the second crew room aft of the vestibule. The staff captain and the first officer proceeded to crew room 236 where they rescued a crewmember. The crewmember had earlier attempted to exit his room, but flames in the passageway outside of his door blocked his escape. About 2321, the fire appeared to be extinguished in the passageway and vestibule.

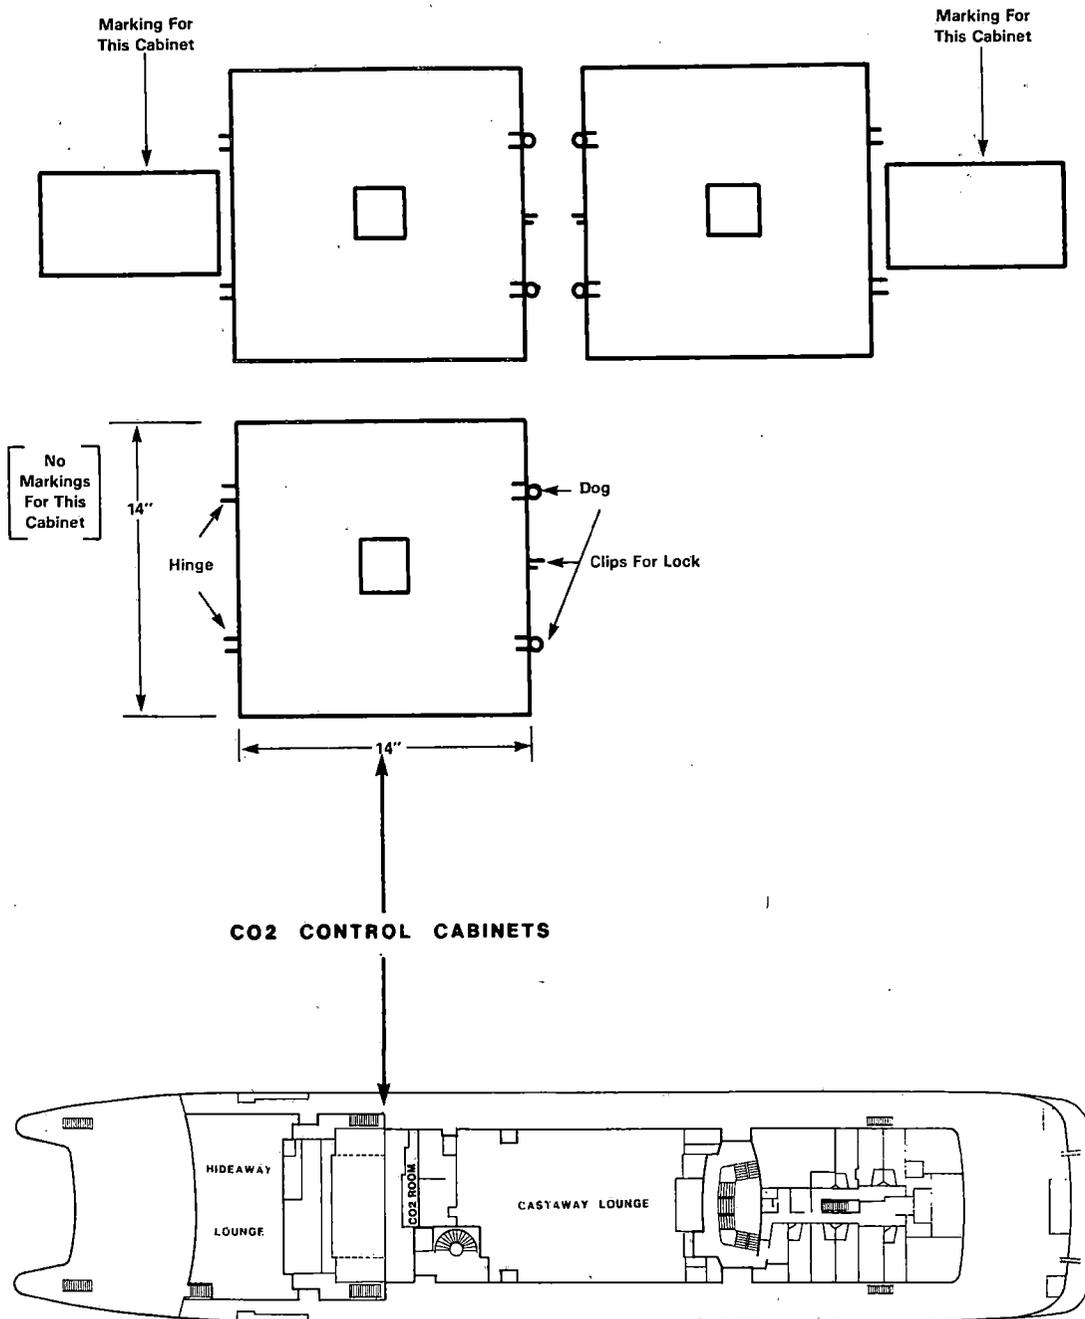
Figure 6.--Carbon dioxide cabinets.

The only control cabinets for CO<sub>2</sub> release for the main engine room/generator room, the stabilizer room, and the separator room are on the port side of the Exuma Deck on the outside bulkhead on the stair tower. Unlocking and opening the CO<sub>2</sub> cabinet door automatically caused the ventilation to shut down and an alarm to be sounded in the space served by the CO<sub>2</sub> system. On the night of the accident, only two of the three cabinets were labeled: the upper left cabinet was marked "separator room" and the upper right cabinet was marked "engine room." The lower left cabinet was unmarked. SOLAS regulations require that CO<sub>2</sub> controls be labeled clearly. The cabinet marked "engine room" contained a single CO<sub>2</sub> control for both the engine room and the generator room. The lower left cabinet contained the CO<sub>2</sub> control for the starboard stabilizer room. This control was activated by the chief engineer after discussion with the engineers assembled at the cabinets as to which control provided CO<sub>2</sub> to the generator room. It was not learned until 5 days after the fire that four cylinders of CO<sub>2</sub> were released into the stabilizer room instead of the generator room. Therefore, the fixed CO<sub>2</sub> system contributed nothing to extinguishing the generator room fire. After the fire, the cabinets were properly labeled.
