PB92-916406  
NTSB/MAR-92/01/SUM

## **MARINE ACCIDENT/INCIDENT REPORT SUMMARY REPORT**

**COLLISION OF THE U.S. SAILING VESSEL  
AMERICAN PROMISE AND THE U.S. FREIGHT  
BARGE E-2, BEING PUSHED AHEAD OF THE  
U.S. TUG M/V SUN COAST, OFF COVE POINT,  
CHESAPEAKE BAY, APRIL 21, 1991**

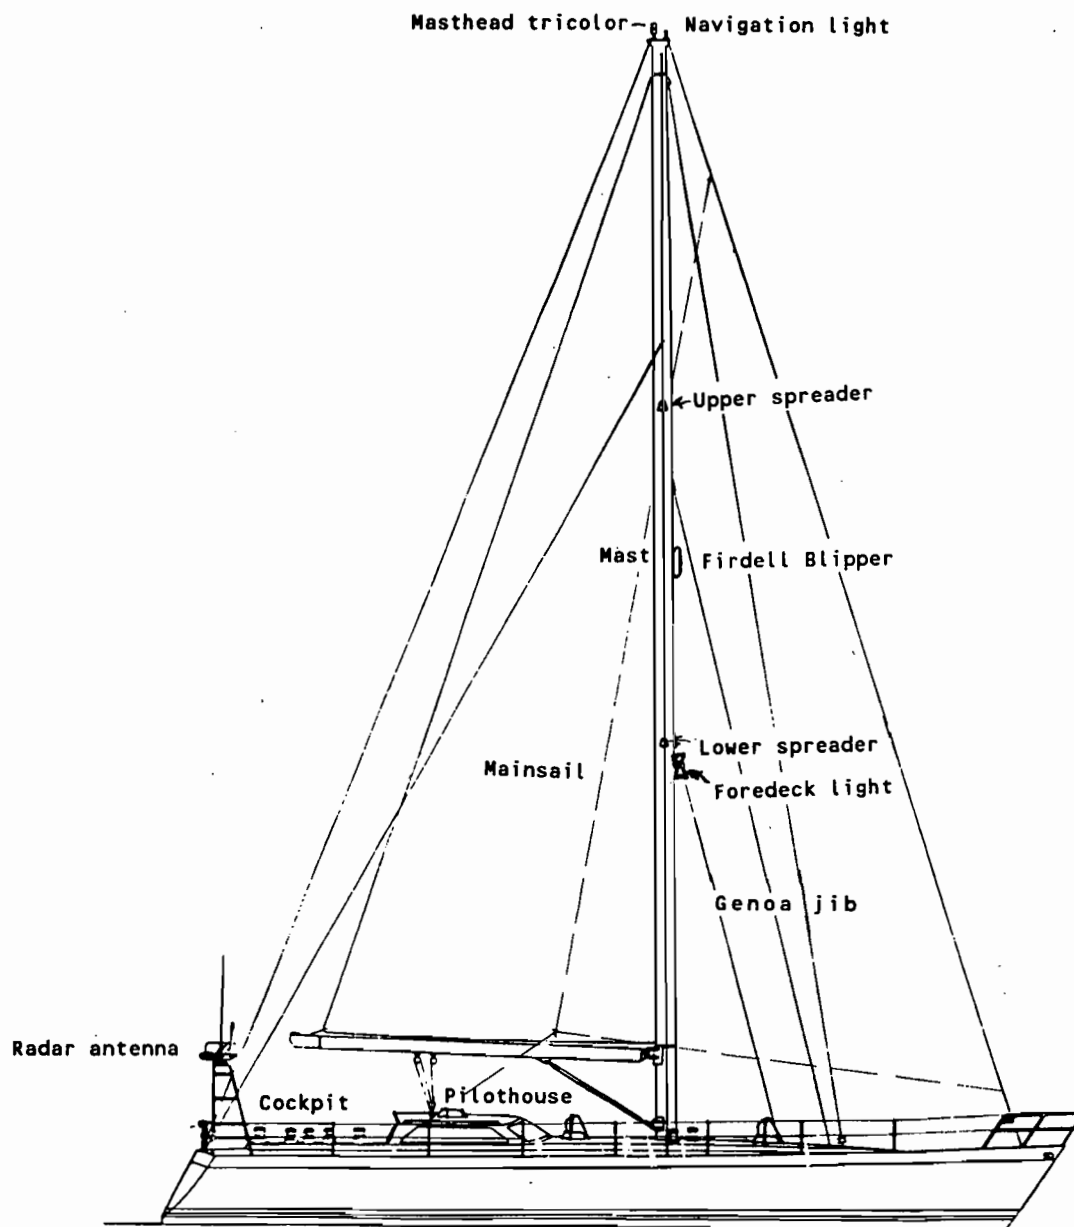
Figure 1.-- AMERICAN PROMISE profile.

On April 20, 1991, the U.S. Naval Academy's AMERICAN PROMISE, a wood/figerglass-hulled 60-foot-long sailing vessel (see figures 1 and 2), was returning to the Naval Academy at Annapolis, Maryland, from an overnight training cruise to Point No Point on Chesapeake Bay. Three U.S. Navy officers and nine U.S. Naval Academy midshipmen manned the vessel. The Officer in Charge (OIC) and Assistant Officer in Charge (AOIC), both lieutenant commanders, were experienced and qualified to operate the AMERICAN PROMISE. A captain who was aboard as safety observer (SO) was undergoing qualification to operate the vessel.

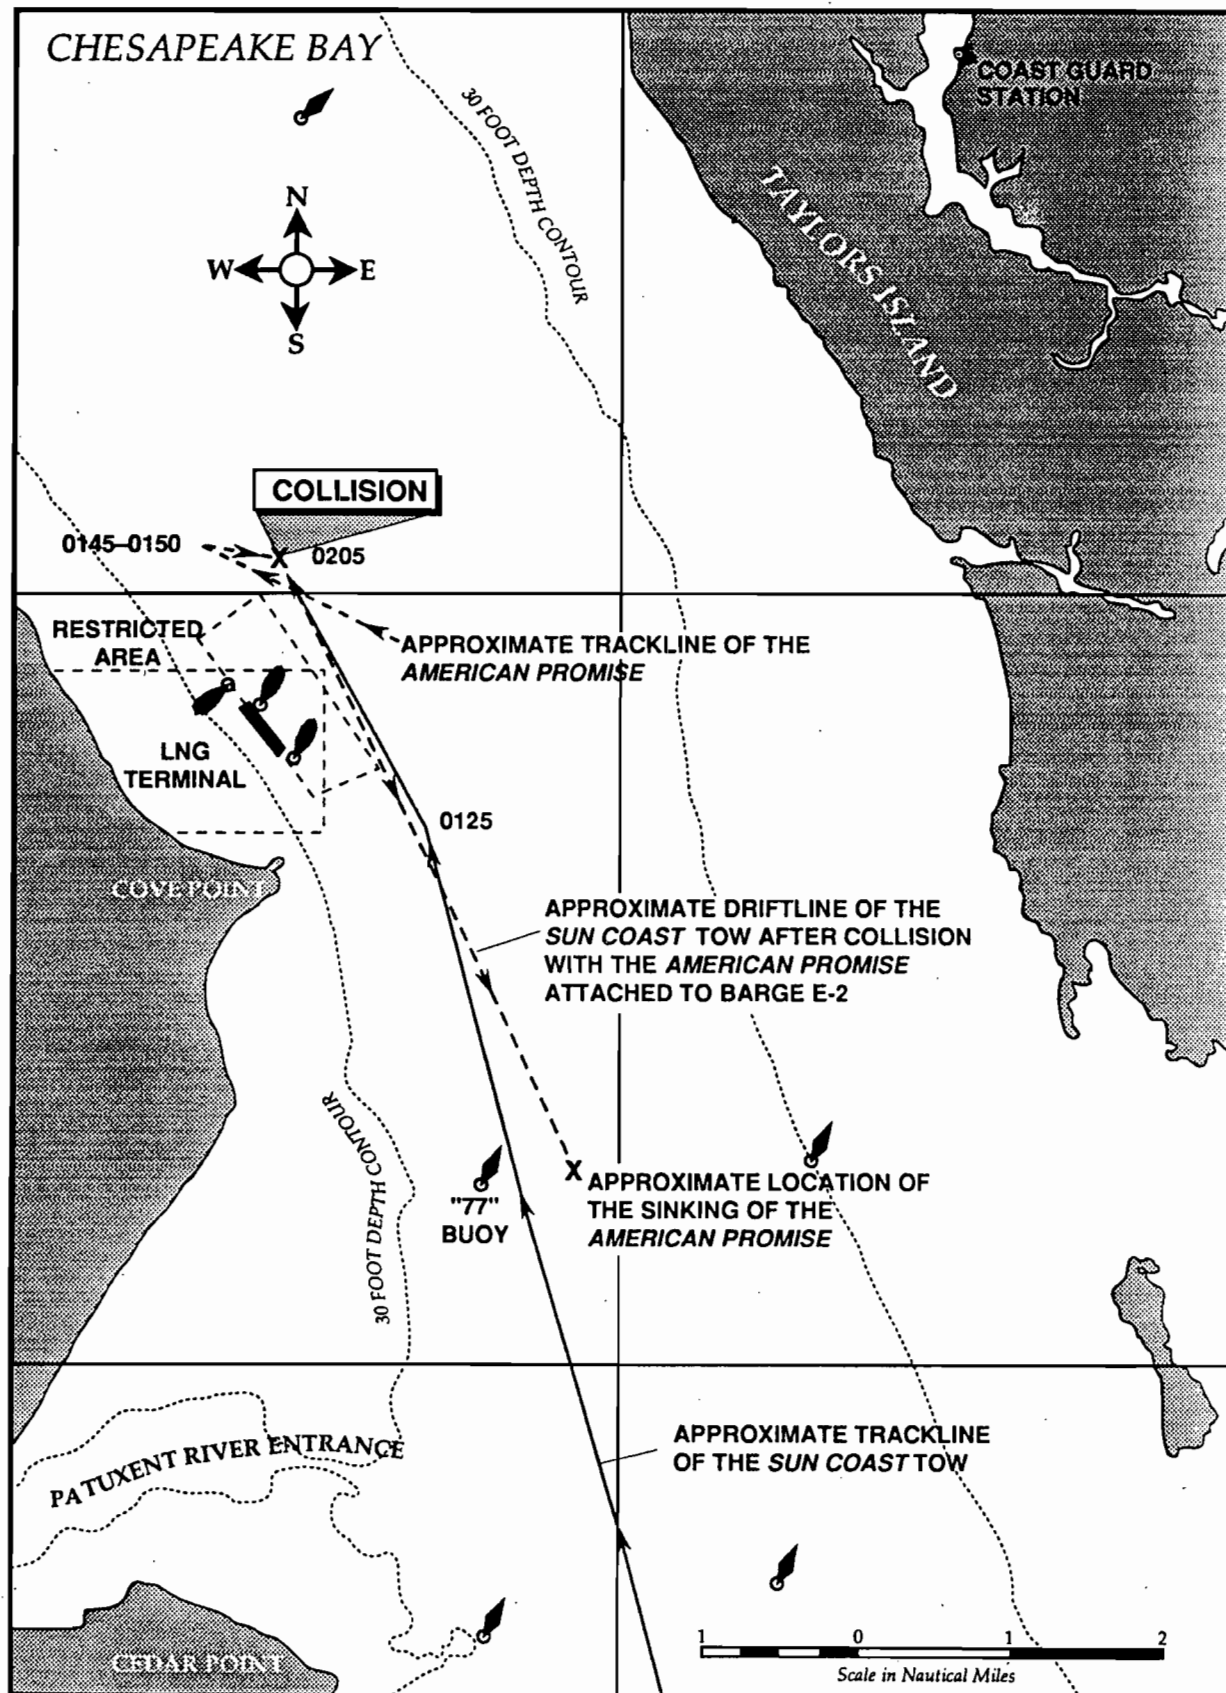
Figure 5.-- Location of the accident.

The SUN COAST's underway watch comprised two persons: the tug operator (master or relief master) and one of the deckhands, standing 6-hour rotational watches. The relief master said that he was awakened on April 20 at 2330 to take the midnight watch (0000 to 0600). When he relieved the watch, the tow was off Cedar Point, 8 nmi south of Cove Point. (See figure 5.)
