February 21, 2024

MIR-24-04

Collision between Tugboat *Mark E Kuebler* and Tanker *Nisalah*

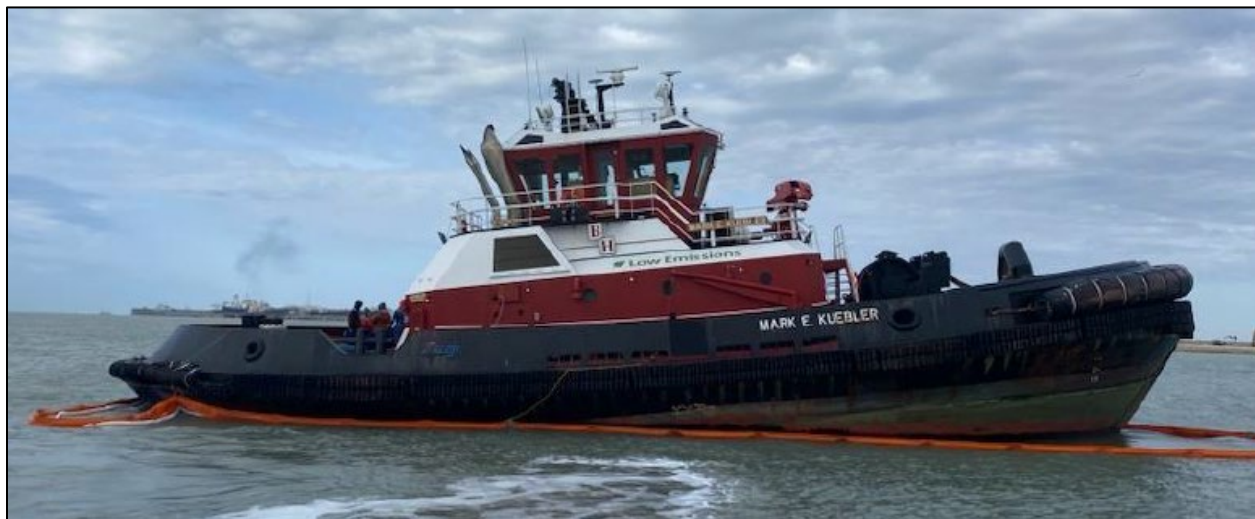
On January 22, 2023, about 1530 local time, the tugboat *Mark E Kuebler* and the tanker *Nisalah* collided while the tanker was transiting inbound in the Corpus Christi Ship Channel near Ingleside, Texas.¹ The tugboat's hull was breached and the tanker's propeller was damaged in the collision. The captain of the *Mark E Kuebler* grounded the tugboat to prevent it from sinking, and, while aground, a small sheen of hydraulic oil was observed near the tugboat (see figure 1). The oil was recovered with absorbent pads. No injuries were reported. Damage to the *Mark E Kuebler* was estimated at \$3 million; damage to the *Nisalah* was estimated at \$3.9 million.

Figure 1. *Mark E Kuebler* aground following the collision. (Source: G & H Towing)

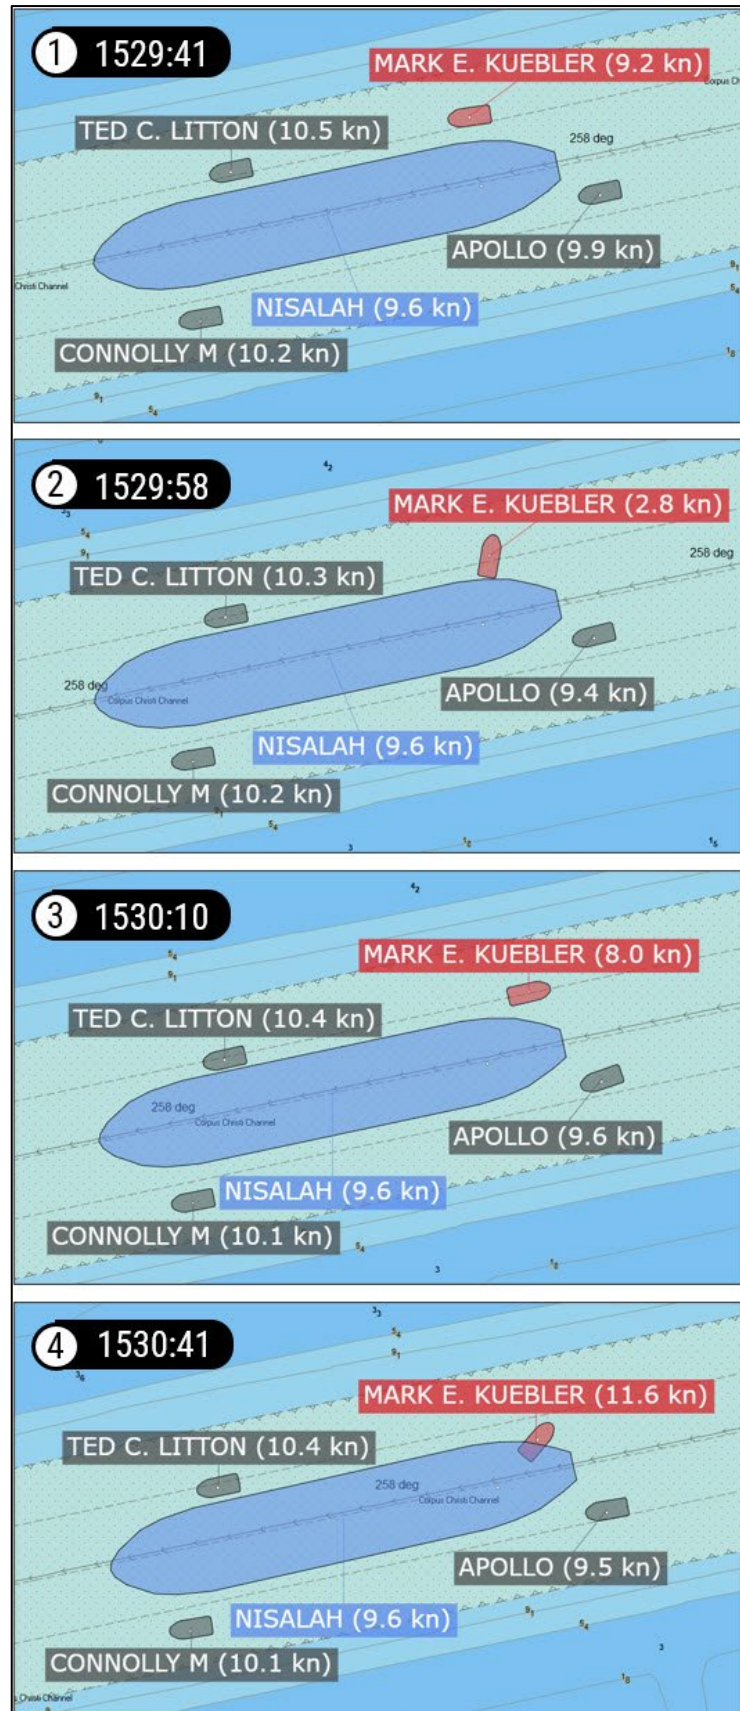
Figure 4. *Mark E Kuebler/Nisalah* collision sequence from automatic identification system data.

To prepare to move into position, the *Mark E Kuebler* mate used the Z-drives to spin the tugboat clockwise 180° (see figure 4). The mate stated that, while completing the spin maneuver, the tugboat fell back near the stern of the *Nisalah*, so he increased power on the tugboat's engines to regain position on the tanker's starboard quarter.

According to the mate, as the *Mark E Kuebler* transited in the astern direction, the tugboat had about 50-60 feet of separation from the tanker. However, as the tugboat moved forward on the tanker, the stern of his vessel began to be drawn in toward the *Nisalah*. The mate increased engine power and attempted to steer the tugboat's stern away from the *Nisalah*, but the tugboat continued to be pulled toward the tanker. As the *Mark E Kuebler* closed on the *Nisalah*, its speed was 11.6 knots.

1) *Mark E Kuebler* paces *Nisalah*.
 2) Tugboat conducts 180° spin maneuver. 3) *Mark E Kuebler* begins to regain position, transiting in astern direction. 4) Tugboat is pulled in toward tanker, and vessels collide. (Source: Made Smart plotter)

After the casualty, G & H Towing instituted a policy restricting stern-first landings of tugboats on assisted vessels to speeds of 7 knots or less. According to a company representative, attempting the maneuver at speeds over 7 knots would be ineffective because all of the tugboat's engine thrust would be used to maintain the tugboat's position alongside the assisted vessel. The company representative added that the margin for error "significantly increases" at speeds greater than 7 knots, and stated, "We have recently seen incidents across industry, and the common factor is operators trying to perform advanced maneuvers at high speeds which gives a higher risk factor with no reward."

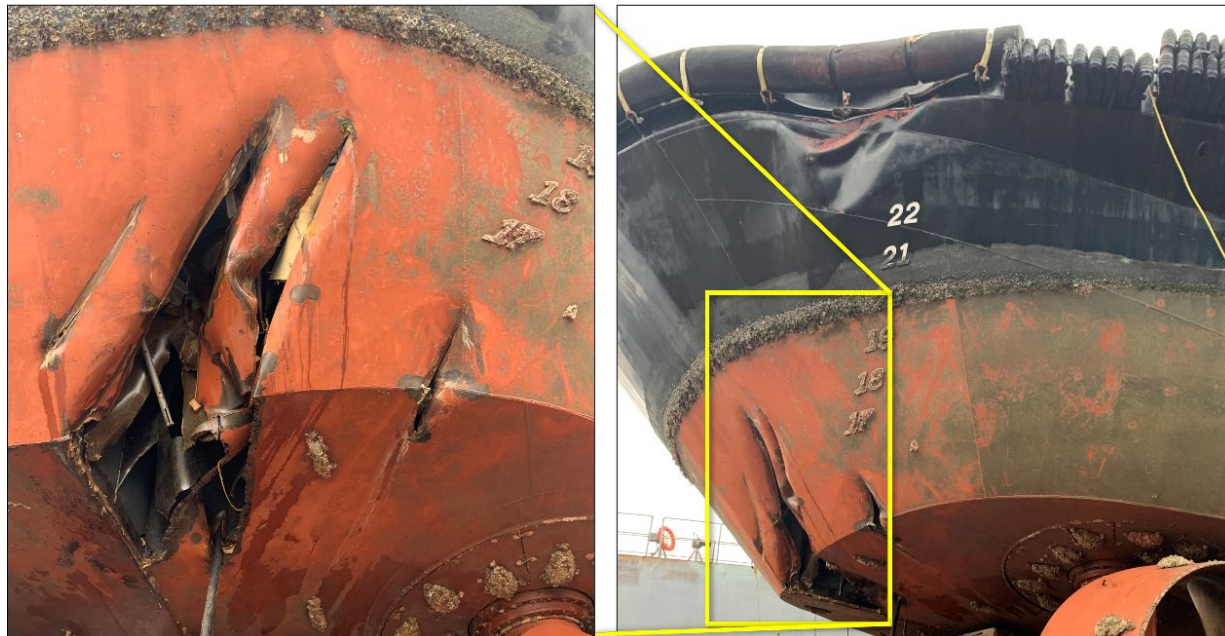
The *Nisalah* propeller strike caused multiple gashes in the *Mark E Kuebler*'s hull at the stern, along with hull warping and damage to the vessel's fendering system (see figure 5). The tugboat's aft peak tank and Z-drive machinery room were breached, flooding both spaces to the waterline and inundating equipment. Salvage expenses for the tugboat were estimated at \$1 million, and repair costs were estimated at \$3 million.

Figure 5. Damage to *Mark E Kuebler* stern hull and fendering system from the *Nisalah* propeller.

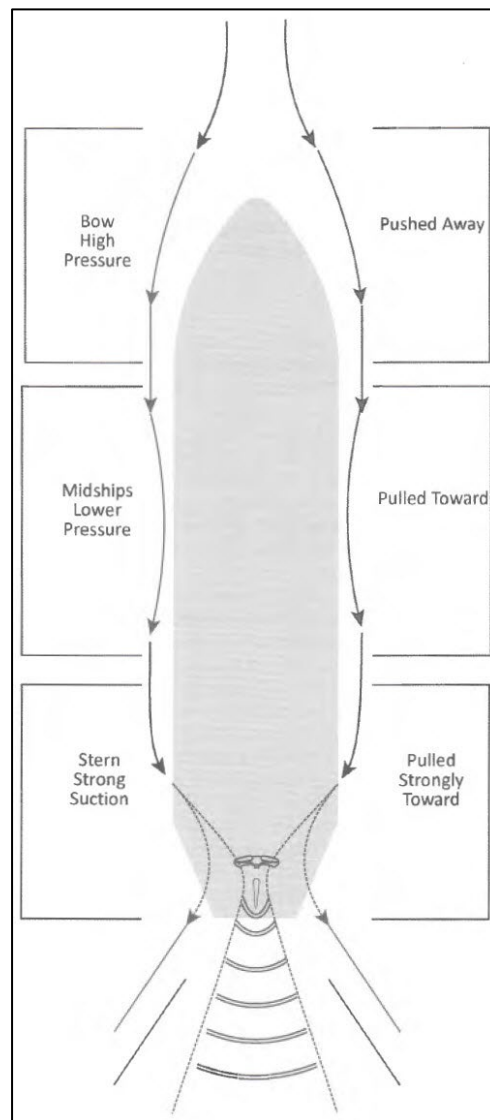
Figure 6. Pressure zones around a ship moving through a channel. (Source: J. Slesinger)

As the *Mark E Kuebler* moved to get into position alongside the *Nisalah* after executing the 180° spin, the tugboat (moving in the astern direction) approached the area of low pressure on the *Nisalah*'s starboard quarter. Because the *Nisalah* was in ballast, the inward curve of the ship's hull toward the stern at the waterline was more pronounced than it would have been if the ship were loaded. Thus, the pressure near the VLCC's starboard quarter was further reduced as compared to the vessel at its loaded draft. In addition, the drop in pressure was further accentuated near the propeller. The hydrodynamic suction produced by the low pressure in this area caused the *Mark E Kuebler*'s stern to be drawn into the tanker.

As the *Mark E Kuebler* attempted to regain position on the *Nisalah*, the VLCC's speed was 9.6 knots. Hydrodynamic forces created by a ship increase exponentially with speed, and therefore an increase of even a few knots has a significant effect on the forces acting on a tugboat operating nearby.⁴ Moreover, as the *Mark E Kuebler* attempted to move into position, the tugboat's speed increased to 11.6 knots—just 1.4 knots less than its maximum-rated ahead speed. Higher speed reduces the amount of reserve propulsion power available to the operator. Because most of the tugboat engines' power was being used to regain position on the *Nisalah*, the *Mark E Kuebler* had insufficient power to counteract the hydrodynamic forces created by the tanker. After the collision, the tugboat's operating company instituted a policy limiting stern-first landings of tugboats on assisted vessels to speeds of 7 knots or less.

As a large ship moves through a channel, a low-pressure suction is particularly strong on the vessel's quarters near the inlet side of the propeller, and hydrodynamic forces increase exponentially with the vessel's speed. Therefore, a small vessel operating near a larger vessel must maintain a safe operating distance or have sufficient reserve power to counteract the hydrodynamic forces to avoid being pulled into the other vessel and risking collision. If a small vessel must operate near a larger vessel—such as a tugboat conducting harbor-assist operations—the operator of the smaller vessel should be aware of the hazards caused by hydrodynamic forces and, if necessary, maintain a safe distance until the larger vessel slows and the hydrodynamic forces are reduced.
