MIR-24-17

Engine Room Fire on board Passenger Ferry *Sandy Ground*

Anchorage Channel, New York Harbor
Staten Island, New York
December 22, 2022

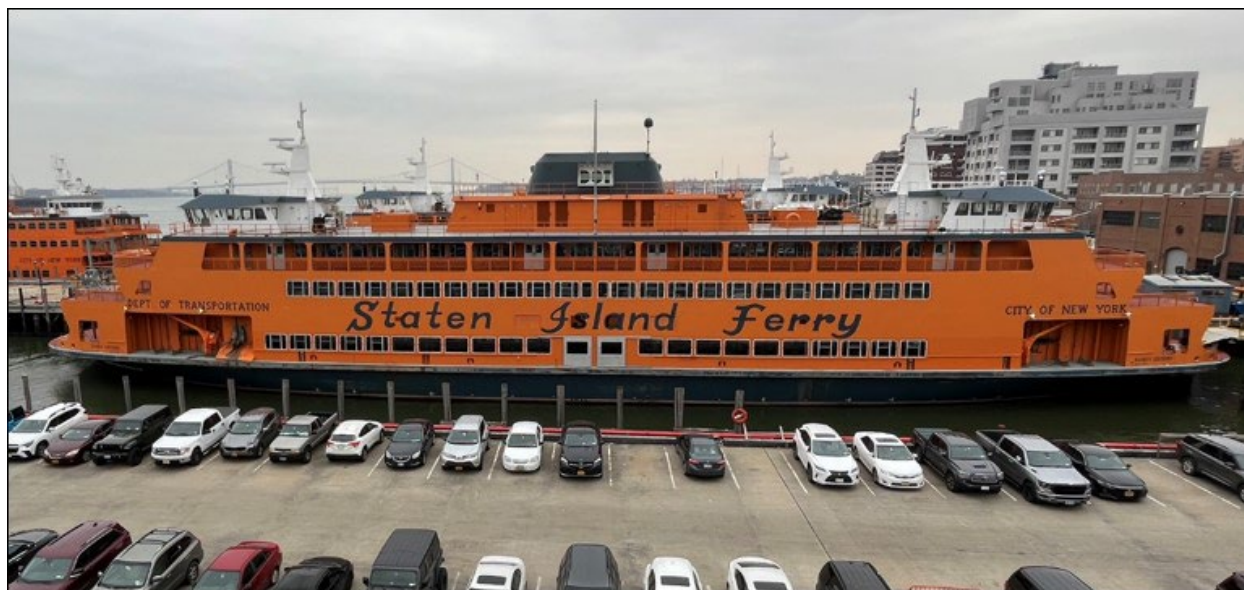
On December 22, 2022, about 1654 local time, an engine room fire broke out aboard the passenger ferry *Sandy Ground*, shown below in figure 1, while the vessel was underway in Anchorage Channel, New York Harbor, near Staten Island, New York, with 884 persons aboard.¹ The crew extinguished the fire by activating the engine room's fixed fire extinguishing system. The vessel lost propulsion and electricity, and the crew deployed both anchors. The majority of the passengers transferred to responding Good Samaritan vessels; the *Sandy Ground* was towed to the St. George Ferry Terminal in Staten Island, where the remaining persons on board disembarked. There were no injuries, and no pollution was reported. Damage to the vessel was estimated at \$12.7 million.

Figure 1. *Sandy Ground* docked after the fire.

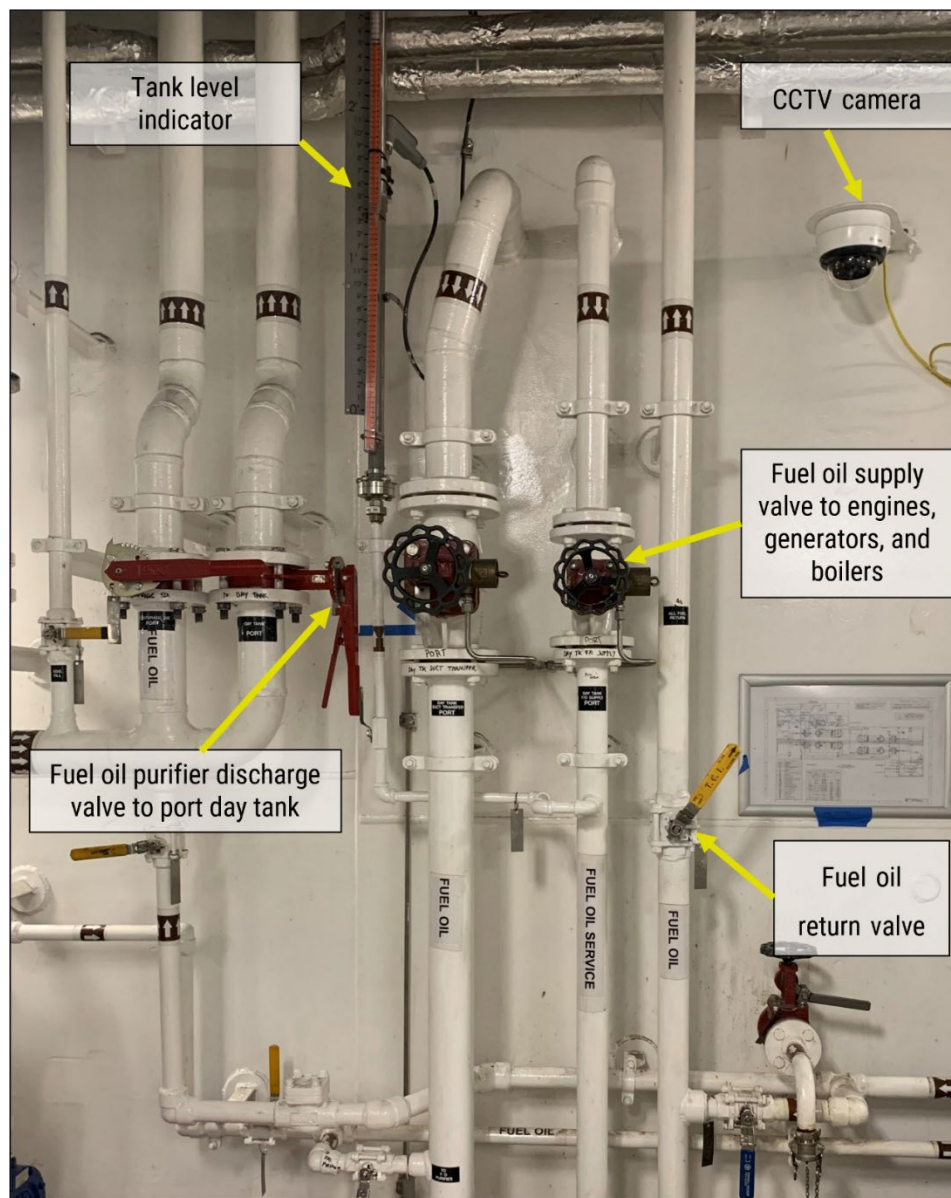
At 1602, oiler 2 made several turns in the clockwise (closing) direction of the fuel oil service supply globe valve at the port fuel oil station and then walked toward the starboard fuel oil station (see figure 5). At 1606, the port fuel oil day tank alarmed with a low level. At 1609, oiler 2 returned to the port fuel oil station and made several turns in the counterclockwise (opening) direction of the fuel oil service supply globe valve and then headed in the direction of the starboard fuel oil station. At 1611, the port fuel oil day tank alarmed again with a low level. The engineers acknowledged both alarms on the MCS, and at 1612, the chief engineer disabled the port fuel oil day tank low level alarm using the MCS computer keyboard.⁶ At 1613, the starboard fuel oil day tank alarmed with a low level; the chief engineer acknowledged the alarm and then disabled the starboard fuel oil day tank low level alarm. The chief engineer stated that he considered these to be “nuisance alarms.” The chief engineer and the assistant engineer looked at the MCS screens for several minutes.

Figure 5. Fuel oil piping at the port (Staten Island end) fuel oil station aboard *SSG Michael H. Ollis*, which was a vessel of the same class as the *Sandy Ground* and had a similar piping arrangement (*SSG Michael H. Ollis* piping shown due to postfire condition of *Sandy Ground* fuel oil station). The fuel oil return valve is a ball-type valve. Note the valve is partially closed (ball valve open-to-close range is 90° and indicated by handle position).

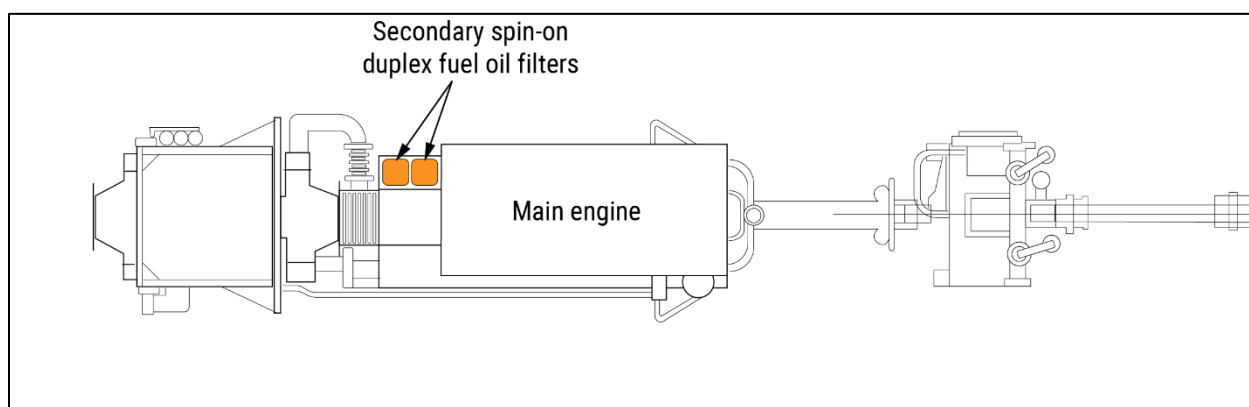
About 1647, 5 minutes after the transit began, multiple alarms for all four main engines sounded simultaneously on the MCS. These alarms included high fuel oil filter pressure differential alarms (the differential alarm sensor was located on the engine-mounted secondary spin-on duplex fuel oil filters on each main engine [see figure 6]); low fuel oil pressure alarms; and “check engine” alarms.⁸ At this time, the CCTV camera near the no. 2 main engine showed fuel dripping from the overhead onto the side of the running engine and puddling on the deckplates below (see figure 7).

Figure 6. Location of engine-mounted secondary spin-on duplex fuel oil filters (shown as circles) on *Sandy Ground* main engine.

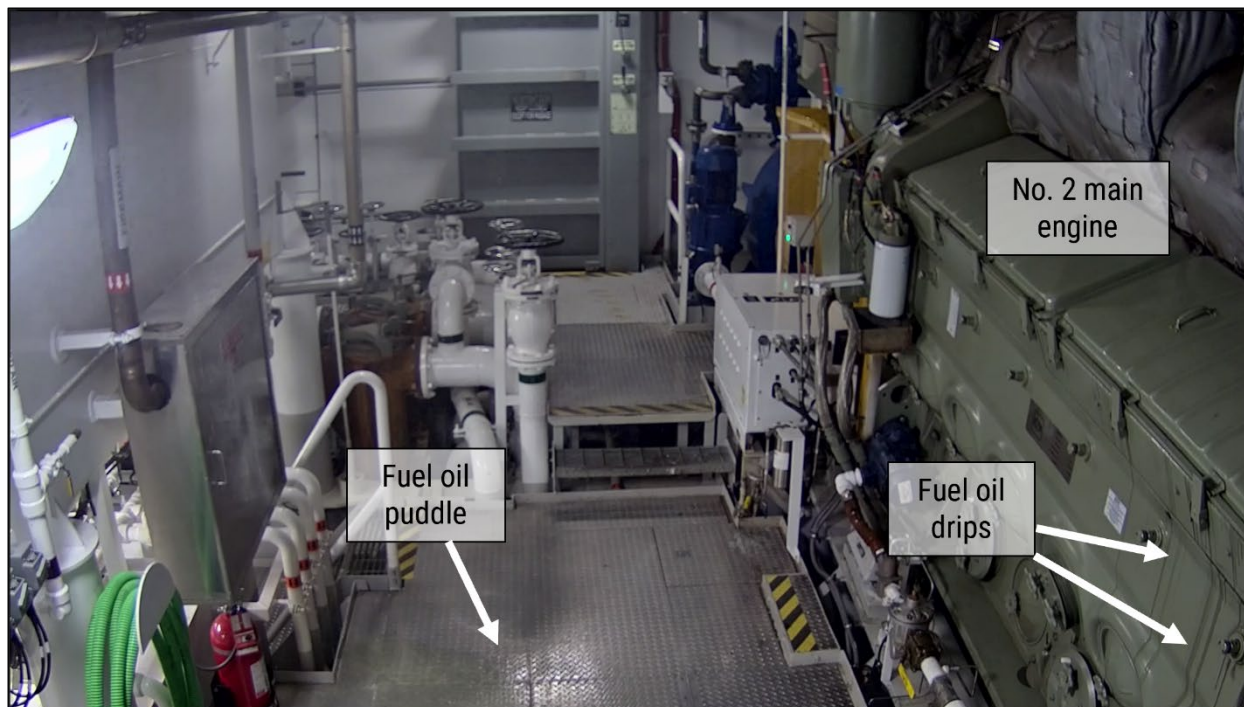
Figure 7. Fuel oil dripping onto the no. 2 main engine and on the adjacent deck in the lower engine room (looking toward the New York end) aboard *Sandy Ground* at 1648. (Background source: NYCDOT Ferry Division)

The chief engineer began acknowledging and silencing alarms on the MCS computer. He stepped out into the engine room and saw fuel oil leaking from the no. 2 main engine secondary duplex spin-on fuel filter assembly and that nos. 3 and 4 main engines had "fuel on them." The chief engineer returned to the EOS. The oilers, who were in the engine room at this time, told the chief engineer they observed fuel oil spraying from the nos. 3 and 4 main engines. Several alarms displayed on the MCS, including "stop engine" and "check engine," for all four main engines. About a minute after the initial fuel alarms activated, the vessel's fire detection system alarmed (the alarm sounded on the fire control panels in both pilothouses and the EOS).⁹

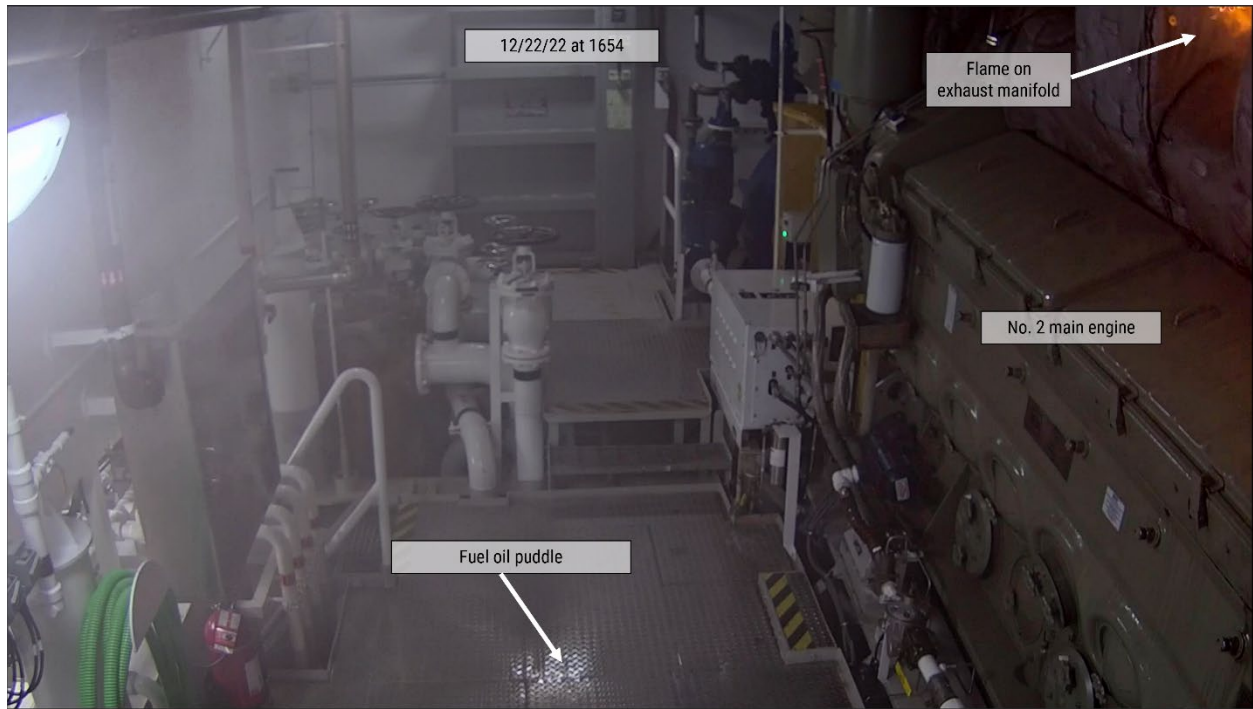
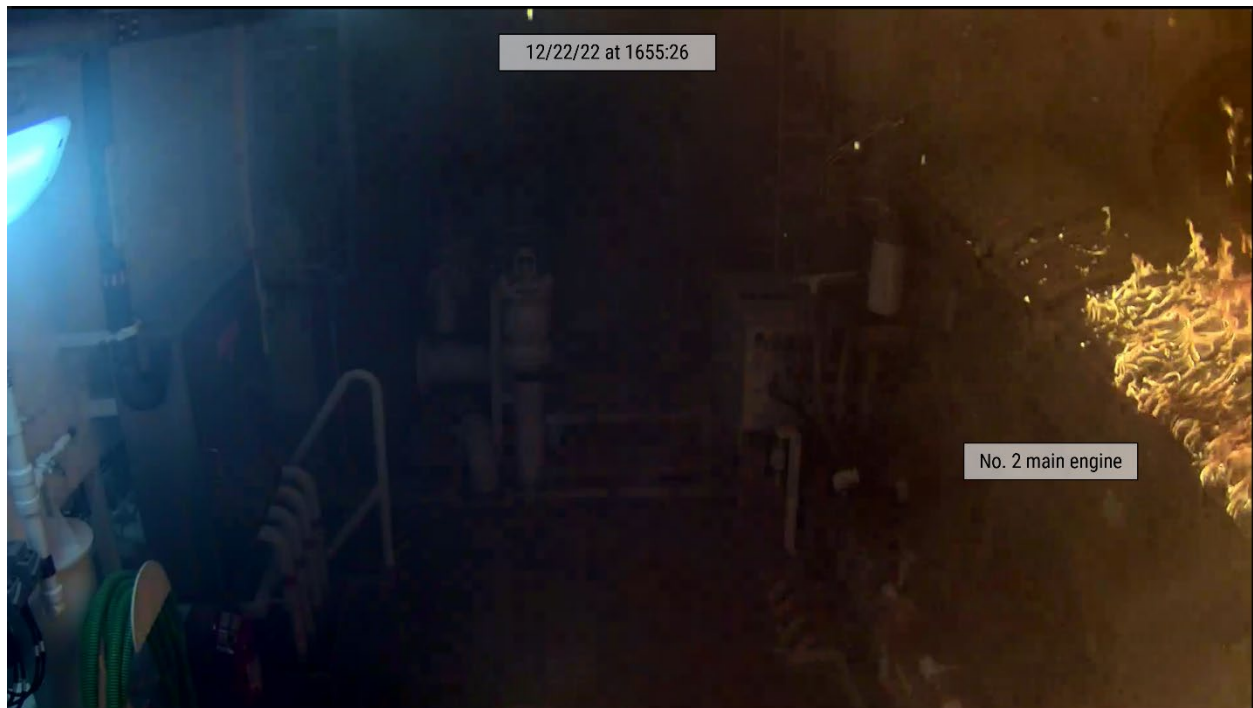
At 1654, when the *Sandy Ground* was near buoy 30 in Anchorage Channel, about 12 minutes after departing Manhattan, CCTV footage showed a fire breaking out on the exhaust manifold of the no. 2 main engine (see figure 8 and figure 9). Oiler 1, in the engine room by the no. 1 main engine, smelled smoke and saw fire. The fire spread onto the upper covers of the engine, and embers began falling from the overhead.

Figure 8. Initial fire breaking out on exhaust manifold on no. 2 main engine at 1654 (*above*) and fire on the no. 2 main engine at 1655:26 (*below*) looking toward the New York end. (Background source: NYCDOT Ferry Division)

The postcasualty examination of the damage found that the no. 2 main engine exhaust manifold insulation and exterior components sustained smoke and fire damage. While the no. 2 engine was operating, the temperature of its exhaust manifold, which was wrapped in insulation blankets, would have been similar to the combined cylinder exhaust temperatures of the *Sandy Ground* engines—which ranged from 624°F to 942°F, depending on engine load. This surface temperature of the exhaust manifold would have provided an ignition source for the fuel oil spraying from the no. 1 main engine directly onto the heated surface of the no. 2 main engine’s exhaust manifold between the joints of the insulation (see figure 15). Therefore, the NTSB concludes that the engine room fire started when fuel oil sprayed from the ruptured secondary duplex fuel oil filter of the no. 1 main engine onto the no. 2 main engine’s exhaust manifold and ignited.

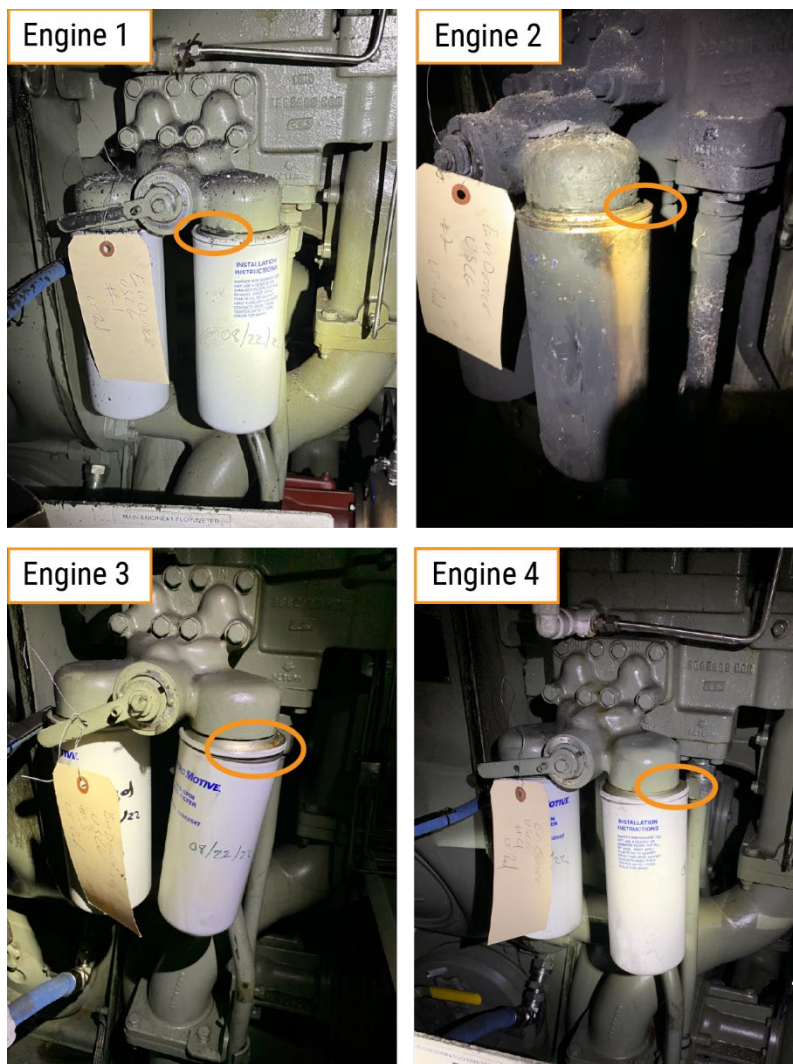
After the vessel returned to the dock and the engine room was cleared for safe entry, Staten Island Ferry management, technicians, *Sandy Ground* crewmembers, and Coast Guard and National Transportation Safety Board (NTSB) investigators examined the damaged areas of the engine room.¹⁴ They found the engine-mounted secondary spin-on duplex fuel filter assemblies that had been in service (online) at the time of the casualty on all four main engines were each distorted at the connection points where the filters sealed against the filter bases. The gasket on the no. 1 main engine secondary spin-on duplex engine-mounted secondary fuel filter had ruptured and protruded out of the sealing surface in the direction (outboard) of the no. 2 main engine (see figure 11).

Figure 11. Damage (circled) found on secondary spin-on duplex fuel oil filters from each of the four main engines after the casualty. The no. 1 main engine has a protruding gasket in the direction (outboard) of the no. 2 main engine, and the nos. 2, 3, and 4 main engine filter housings are distorted.

A postcasualty examination found the secondary spin-on duplex fuel oil filter assemblies on all four main engines were distorted at the connection points where the filters sealed against the filter bases. Additionally, the gasket on the no. 1 main engine secondary fuel oil filter had ruptured and protruded out of the sealing surface, indicating the fuel oil system had experienced overpressurization. In fact, all four running main engines had a high fuel oil pressure differential alarm, which was followed 2 seconds later by a low fuel oil pressure alarm, indicating that the excessive fuel oil pressure was instantly released through the ruptured filter gaskets into the engine spaces.

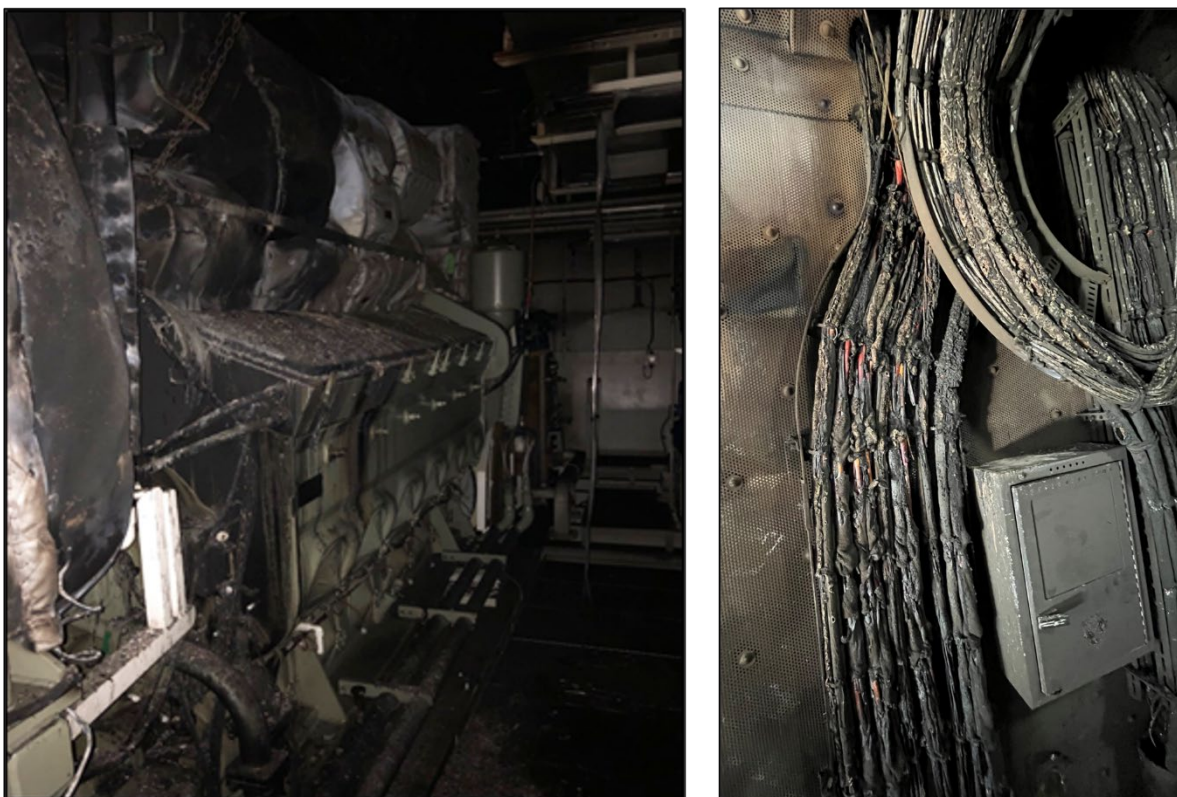
More than 60 electrical power and control cables were damaged by fire and heat above and around the no. 2 main engine and in the adjacent main deck machinery casing (see figure 12). The no. 2 main engine had smoke and fire damage to the exhaust manifold insulation and to the exterior components. Several deck plates and their supporting steel frames were distorted due to the heat of the fire. As a result of the fire, the *Sandy Ground* incurred an estimated \$12.7 million in total costs for repairs.

Figure 12. (Left to right) No. 2 main engine and damaged electrical cables in the machinery casing above no. 2 main engine after the casualty.

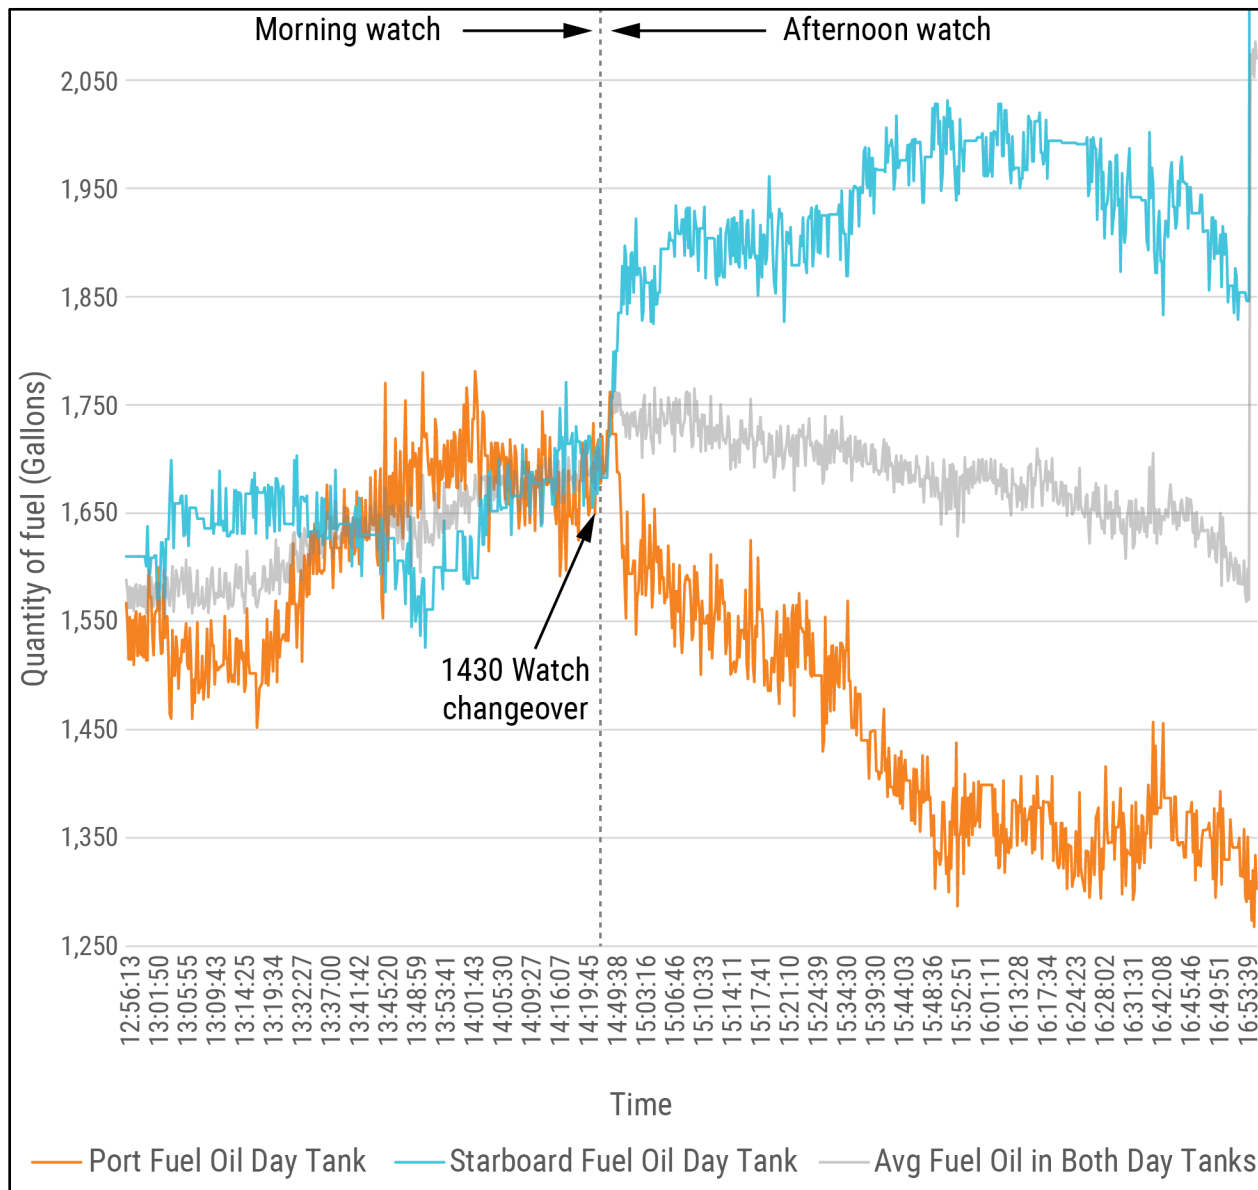
Data from the MCS log showed that, on the day of the casualty, the port fuel oil day tank level declined from about 1,700 gallons at 1430 when the afternoon crew came on watch to about 1,300 gallons at the time of the fire (see figure 14). The level in the starboard fuel oil day tank rose from about 1,700 gallons (at 1430) at the start of the watch to nearly 2,000 gallons before it began to decline about 1625.

Figure 14. Graphic representation of fuel oil quantities in port fuel oil day tank and starboard fuel oil day tank. Average fuel oil in both tanks, calculated by NTSB, is depicted in gray. (Data source: *Sandy Ground* MCS).

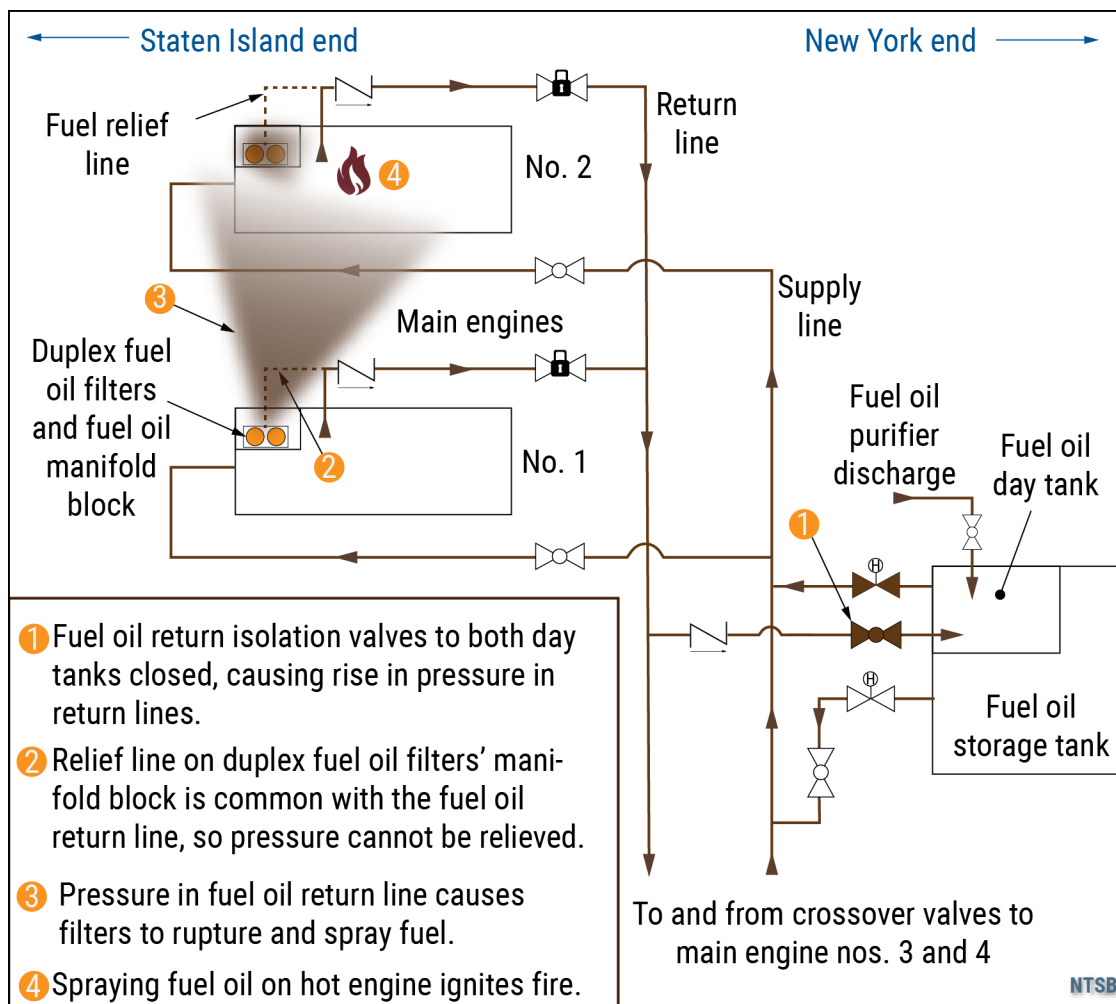
Postcasualty examination revealed that the check valves installed on each of the main engines' fuel oil return piping had been correctly installed and were operating properly. Additionally, the common return piping system from the engines to the day tanks was found free of any obstructions that could have restricted return fuel oil flow, and the day tanks were clean and free of debris or blockages. Thus, the only possible scenario that could have led to the overpressurization was the complete closure of the fuel oil return isolation ball valves to both fuel oil day tanks, which would have prevented any return fuel oil from flowing freely into either of the fuel oil day tanks. Therefore, the NTSB concludes that, in their ongoing response to correct the divergence in the *Sandy Ground's* fuel oil day tank levels, the on-duty oilers closed both the port and starboard day tank fuel oil return isolation ball valves, causing the fuel oil system to overpressurize and, subsequently, the secondary duplex fuel oil filters to rupture.

Figure 15. Simplified New York end main engine fuel oil supply/return system drawing for *Sandy Ground* and sequence of events leading to overpressurization and fire.
