July 25, 2024

MIR-24-20

Flooding and Sinking of Towing Vessel *Jacqueline A*

On August 8, 2023, about 1859 eastern daylight time, the towing vessel *Jacqueline A* sank about 3 miles east of North Myrtle Beach, South Carolina, after taking on water while transiting in the Atlantic Ocean (see figure 1 and figure 2).¹ The three crewmembers abandoned the vessel and were recovered by local emergency responders. There were no injuries. Most of the estimated 5,000 gallons of diesel fuel on board the vessel leaked into the sea. Following salvage, the vessel was determined to be a constructive total loss valued at \$660,000.

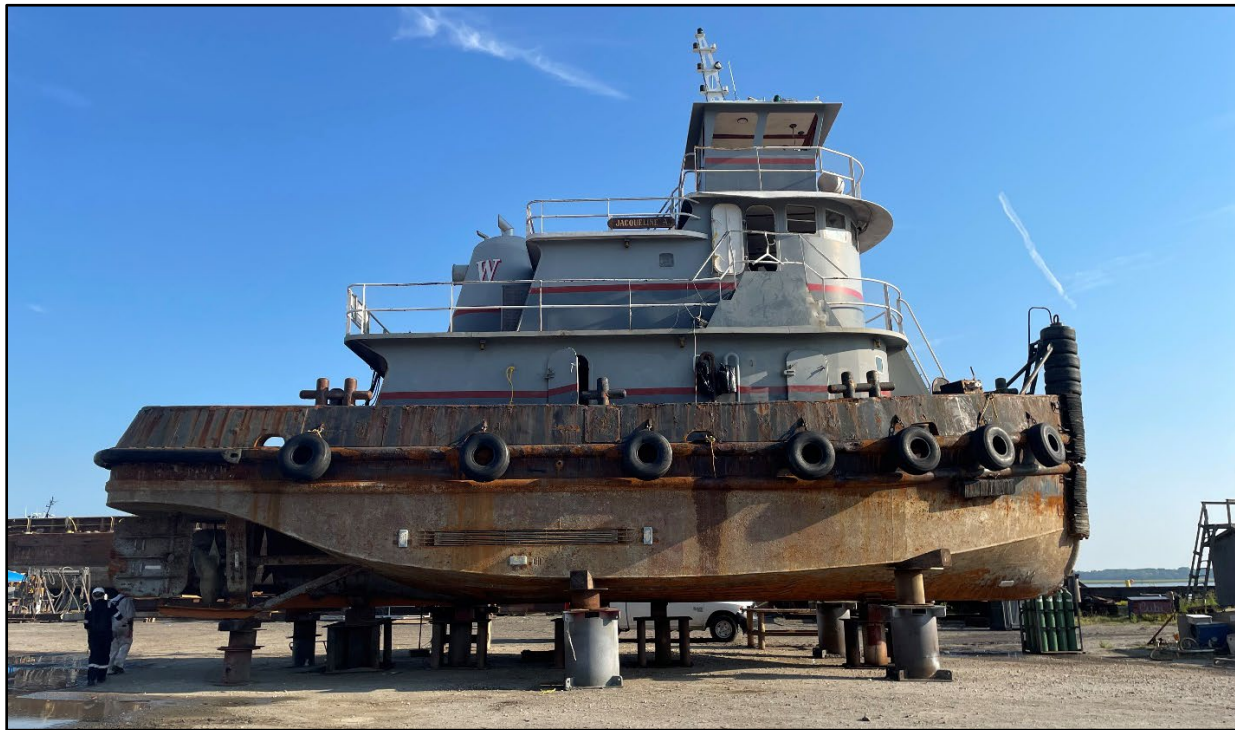
Figure 1. *Jacqueline A* following salvage after the sinking.

The sinking damaged the *Jacqueline A*'s main propulsion engines and generators beyond repair. Electrical and hydraulic systems, electronics, insulation and paneling, galley and lavatory equipment, and various windows and doors were also destroyed. Diesel fuel, hydraulic oil, and potable water tanks were fouled. The estimated cost to repair this damage (not including salvage costs and any other required work) exceeded the \$660,000 value of the vessel, and therefore, it was declared a constructive total loss.

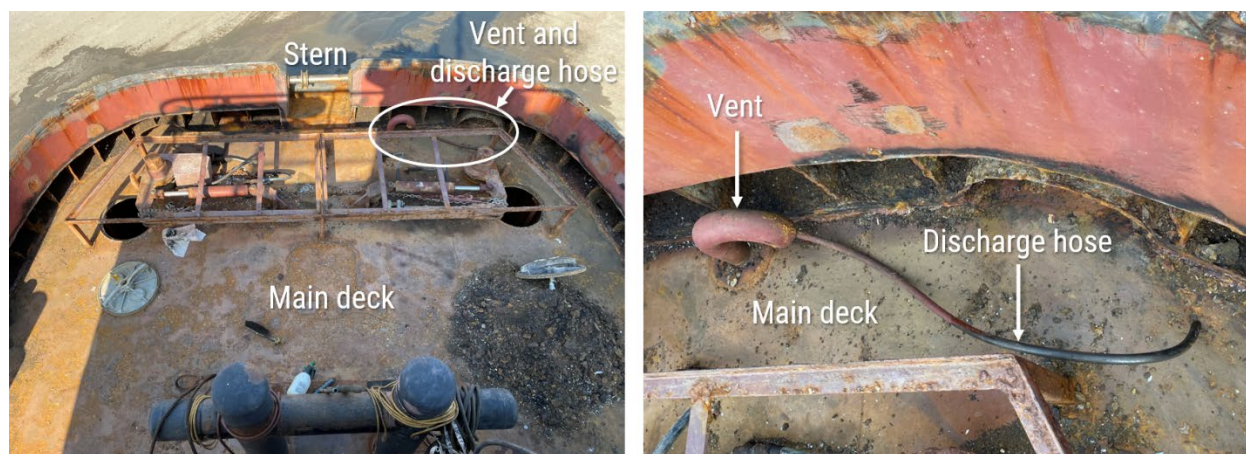
The lazarette could only be dewatered using a portable submersible electric pump that had been placed in the space. The power cord for the pump was rigged to the engine room through one of the wire runs, and the discharge hose was routed to the main deck via a vent in the lazarette overhead (see figure 5).

Figure 5. (Left to right) *Jacqueline A* main deck aft, with lazarette vent and lazarette's submersible electric pump discharge hose circled. Close-up view of lazarette vent and pump discharge hose on main deck.

According to the port engineer, the *Jacqueline A* never took on water while it sat at its berth in Weems. "That boat was always dry," he said. He stated that he checked to ensure the lazarette was dry by plugging in the submersible pump from the engine room—he did not enter the lazarette when energizing the pump. The port engineer stated that, whenever he ran the pump, "nothing ever came out, I mean, a cup, if anything." Although he did not inspect the lazarette before the *Jacqueline A*'s departure en route to Louisiana, he had plugged in the pump about 3 days before the voyage, and no water was discharged. While the vessel was flooding on the casualty voyage, the crew did not plug in the lazarette submersible pump.

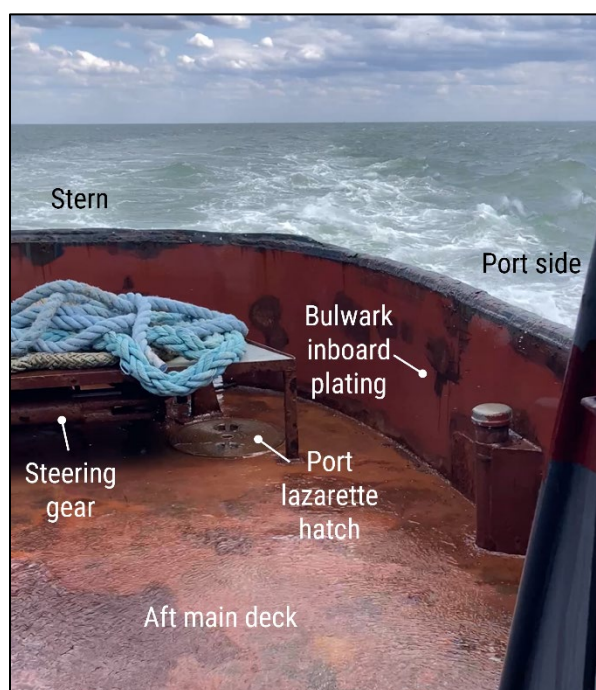
Figure 6. *Jacqueline A* aft main deck and bulwarks during transit from Newport News to Weems, on May 1, 2023. (Background source: Jackson Creek Marine, LLC)

The *Jacqueline A* returned to Weems from the shipyard in Newport News on May 1. The port captain stated that, during the return transit, winds were “blowing pretty good” and “we were taking water all over the boat.” Figure 6 is a screen

capture from video taken during the voyage to Weems, showing water on the aft deck of the vessel. The port engineer stated that the lazarette was “dry when we got back [to Weems].”

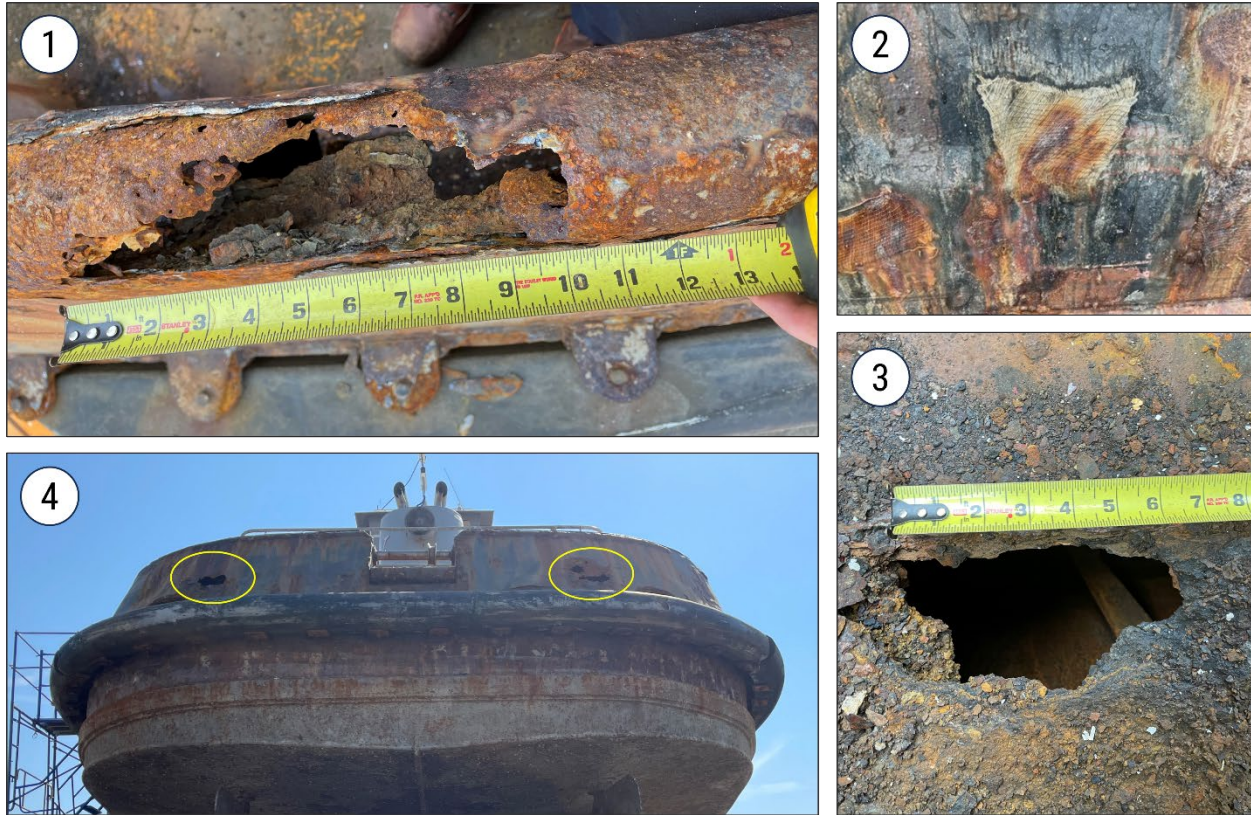
The inboard plating of the bulwarks above the aft deck was cut away for examination of the formerly enclosed volumes (voids) in the bulwarks. The surveyor found “significant deck plate wastage” above the lazarette, with holes ranging in size from 2 to 8 inches in diameter. The surveyor also discovered a hole, less than 1 inch in diameter, on the stern hull plating (forming the aft bulkhead of the lazarette), about 2 inches below the main deck. The surveyor noted that this hole had been hidden from exterior view by a rub rail on the stern.

On the bulwarks, investigators found corrosion, with wastage holes up to 12 inches in length along the tops and exterior side plating, notably along the bulwarks surrounding the aft deck and stern (see figure 7). Some of the wastage holes on the exterior plating had been covered with patches made from fiberglass or other materials. Patches that remained in place postsalvage were degraded.

Figure 7. Clockwise from top left: 1) wastage hole on top rail of portside aft bulwarks; 2) fiberglass patch on portside outboard plating of bulwarks; 3) wastage hole in main deck above lazarette within enclosed bulwarks; 4) wastage holes (*circled*) on outboard plating of stern bulwarks.

The voids on the *Jacqueline A* were inaccessible spaces (“places that cannot be reached,” as described in *Merchant Ship Construction*) in which corrosion cells developed, and eventually progressed into large wastage holes in the bulwark top, side, and deck plating. The port engineer had previously identified the hazard created by the enclosed bulwarks, and the owners planned to remove the inboard plating in the Louisiana shipyard.

Inaccessible voids or difficult to reach pockets or crevices that are poorly ventilated and provide no access for maintenance pose a risk to vessels due to the potential for severe rusting/corrosion. Because these spaces are inaccessible, corrosion can grow undetected. Operators and manufacturers should keep these risks in mind when designing, constructing, or modifying a vessel. Ensuring all spaces are accessible enables maintenance personnel to check for and remediate any potential hazards, such as corrosion.

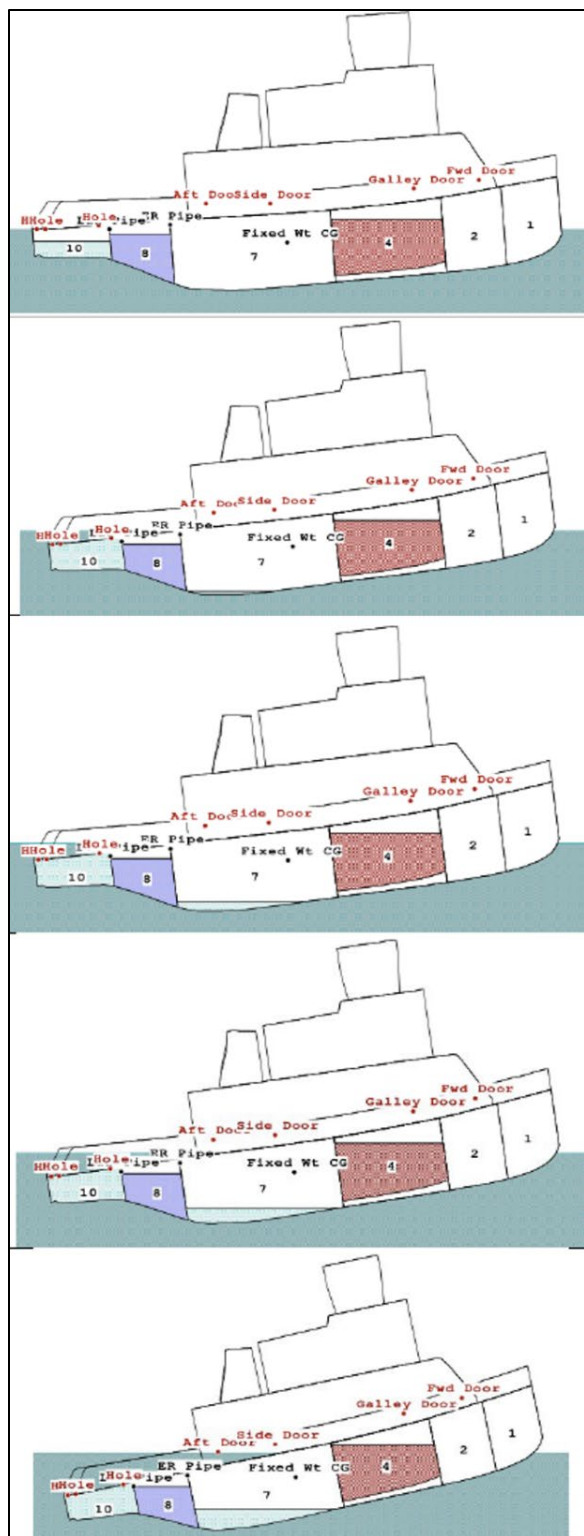
Figure 8. Example analysis showing progression from partial lazarette flooding to rapid flooding of the engine room. (Source: Coast Guard)

The MSC used the measured area of the corrosion holes between the main deck and the lazarette and the dimensions of the steel-pipe wire runs between the lazarette and the engine room to evaluate the progressive flooding of the vessel. The MSC calculated the freeboard of the *Jacqueline A* at the stern to be between 10 and 14 inches, and the analysis assumed that the vessel’s motion and waves would have gradually filled the lazarette with seawater. As the stern sunk lower into the water, the wastage holes in the deck would have eventually submerged, quickly filling the remaining unflooded space in the lazarette.

The MSC found that, because of the aft trim and the location of the unsealed wire runs near the top of the lazarette (6.5 inches beneath the main deck) at the forward bulkhead of the space, no engine room flooding would have occurred until the lazarette was completely full. However, the MSC analysis showed that once the lazarette was full, progressive flooding through the 4-inch wire runs would have begun and the engine room would have quickly flooded (see figure 8). In one

example analysis, the flooding rate in the engine room began at 460 gallons per minute and, as flooding continued, increased to 1,100 gallons per minute within 9 minutes.

The MSC analysis concluded that once the wastage holes in the main deck above the lazarette were submerged, progressive flooding led to a sinking of the *Jacqueline A* by the stern in 9-16 minutes.

For the safety of a vessel and all on board, the integrity of the hull and watertight bulkheads must be maintained, and any deficiencies must be appropriately addressed. Known issues with watertight integrity, including unsealed watertight bulkhead and deck penetrations and deck and hull plate wastage, need to be addressed by permanent means. The Coast Guard advises, "Ensure electrical cables and conduits, piping runs, remote valve actuators, and other components that penetrate watertight bulkheads, decks, and compartments are inspected frequently and properly maintained. Each may have a unique sealing method involving glands with packing assemblies, penetration seals, or other methods. Frequent inspection and proper maintenance of these various fittings and assemblies will assist in minimizing the possibility of progressive flooding."⁷
