July 29, 2024

MIR-24-21

Contact of Recreational Vessel *Flagship 604* with Dock and Subsequent Marina Fire

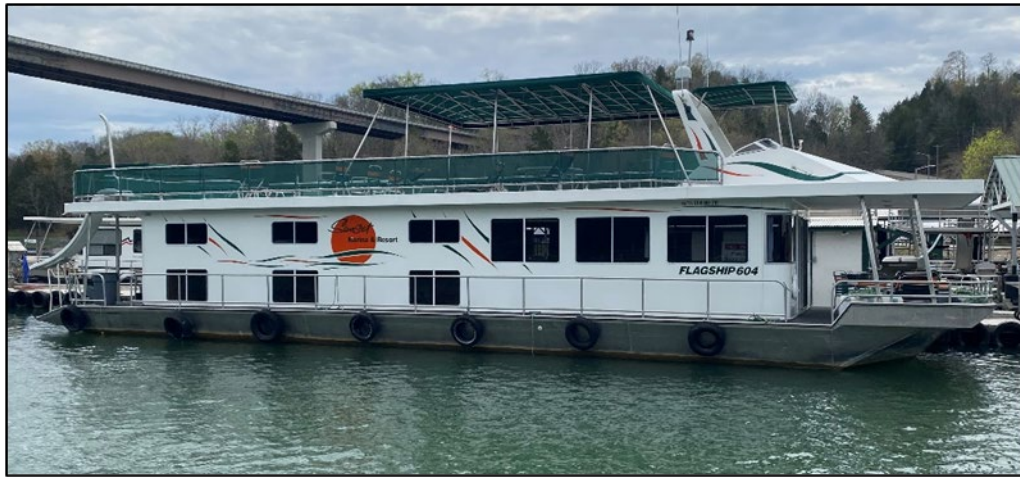
On August 10, 2023, about 1705 local time, the rental houseboat *Flagship 604* (state number TN 0174 BD 219), with nine people aboard, was docking at the Sunset Marina on Dale Hollow Lake in Byrdstown, Tennessee, to refuel, when the bow struck one of the marina's gasoline fuel pumps, knocking it over (see figure 1 and figure 2).¹ Minutes later, a fire began near the gas dispenser and spread to the marina store and three pontoon boats moored at the marina. One injury was reported; no pollution was reported. The houseboat was not damaged. Damage to the marina and the pontoon vessels was estimated at \$1.75 million.

Figure 1. *Flagship 604* moored in 2024. (Source: Sunset Marina)

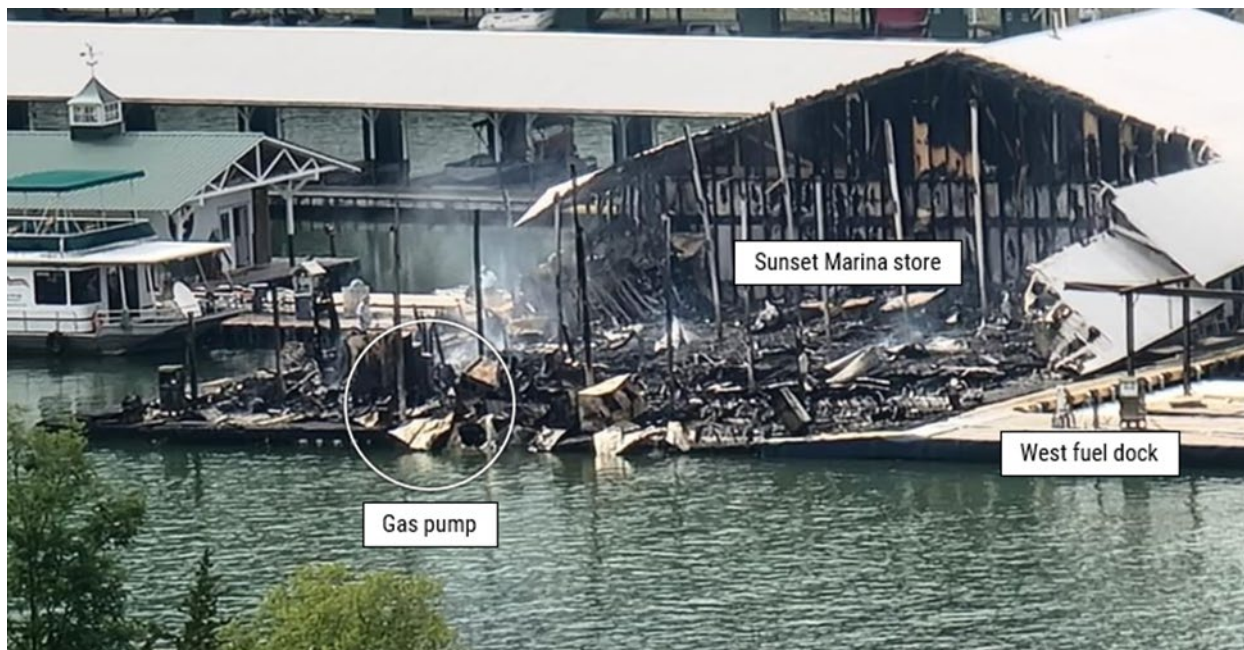
The marina store was destroyed (see figure 3). Three rental pontoon boats tied up on the west side of the marina store incurred damage to their seats and deck carpeting from the heat of the fire. *Flagship 604* was not damaged.

Figure 3. Sunset Marina store and fuel dock after the fire. (Source: TWRA)

The contact dislodged the gas dispenser, and the fuel line broke, exposing wiring and spraying gasoline from the line onto a bait tank and ice machines powered by electric motors. Almost immediately, the vapors covering the area around the fuel dispenser ignited into a fire. With the presence of the exposed wiring and electric motors within the fuel spray's radius, it is likely that an electrical arc ignited gasoline vapors.

Following the fire, the marina relocated the three fuel dispensers from in front of the marina store to the center of a new 20-foot-wide east dock, 9 feet 4 inches from the edge of the dock. The owner also installed an automatic emergency shutoff valve (shear valve) in the fuel supply line just below each of the dispensers on the east and west docks.

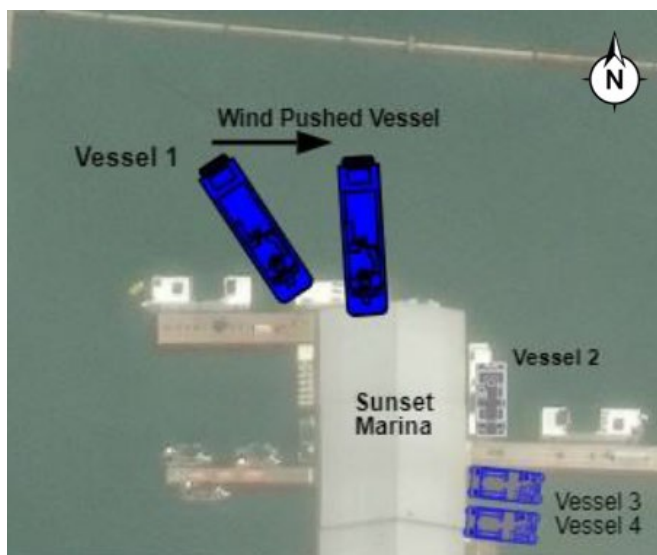
The operator told investigators that he lost propulsion (and steering) as he attempted to dock the houseboat starboard side to the dock; a marina mechanic did not find any issues with the boat's engine after the contact. However, even if the 150-hp engine had been fully functional, docking the 74-foot-long houseboat in the reported 10-15 mph winds would have been a challenge because of the houseboat's large sail area, which included the vessel's hull above the water, the superstructure, and the upper deck rail skirts. The winds from the west, acting on the vessel's sail area, set the vessel east along the dock—twisting the houseboat to the east and moving the bow into the dock, causing the houseboat's duckbill bow to extend over the dock and strike the gas dispenser (see figure 4).

Figure 4. Diagram from the TWRA boating accident report showing the *Flagship 604* (Vessel 1) and the location of the additional damaged vessels. (Background source: TWRA)

The gas dispenser was set back 5 feet from the dock face as a measure to meet the standard for protecting fuel pipes against physical damage arising from impact for marina fuel docks (both at the time of dock construction and currently) as required by the Tennessee Fire Code. The 5-foot setback was intended to protect the gas dispenser from strikes by docking boats and prevent contact with the gas dispenser by boats with standard bow designs coming alongside the dock. However, in this casualty, the dock's height and houseboat deck's overhang dimensions (above the water and from the bow stem) allowed the houseboat's duckbill bow to freely move over the fueling dock and strike the dispenser. Therefore, the 5-foot setback was not sufficient to protect the gas dispenser from the contact from the duckbill bow of *Flagship 604*.
