August 29, 2024

MIR-24-25

Breakaway of Bulk Carrier *Sirocco* and Subsequent Collision with Moored Barge

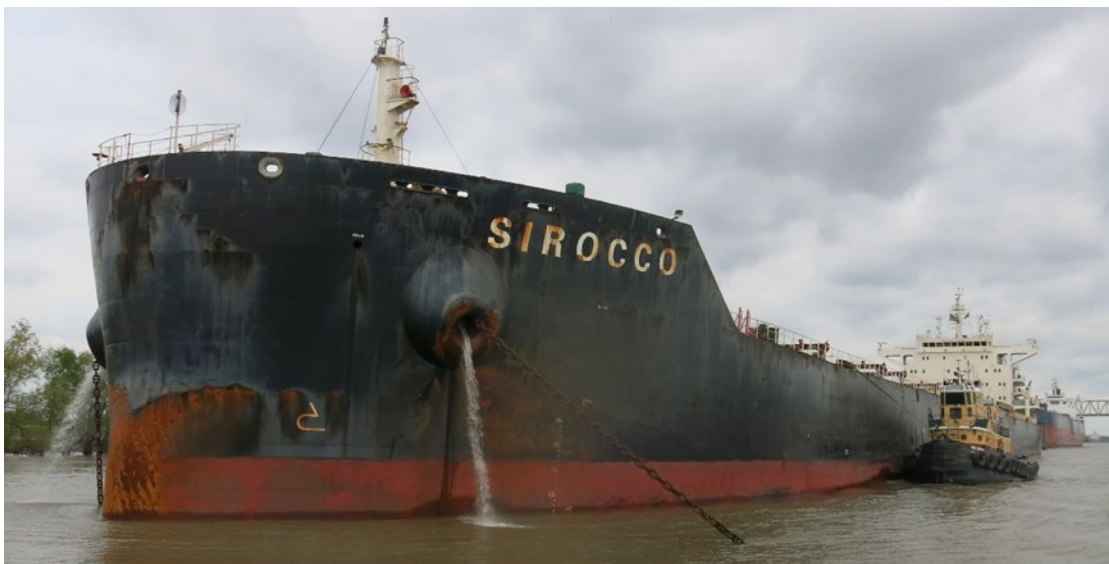
Figure 1. *Sirocco* at anchor after the collision, on March 28, 2023.

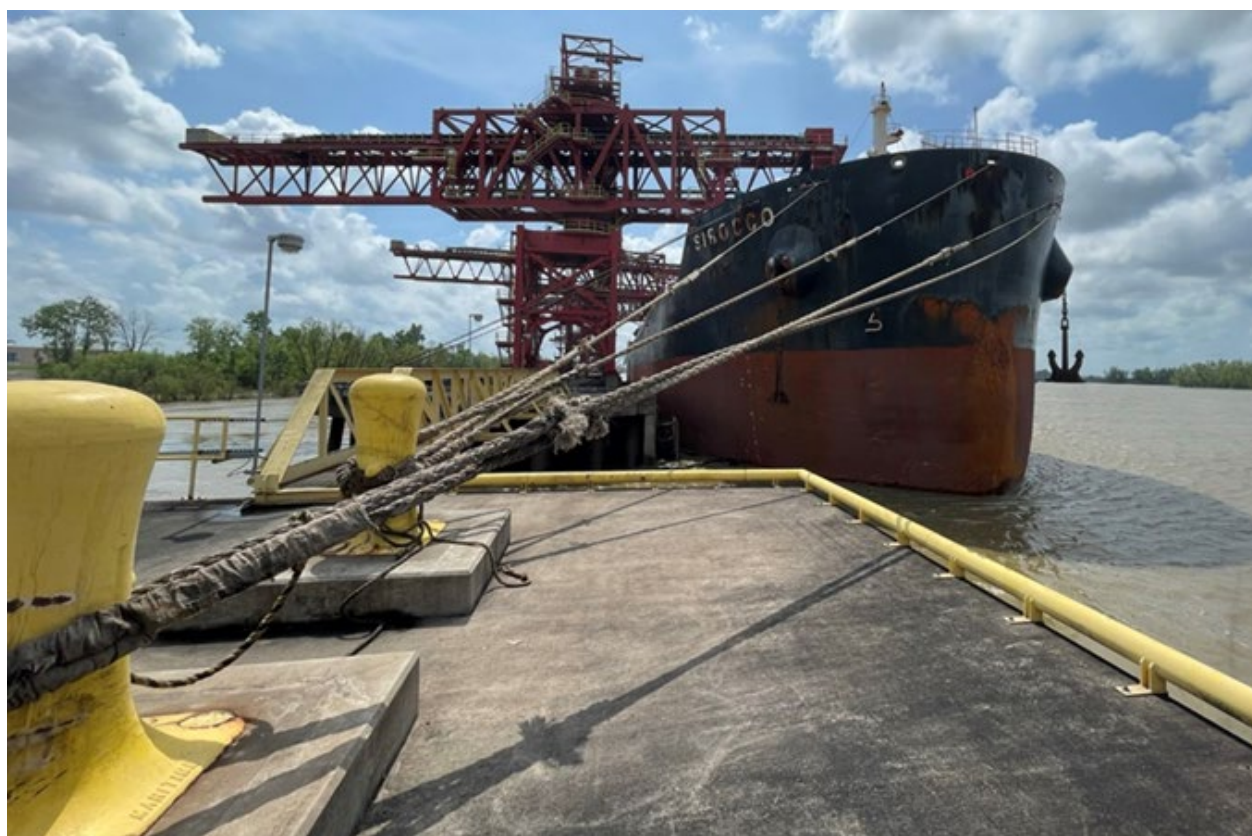
On March 25, about 1712, the *Sirocco* got underway, headed upriver to CMT. The vessel moored starboard side to the north dock at 0100 on March 26 (its bow pointed upriver into the current). At the time, the Carrollton gage was at 11.9 feet and falling. The master ordered 16 lines to secure the *Sirocco*; under normal conditions, they would have used only 12 lines. The 16-line arrangement consisted of four head and four stern lines, two forward and aft spring lines, and two forward and after breast lines on a bight (loop), all placed according to the CMT high-water loading plan (see figure 3 and figure 4).

Figure 3. The forward mooring arrangement of the *Sirocco* at the CMT dock at 1227 on March 26, 2023. (Source: Oldendorff port captain)

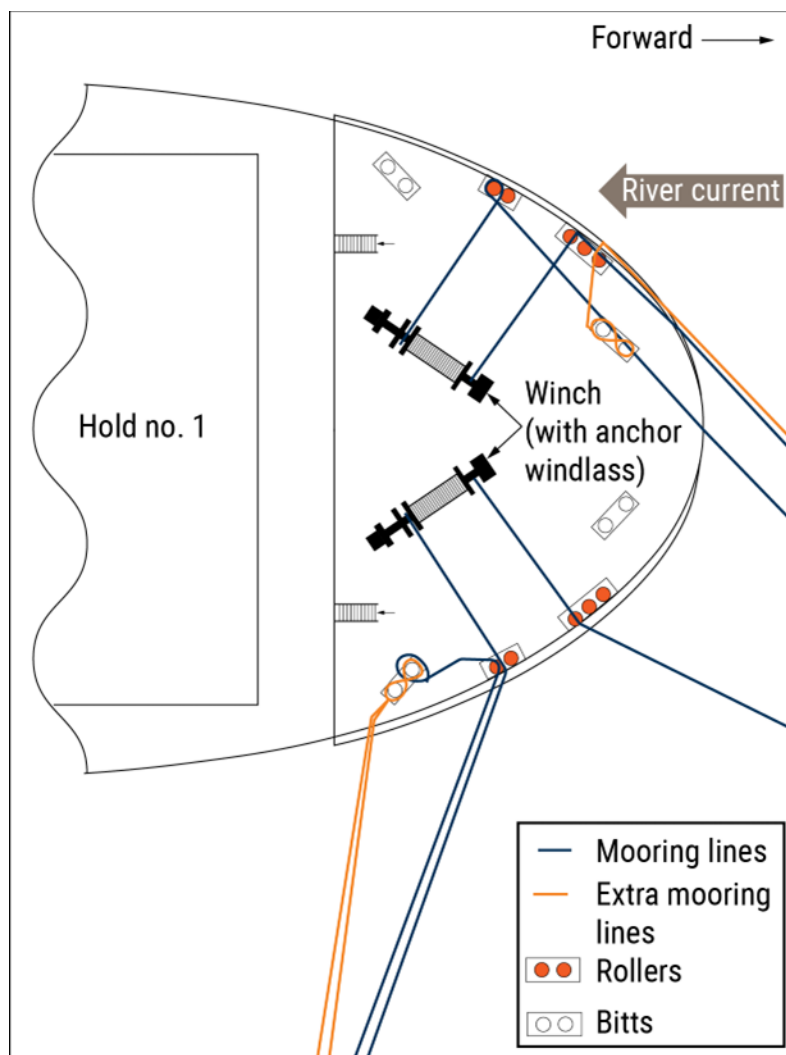
Figure 4. Forward mooring arrangement based on a drawing by the chief officer.

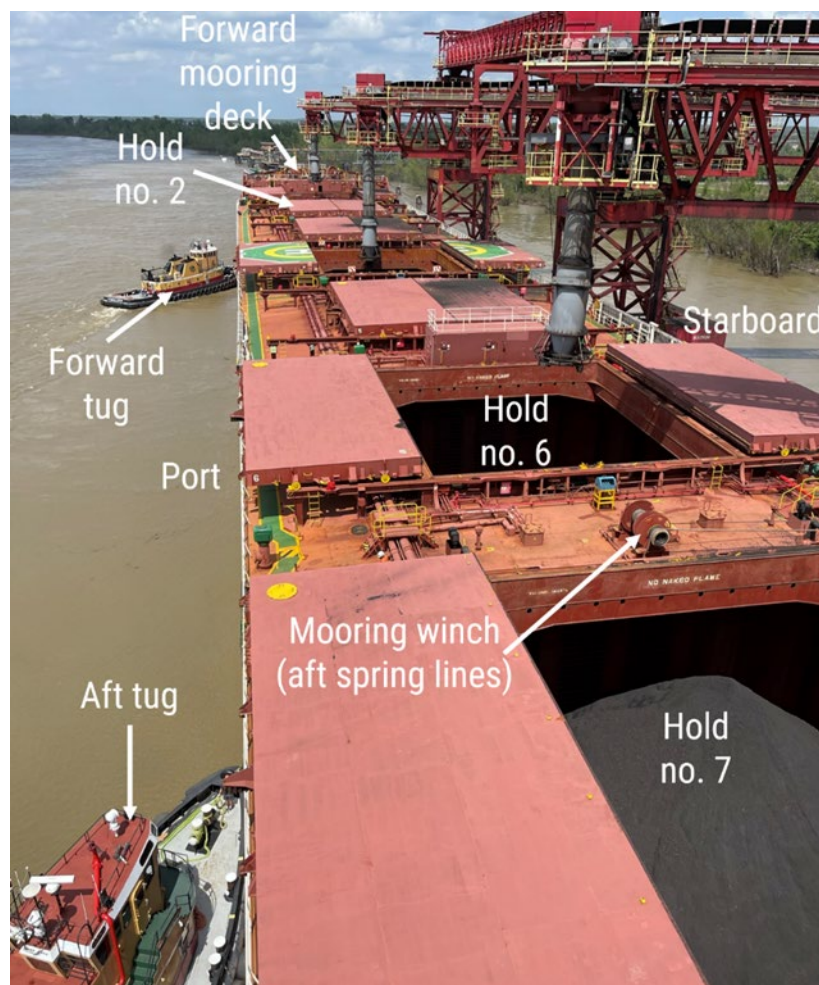
At the master's request, two hold-in tugs were positioned on the port side—one near the bow and one near the aftermost cargo hold (hold no. 7) (see figure 5).

Figure 5. The two tugs on the *Sirocco*'s port side on March 26 at 1314. (Background source: Oldendorff port captain)

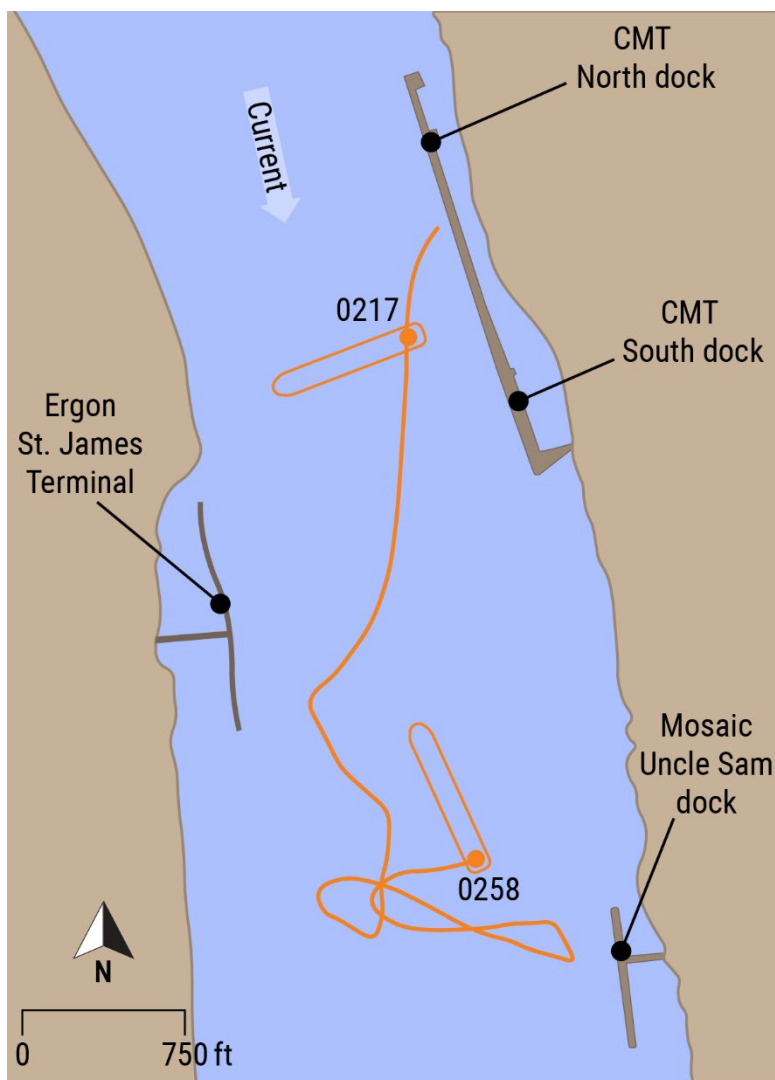
Figure 7. The *Sirocco's* track after breaking away from the CMT north dock. (Data source: *Sirocco* ECDIS)

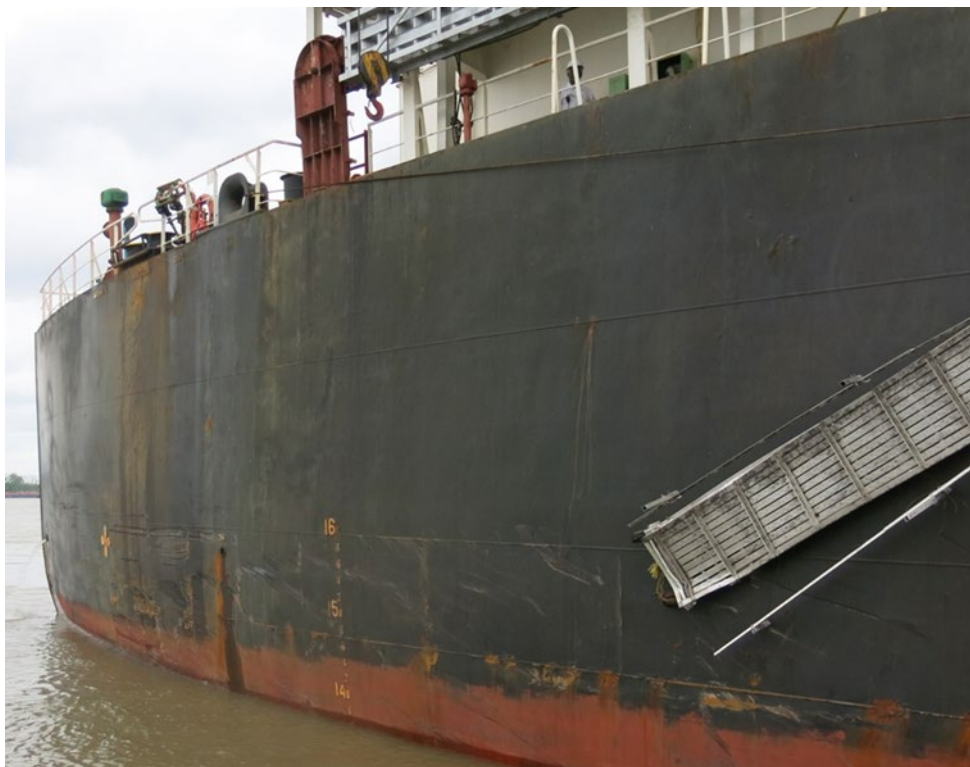
The *Sirocco* sustained damage to the starboard-side accommodation ladder and starboard aft rail (see figure 8). Two mooring lines parted: an aft breast line and an aft spring line. All other lines payed out, remained secured on the bollards at the dock, and showed no visible signs of damage.

Figure 8. The *Sirocco*'s damaged starboard-side accommodation ladder.

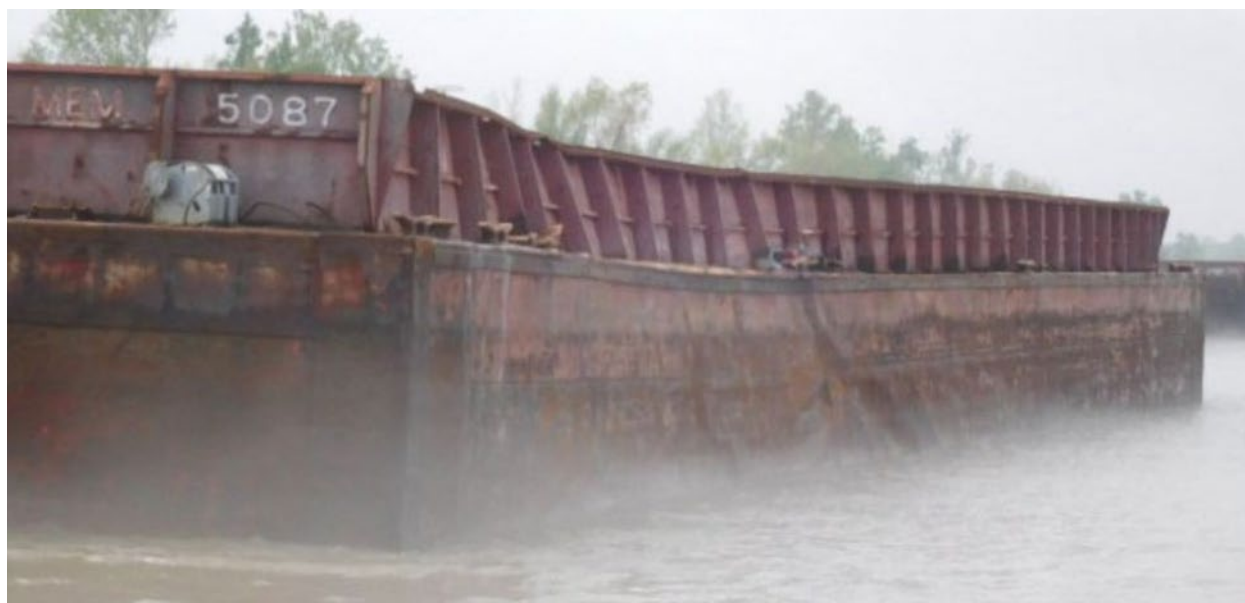
Pilings and several beams supporting the Mosaic Uncle Sam dock were pushed out of position, and the dock's concrete surface was damaged. Barge *MEM 5087* sustained extensive damage to its hull on the port side (150 feet in length), and about 100 feet of its coaming was set in, causing several deck and gunwale fractures (see figure 9). Five of the barge's transverse bulkheads were set in. The *MEM 5087* was considered a total constructive loss. The barges *Glenn S* and *Burnside II* sustained minor damage.

Figure 9. The damaged barge *MEM 5087*. (Source: Campana Marine Service)
