October 22, 2024

MIR-24-33

Collision of Fishing Vessel *Kathleen K* with Vessels Moored at Marina

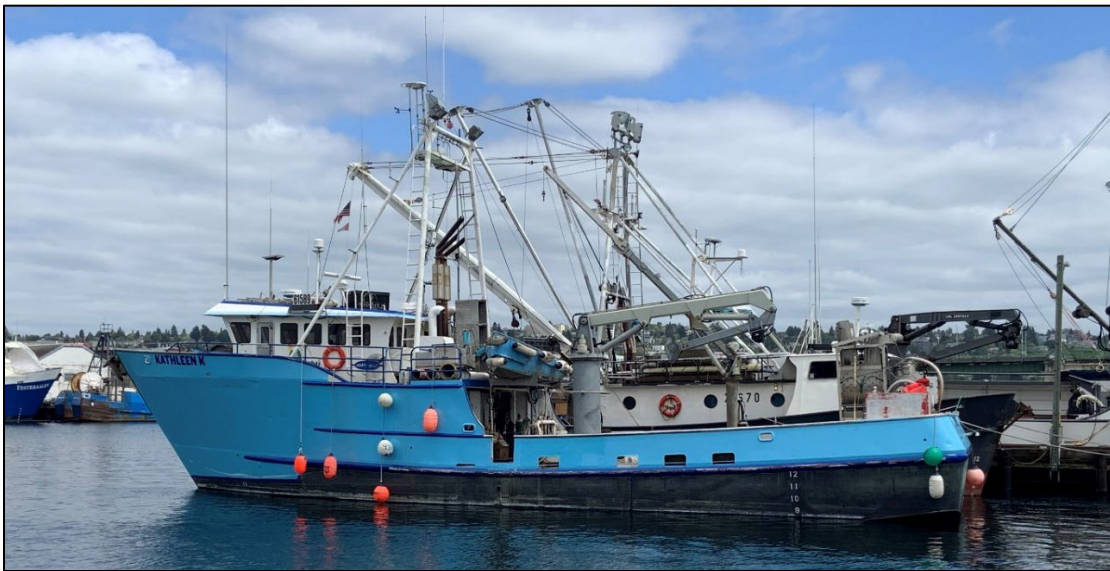
Figure 1. *Kathleen K* on the day after the collision. (Source: US Coast Guard)

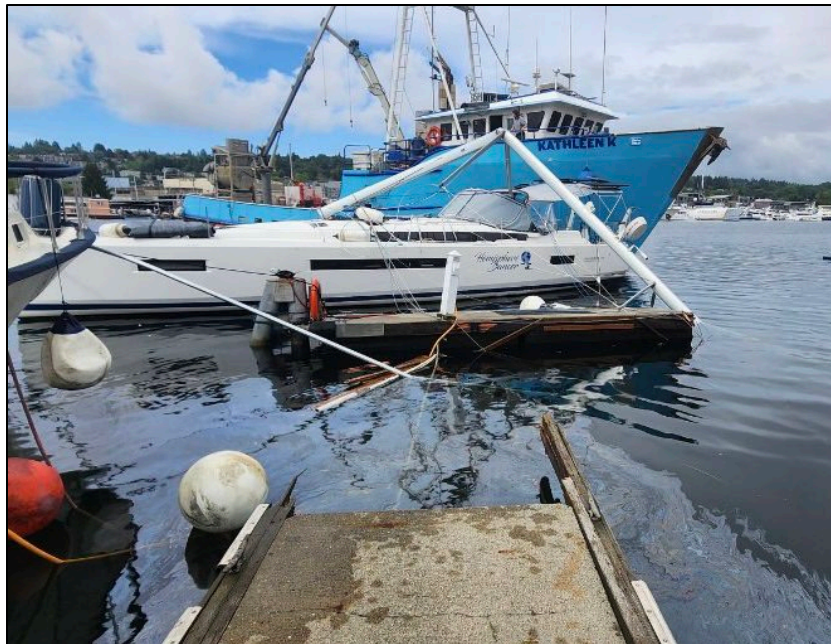
While the captain was in the engine room, the *Kathleen K* had moved toward docks at the CSR Marine boatyard across the bay.² The docks were occupied by recreational sail and motor vessels. A *Kathleen K* crewmember on the main deck aft, seeing that a collision with the moored vessels and the docks was imminent, deployed a fender over the side of the fishing vessel. Soon after, the *Kathleen K*'s bow struck a vessel moored at one of the floating docks. The *Kathleen K* continued moving forward, striking another vessel moored at a second floating dock and pushing that vessel into another vessel moored at a third dock. The *Kathleen K* then struck the second floating dock, severing a section of the dock and damaging several other moored vessels. In total, nine moored vessels were damaged (see figure 3).

Figure 3. The *Kathleen K*, a damaged sailing vessel, and a damaged dock following the collision. (Source: Coast Guard)

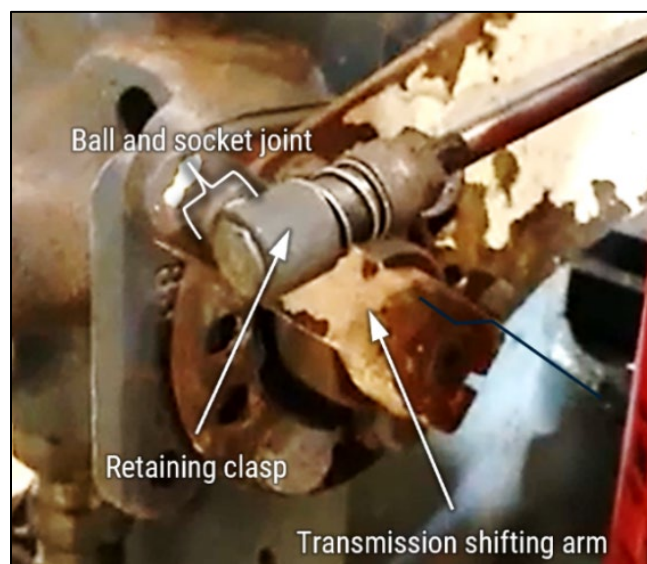
Figure 4. *Kathleen K* transmission mechanical linkage at ball and socket joint. (Source: Coast Guard)

The captain believed that when he reconnected the port transmission linkage, the ball did not fully seat in the socket and the securing clasp did not fully engage. The captain stated that, even when not fully seated, the joint could appear to be correctly seated. Following the casualty, the captain and Coast Guard investigators examined the mechanical linkage, including the ball and socket joint, for the port engine transmission and found no material deficiency.

In the engine room, the captain found that the mechanical linkage from the port propulsion control box had disconnected from the port transmission shifting lever at the ball and socket joint. This disconnection prevented any direction changes from being transmitted from the wheelhouse control lever for the port engine to the shifting lever on the transmission, resulting in the port transmission remaining stuck in the ahead direction. Thus, when the captain had shifted the wheelhouse controls to astern, the port engine continued to push ahead.

During propulsion system maintenance conducted in the months before the *Kathleen K* got underway for the casualty voyage, the captain had disconnected the linkage at the ball and socket joint. He reconnected the joint when the maintenance was completed; however, according to the captain, the ball may not have been fully seated in the socket with the securing clasp engaged when it was reconnected, even though it would have appeared to be seated correctly. A postcasualty examination found no material discrepancies with the transmission linkage, including the ball and socket joint. Therefore, disconnection of the port transmission linkage at the ball and socket joint was most likely due to the ball not being fully seated in the socket when the joint was reconnected after maintenance.

The National Transportation Safety Board determines that the probable cause of the collision of the fishing vessel *Kathleen K* with recreational vessels moored at a marina was the loss of directional control to one of the *Kathleen K*'s propulsion engines due to the disconnection of its transmission linkage, likely because the linkage's ball and socket joint was not fully reconnected after maintenance.
