## Contact of *Kitty* Tow with Algiers Lock Gate

On July 4, 2023, about 1808 local time, the towing vessel *Kitty* was pushing two loaded tank barges through the Algiers Lock near mile 88.4 on the Lower Mississippi River in New Orleans, Louisiana, when the lead barge, *EMS 317*, struck one of the lock gates (see figure 1 and figure 2).<sup>1</sup> There were no injuries, and no pollution was reported. Damage to the barge was negligible, while damage to the lock gate was about \$2 million.

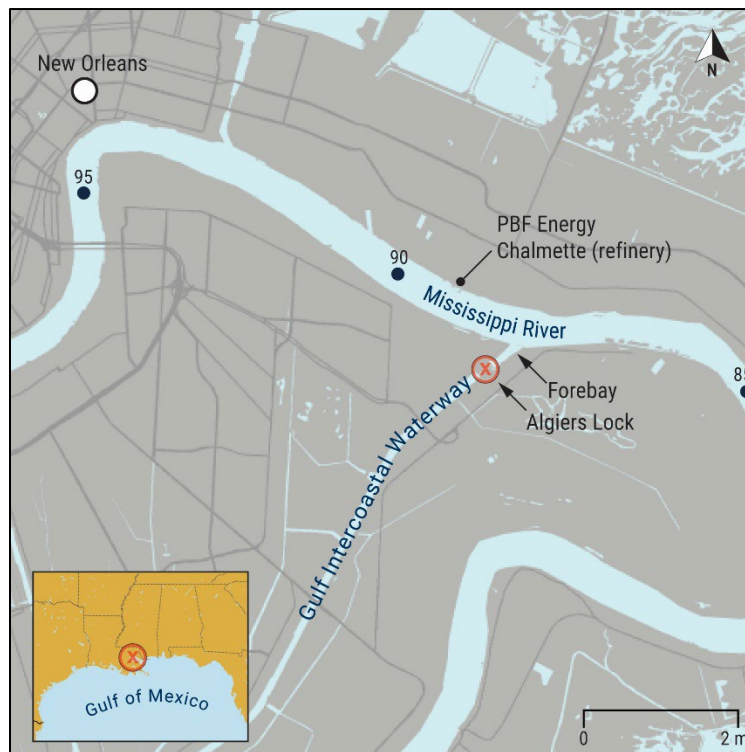
**Figure 2.** Area where the *Kitty* tow contacted Algiers Lock Gate D as indicated by a circled X. (Background source: Google Maps)

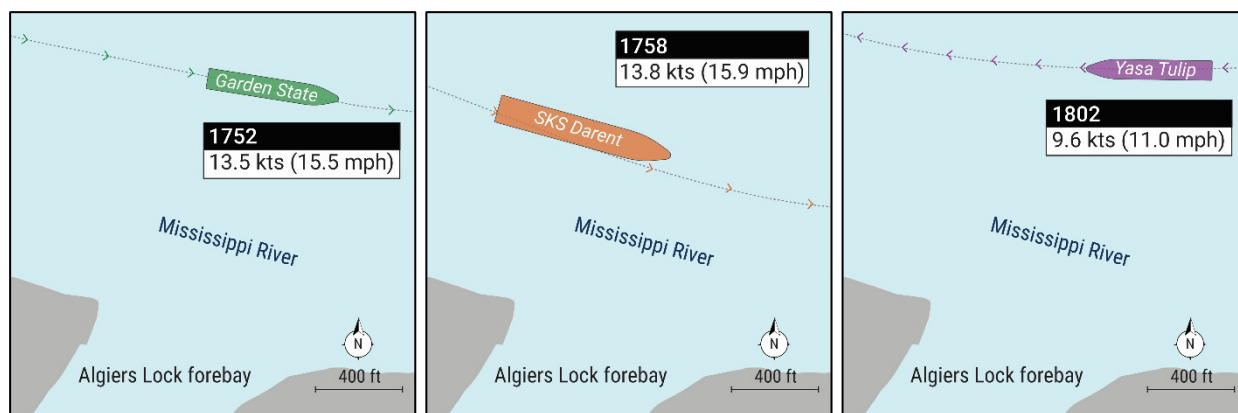
**Figure 6.** Left to right: Positions, tracks, times, and speeds of the *Garden State*, *SKS Darent*, and *Yasa Tulip* (approximate scale) while transiting the Mississippi River, near the Algiers Lock forebay, in the minutes leading up to the casualty (based on automatic identification system data).

which is consistent with the movement of receding water. Following that, the tow was pushed back into the lock chamber, consistent with rising water. Neither of these conditions occurred when there were no ships transiting in the river nearby. Thus, it is likely that wake effects from deep-draft ships, transiting the Mississippi River adjacent to the Algiers Lock forebay during extremely low water conditions, moved water in and out of the forebay and lock chamber, causing the vessels in them areas to surge.

The National Transportation Safety Board determines that the probable cause of the contact of the barge *EMS 317* with Algiers Lock Gate D was surging water within the lock chamber, which was likely caused by the wakes from three deep-draft ships passing the lock forebay in quick succession during extreme low water conditions on the Mississippi River.

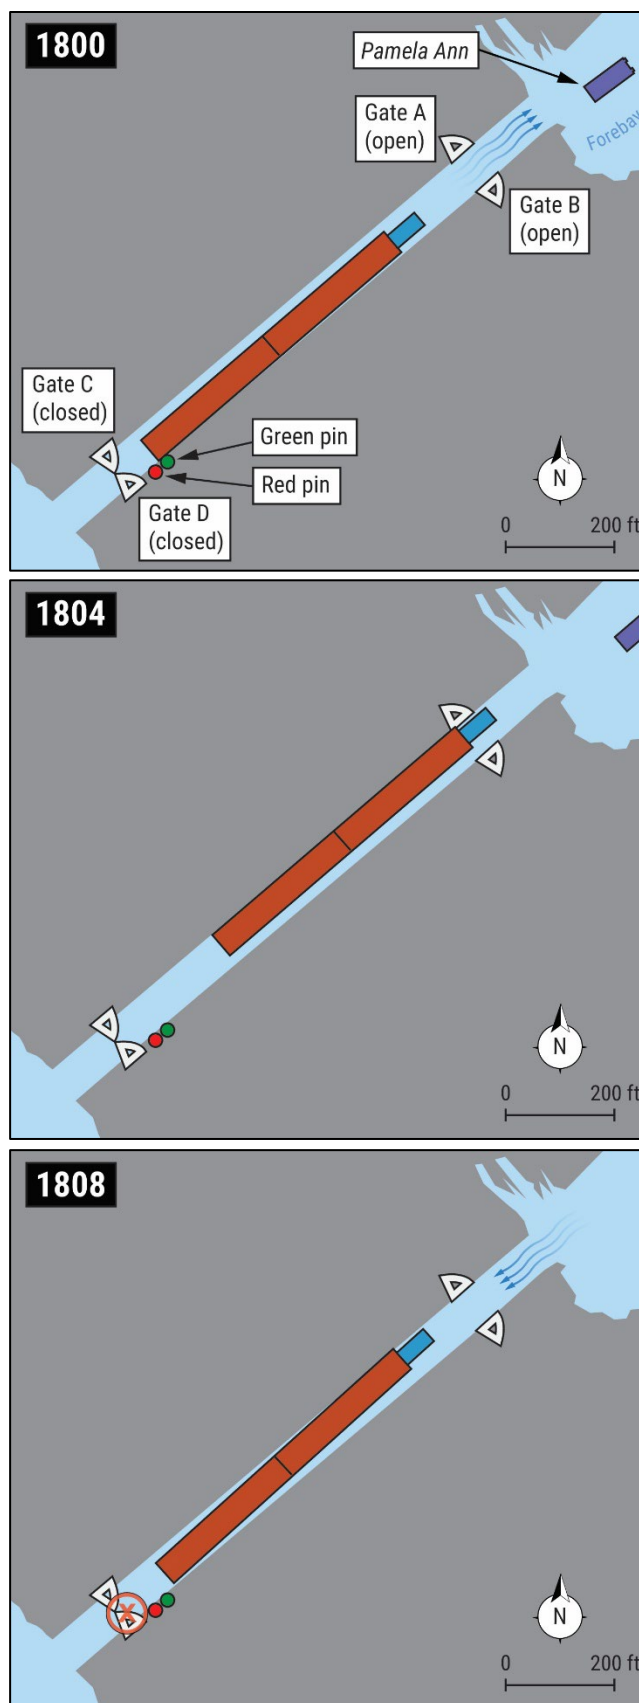
**Figure 7.** Top to bottom: The positions of the *Kitty* tow and the *Pamela Ann* at 1800, 1804, and 1808. Direction of water movement in and out of the lock is indicated by wavy arrows, and the contact area is indicated by a red X.

At the bow of the lead barge, the deckhand saw that the tow was going to hit the closed lock gate and walked aft on the barge to safety. At 1808, at 1.4 mph, the port bow of barge *EMS 317* struck Gate D, the closed gate on the south side of the lock. The *Pamela Ann*, which was aft of the *Kitty* and waiting in the forebay, also surged forward. In response to the *Pamela Ann* moving forward at a fast rate, its captain backed down hard to slow the vessel's forward motion.

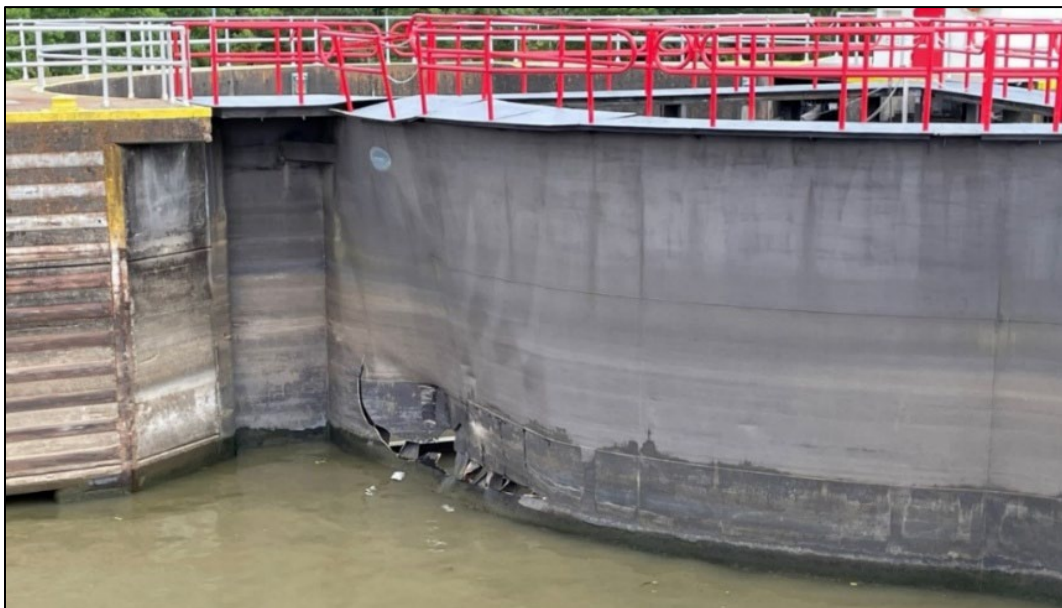
Algiers Lock Gate D sustained an approximately 16-20-foot gash and a large inset in the steel plating (see figure 8). The steel support members were also damaged, and the gate walkway was bent. The Corps of Engineers reported the cost of repairs was \$2,082,677. The Algiers Lock was reopened approximately 3.5 hours after the strike and remained functional.

**Figure 8.** Damage to Gate D as viewed from the north wall of the lock chamber.
