National Transportation Safety Board

Pipeline Accident Brief

Accident Number:	DCA99-MP005
Owner/Operator:	Colonial Pipeline Company
Type of System:	Hazardous liquid petroleum products pipeline
Accident Type:	Pipe rupture
Location:	Knoxville, Tennessee
Product Released:	Diesel fuel, high sulfur, 86 Grade
Time:	11:58 p.m. EST
Date:	February 9, 1999
Fatalities/Injuries:	None
Property Damage:	\$7 million
Quantity Released:	About 53,550 gallons (1,275 barrels)
Pipeline Pressure:	Approximately 91 psig
Component Affected:	10-inch-diameter, Grade 5L X-42, 0.250-inch wall thickness, electric resistance weld steel pipe

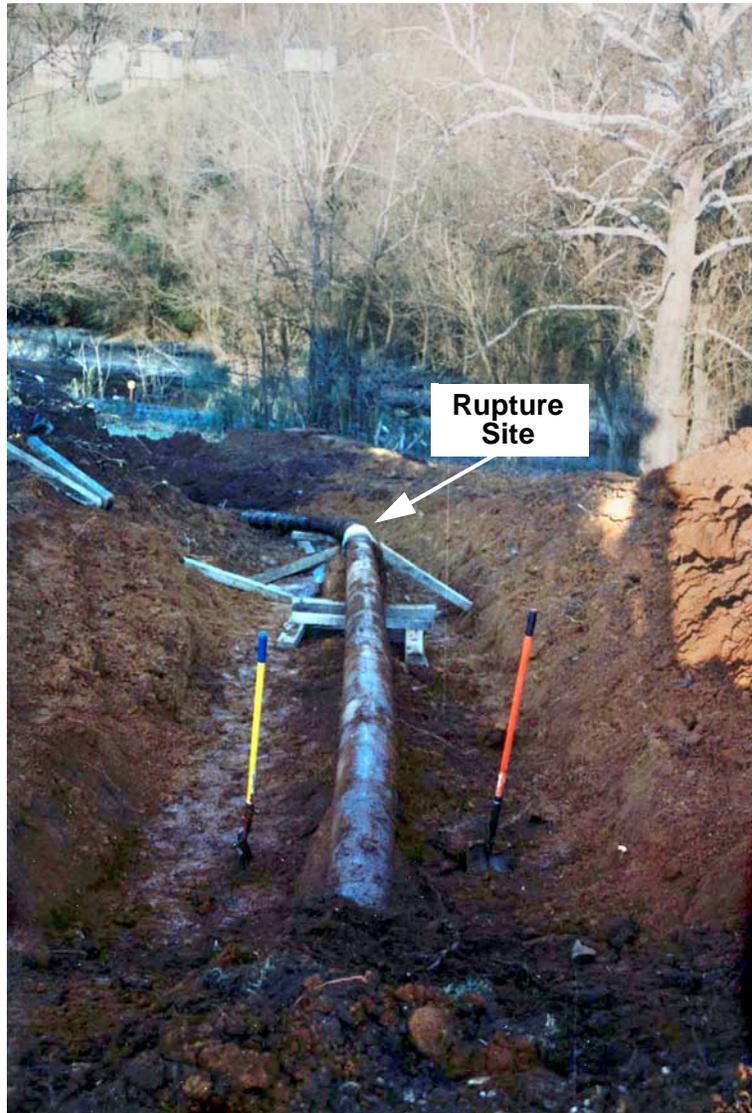
The pipeline was constructed in 1962 and put into service in early 1963. The pipe installed was 10-inch-diameter, Grade 5L X-42, 0.250-inch wall thickness, electric resistance weld (ERW) steel pipe. At the rupture site, the pipeline was installed on a slope and had a slight side bend to the left below the rupture (figure 1) in the downstream flow direction. Colonial records indicate that the pipe had asphalt enamel coating. A coating defect (wrinkled coating) was also evident 2 to 3 feet upstream of the rupture (figure 2). Safety Board investigators and Colonial personnel observed no visible damage to the pipe coating that remained immediately adjacent to the rupture area before the pipe was removed for examination. Colonial did not have a toughness requirement⁵ for pipe when it was purchased for this pipeline, and no pipeline industry standards had been established at that time. Since July 13, 1990, Colonial's line pipe purchasing specifications have had minimum toughness requirements that include, among other factors, a minimum acceptance criteria of 25 ft/lbs of absorbed energy at 32° F for Charpy V-Notch (Charpy) impact tests.⁶

Figure 1. Pipeline on slope showing side bend to the left beyond the rupture.

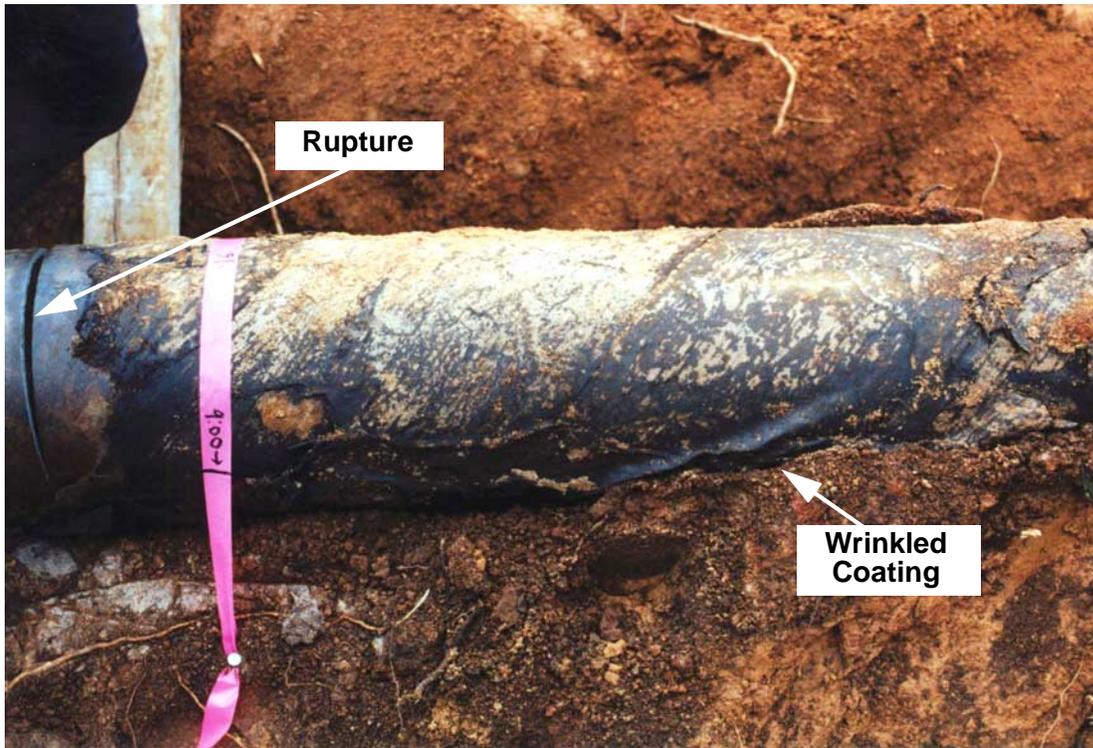
Figure 2. Wrinkled coating 2 to 3 feet upstream of the circumferential crack that terminates at the 9 o'clock position.

The crack ran in both directions from its initiation point. The crack propagated clockwise past the longitudinal weld seam. In the clockwise direction, the brittle fracture extended less than 0.5 inch before changing to a ductile fracture. In the counterclockwise direction, the brittle fracture extended over the top of the pipe to approximately the 9 o'clock position, where it also terminated in a ductile fracture. (Refer to figure 2.)

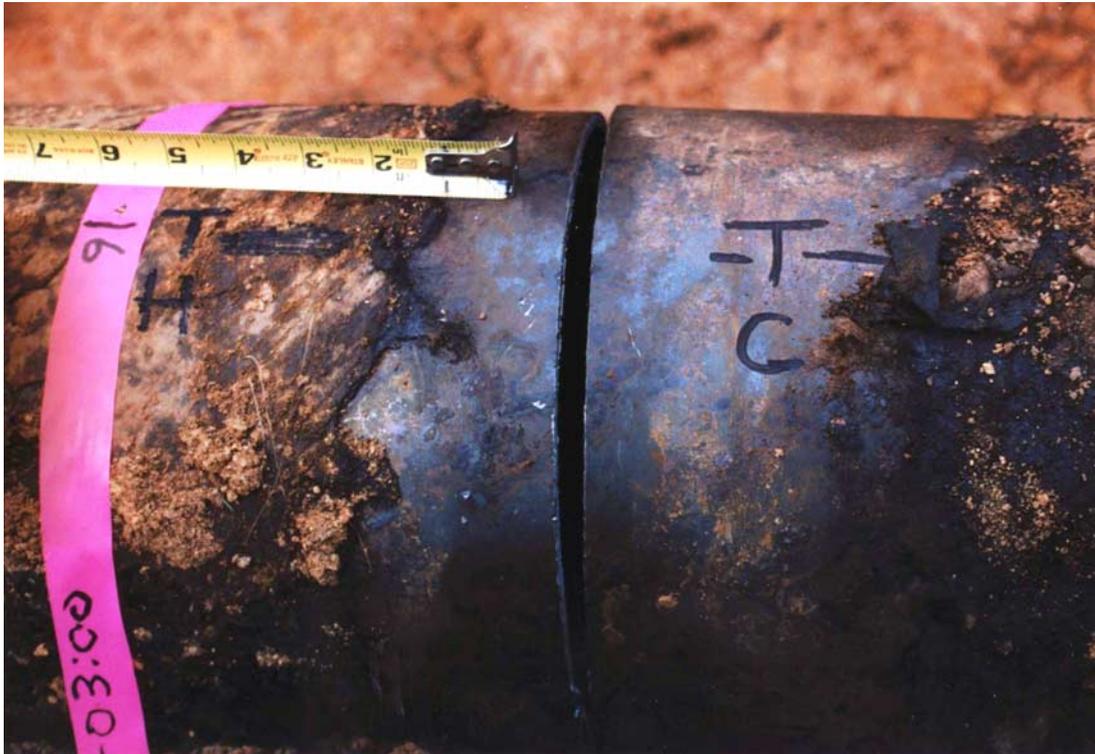
When the pipe was exposed, a circumferential crack was found around the top half of the pipe's diameter (figure 3), and no pipe coating remained in the area of the crack. The crack was not located in a girth weld, visible dent, or gouge; however, the crack ran through an area of surface corrosion. Close examination of the fracture surface established that the crack initiated at an area with at least nine separate darkly colored thumbnail-shaped corroded regions (thumbnails). The failure initiation region was centered at the 3 o'clock position (looking downstream, toward East Knoxville) in the area of the external surface corrosion. The thumbnail shape, dark coloration, and fracture surface features were consistent with corroded preexisting cracks that initiated on the external surface of the pipe and propagated radially inward. None of these preexisting cracks penetrated through the pipe wall, with 0.120-inch being the deepest penetration observed, which was 48 percent of the nominal pipe wall thickness. Similar corroded preexisting cracks were noted nearby in the surface corrosion area.

Scanning electron microscope examination of the fracture face revealed heavy oxide deposits on the thumbnails that obscured some and obliterated other fracture details; however, sufficient detail was visible to indicate that the thumbnails originated at shallow corrosion pits on the external surface. Each of the thumbnail regions was associated with surface corrosion damage and typically had one or two crack origin sites. In some

Figure 3. Circumferential crack on top half of pipe with failure initiation region at the 3 o'clock position.

instances, crack arrest marks were visible within the thumbnail regions. The preexisting crack features in the failure initiating area were consistent with environment-induced cracking.¹⁰

The National Transportation Safety Board determines that the probable cause of this accident was pipe rupture initiated by environment-induced cracking in an area of pipe coating failure. A contributing factor to the failure was the relatively low fracture toughness of the pipe. Contributing to the severity of the accident was Colonial Pipeline Company's failure to determine from the supervisory control and data acquisition system that a leak had occurred, with the result that the pipeline controller started and restarted the pipeline, thereby increasing the amount of diesel fuel that was released.
