National Transportation Safety Board
Washington, D.C. 20594
Pipeline Accident Brief

Accident No.: DCA-03-MP-004
Type of System: Natural gas distribution
Type of Accident: Rupture, explosion, and fire
Location: Wilmington, Delaware
Date and Time: July 2, 2003, at 1:44 p.m., eastern daylight time
Owner/Operator: Delmarva Power and Light Company doing business as Conectiv Power Delivery
Fatalities: None
Injuries: 14
Property Damage and Losses: \$300,000
Material Released: Natural gas
Pressure: 6 to 8 inches water column
Type of Failure: Excavation damage
Component Affected: 1-1/4 inch steel service line

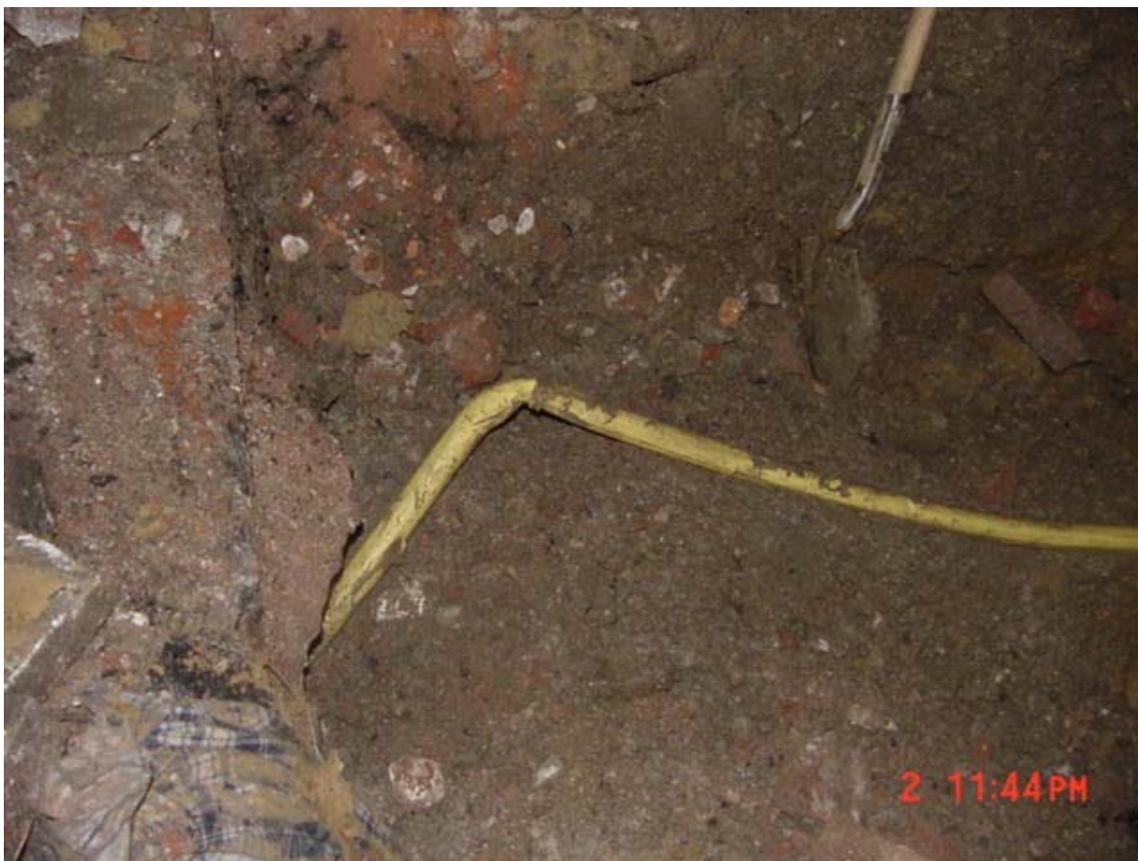
On July 2, 2003, a contractor hired by the city of Wilmington, Delaware, to replace sidewalk and curbing dug into an unmarked natural gas service line with a backhoe. (See figure 1.) Although the service line did not leak where it was struck, the contact resulted in a break in the line inside the basement of 1816 West 3rd Street, where gas began to accumulate. A manager for the contractor said that he did not smell gas and therefore did not believe there was imminent danger and that he called an employee of the gas company and left a voice mail message. At approximately 1:44 p.m., an explosion destroyed two residences and damaged two others to the extent that they had to be demolished. Other nearby residences sustained some damage, and the residents on the block were displaced from their homes for about a week. Three contractor employees sustained serious injuries. Eleven additional people sustained minor injuries.

Figure 1. Pulled natural gas service line.

On July 2, a Quickform backhoe contacted and pulled up an unmarked 1-1/4 inch steel service line serving 1816 West 3rd Street. Contractor employees estimated that the damage to the service line occurred at about 1:30 p.m. The crew was not aware that the action of pulling the service line outside resulted in a break to the line inside the basement at 1816 West 3rd Street. Natural gas then began to accumulate in the residence. The Quickform crew said when they saw the damage, they stopped excavation activities and notified the Quickform manager when he arrived on site a few minutes after the service line was contacted.
