# National Transportation Safety Board

## Pipeline Accident Brief

<b>Accident No.:</b>	DCA-08-FP-006
<b>Type of System:</b>	Natural gas distribution
<b>Accident Type:</b>	Leak, explosion, and fire
<b>Location:</b>	Plum Borough, Pennsylvania
<b>Date:</b>	March 5, 2008
<b>Time:</b>	1:39 p.m. eastern standard time <sup>1</sup>
<b>Owner/Operator:</b>	Dominion Peoples Natural Gas Company
<b>Property Damage and Losses:</b>	\$1,000,000
<b>Fatalities:</b>	1
<b>Injuries:</b>	1
<b>Material Released:</b>	Natural gas
<b>Pipeline Pressure:</b>	10 pounds per square inch, gauge
<b>Component Affected:</b>	2-inch steel natural gas distribution pipeline

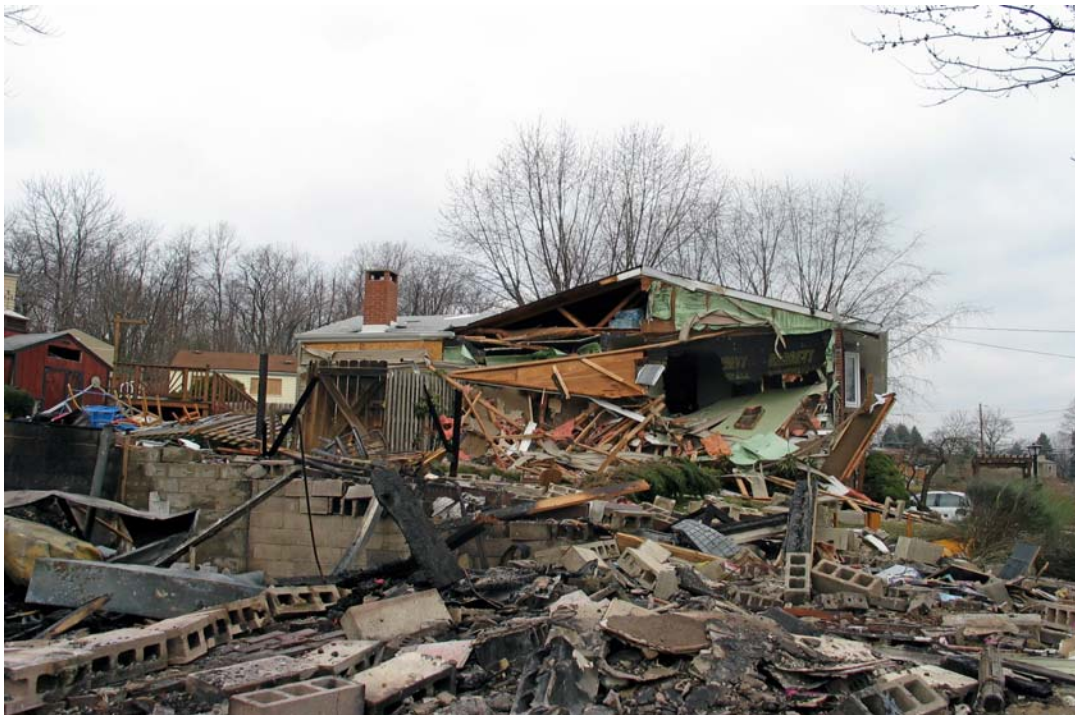
On March 5, 2008, about 1:39 p.m., a natural gas explosion destroyed a residence at 171 Mardi Gras Drive in Plum Borough, Pennsylvania, killing a man and seriously injuring a 4-year-old girl. Two other houses were destroyed, and 11 houses were damaged. Property damage and losses were \$1,000,000.

Figure 1. Damage to 171 Mardi Gras Drive.

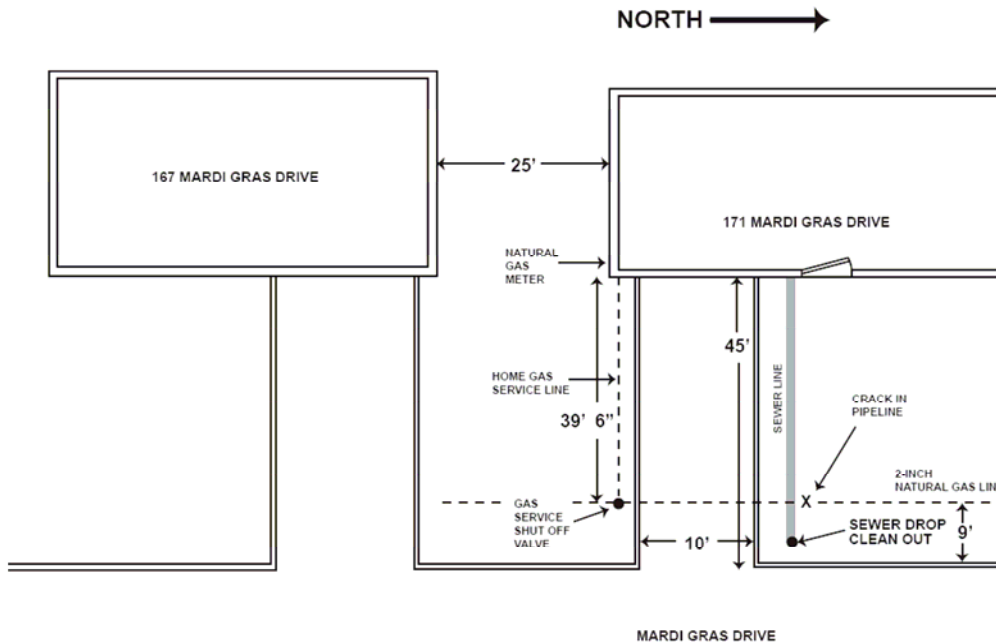
Dominion operated two gas distribution pipelines in the neighborhood: a 2-inch carbon steel main pipeline in front of the destroyed home and an 8-inch carbon steel main pipeline across the street from the destroyed home. (See figure 2.) The 2-inch pipeline provided gas to the homes on the street; the 8-inch pipeline passed through the neighborhood.

Figure 2. Diagram of accident. (North is to the right.)

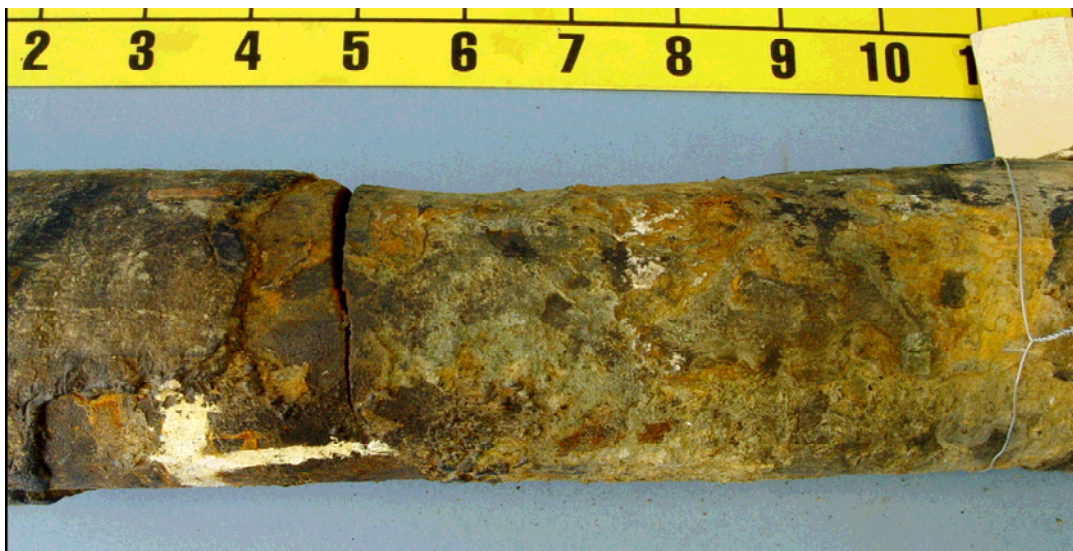
Under the supervision of the PUC, Dominion crews exposed the 2-inch pipeline at 8:29 p.m. A circumferential crack ran about 270 degrees around the pipe; the top section of the pipe was not cracked. The pipe was bowed with a dented underside. The pipe was marked and photographed. (See figure 3.) A 90-inch section of the pipe, which contained the circumferential crack and the dented area, was sent to the Safety Board’s Materials Laboratory for examination.

**Figure 3.** Cracked pipeline. (The large white mark indicates the top of the pipeline when it was excavated.)

The Safety Board's Materials Laboratory examined the section of 2-inch pipe that was removed from the accident site and noted that the pipe had several bends. The coal tar enamel coating was missing from a 3-foot section that included the pipeline's cracked bottom. The bottom was also dented and deformed upward at the crack.

General corrosion was found along the length of the pipeline. Intrusions of intergranular corrosion were found adjacent to the crack. The loss of wall thickness was estimated to be about 0.010 inches at the crack. Mechanical test results were consistent for a pipe that was manufactured in accordance with API 5L Grade B specifications. Based on the crack in the 2-inch pipeline and the results of bar-hole tests and laboratory examination, the crack was the most likely cause of the release of natural gas and the subsequent explosion.

According to Pennsylvania One-Call, the only recorded excavation was the plumber's replacement of the sewer line in 2003. The dents and the deformation in the pipeline indicate that it had been struck from below by something more powerful than a hand shovel. The extent of the corrosion observed by the Safety Board's Materials Laboratory is consistent with 5 years of in-ground exposure. Therefore, it is likely that the excavator struck the pipeline with the backhoe, thereby stripping the pipeline of its protective coating and making the pipeline susceptible to corrosion and failure.

The National Transportation Safety Board determines that the probable cause of the leak, explosion, and fire in Plum Borough, Pennsylvania, on March 5, 2008, was excavation damage to the 2-inch natural gas distribution pipeline that stripped the pipe's protective coating and made the pipe susceptible to corrosion and failure.
