National Transportation Safety Board

Pipeline Accident Brief

Accident No.: DCA09FP003
Accident Type: Release, ignition, and explosion of natural gas
Location: Rancho Cordova, California
Date: December 24, 2008
Time: 1:35 p.m. Pacific standard time¹
Pipeline Operator: Pacific Gas and Electric Company
Fatalities: 1
Injuries: 5
Property Damage: \$267,000

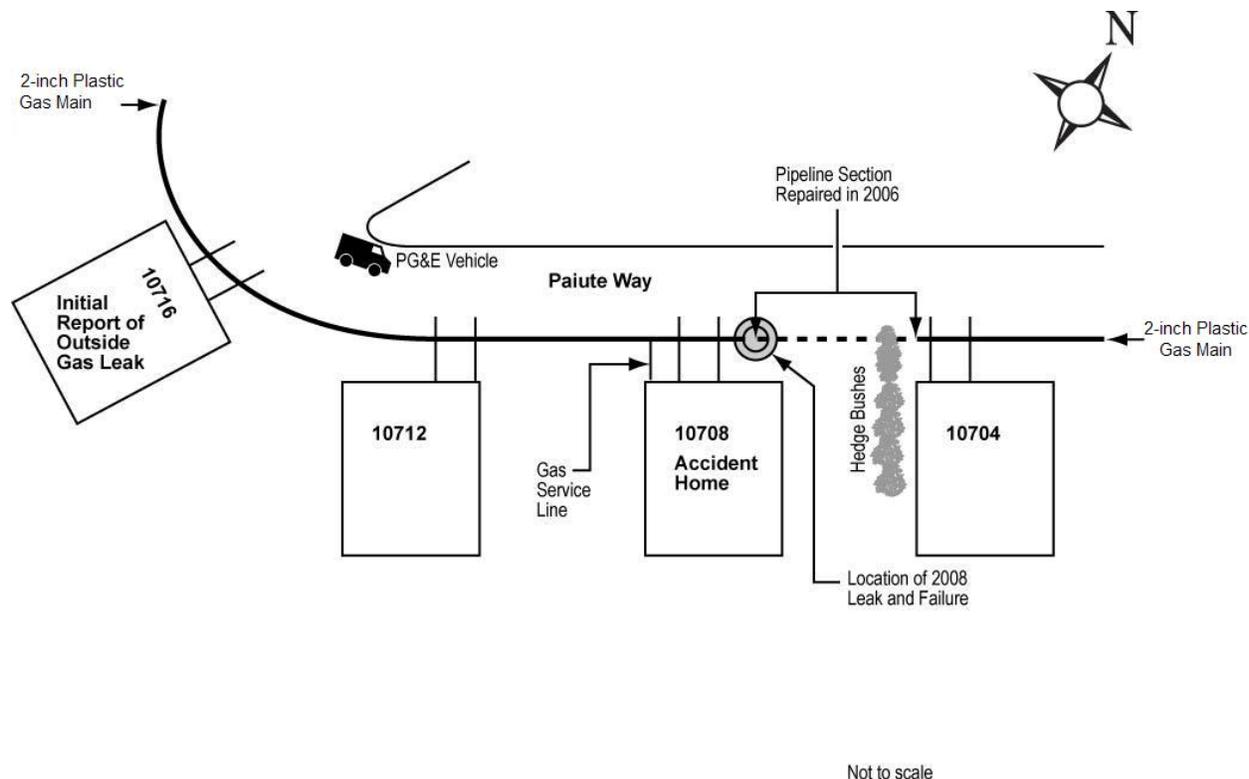
Figure 1. Diagram showing locations of houses, gas lines, leaks and leak reports, and PG&E vehicle.

The resident led the technician outside and into the yard of 10708 Paiute Way. Once in the yard, the technician detected a natural gas leak at a patch of dead grass in the middle of the yard. The location of the leak was about 5 feet west of the driveway, about 45 feet from the house. The technician checked the gas meter at 10708 Paiute Way for leaks but did not find any.

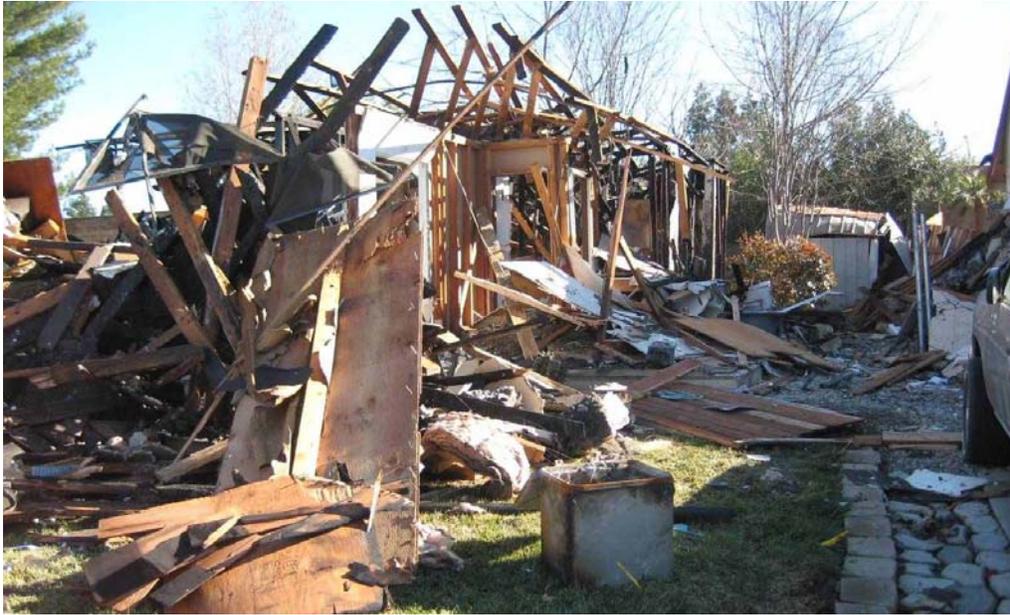
About 1:35 p.m., the foreman went to his truck to get a probe and to prepare for use another type of gas detector, a combustible gas indicator that helps pinpoint leaks. Meanwhile, the leak investigator knocked on the door of 10708 Paiute Way and talked with a resident. When they had finished talking, he turned away from the house to begin further investigation, and the house exploded. (See figure 2.) The homeowner sustained fatal injuries as a result of the explosion.

Figure 2. Damage caused by explosion.

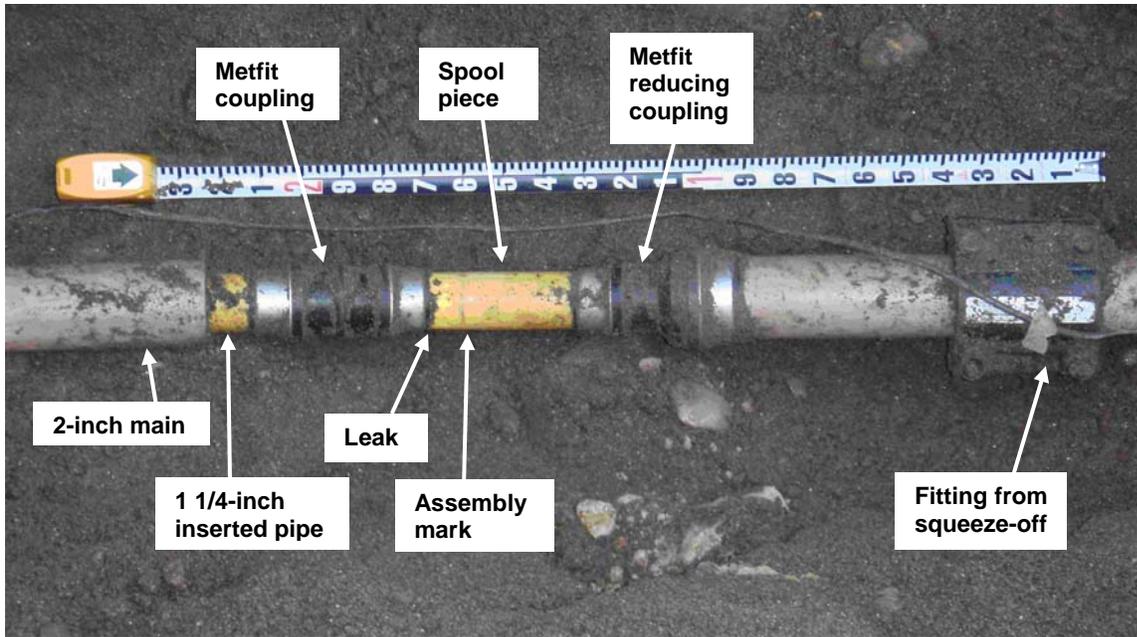
Postaccident excavation revealed that the source of the natural gas leak was the main pipeline, where a spool piece¹¹ of pipe had partially pulled out of a 1 1/4-inch coupling. About 1/4 inch of polyethylene pipe was inside the Metfit¹² coupling, although at least 1 inch of pipe is held in a correctly assembled coupling. (See figures 3 and 4.) PG&E had installed the spool piece of pipe and the coupling during a September 21, 2006, repair of a leak to the 2-inch main pipeline. The sections of pipe and couplings from the accident were submitted to the NTSB's Materials Laboratory for testing. (See figure 4.)

Figure 3. View from above of source of 2008 leak as discovered in the field. Distance between leak and assembly mark is 1 inch.

The short, 6-inch piece of 1 1/4-inch spool pipe had no markings at all, an outside diameter of 1.662 inches, and a wall thickness of 0.148 to 0.152 inches, significantly thinner than the minimum wall thickness for ASTM D-2513 SDR 10 pipe. The coupling cannot be tightened with sufficient sealing pressure if the wall thickness of the pipe does not meet the minimum specifications. Marks made by the field installer were found on all of the piping installed by PG&E, and they indicated the proper depth for insertion of the pipe into the coupling.

- Packing pipe is explicitly prohibited from any use and must be discarded.
- Written requirements have been established to check the wall thickness, outside diameter, and print line on all plastic pipes before installation to be certain that the mechanical fittings are compatible with the pipe.

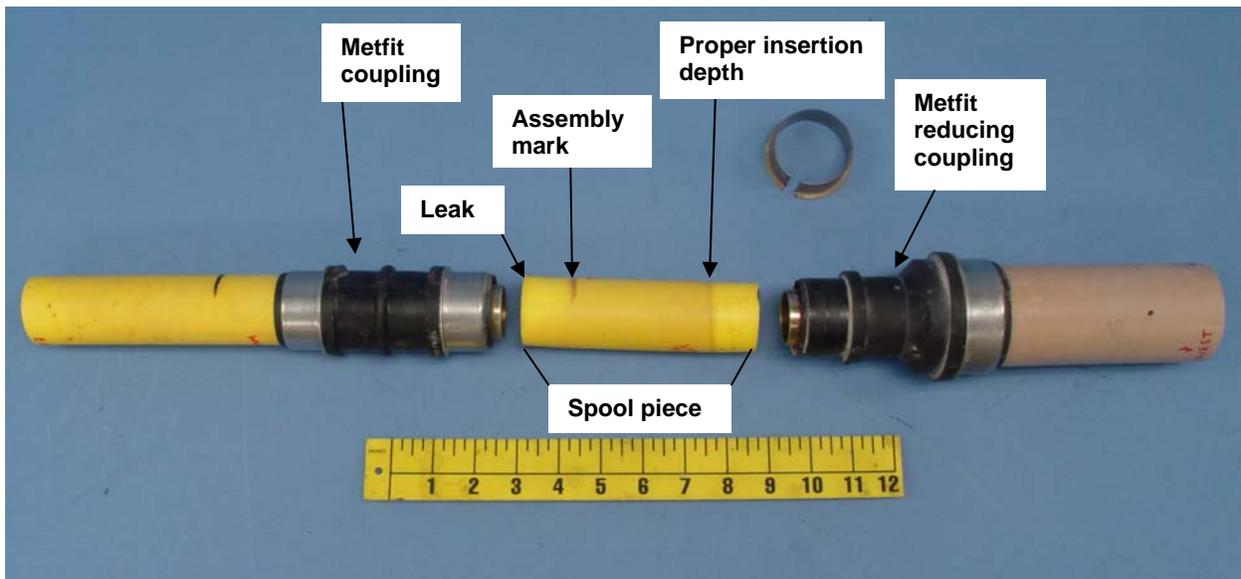
Figure 4. Pipeline components excavated from accident site.
