National Transportation Safety Board

Pipeline Accident Brief

Accident No.: DCA-10-FP-009
Type of System: Crude oil transmission pipeline
Accident Type: Pipeline damage with release
Location: Romeoville, Illinois
Date: September 9, 2010
Time: 11:30 a.m., central daylight time¹
Owner/Operator: Enbridge Energy, Limited Partnership
Fatalities/Injuries: None
Damage/Clean-up Cost: \$46.6 million
Material Released: Heavy crude oil
Quantity Released: 6,430 barrels (270,000 gallons)
Pipeline Pressure: 101 pounds per square inch, gauge
Maximum Operating Pressure: 619 pounds per square inch, gauge
Component Affected: 34-inch diameter steel crude oil transmission pipeline

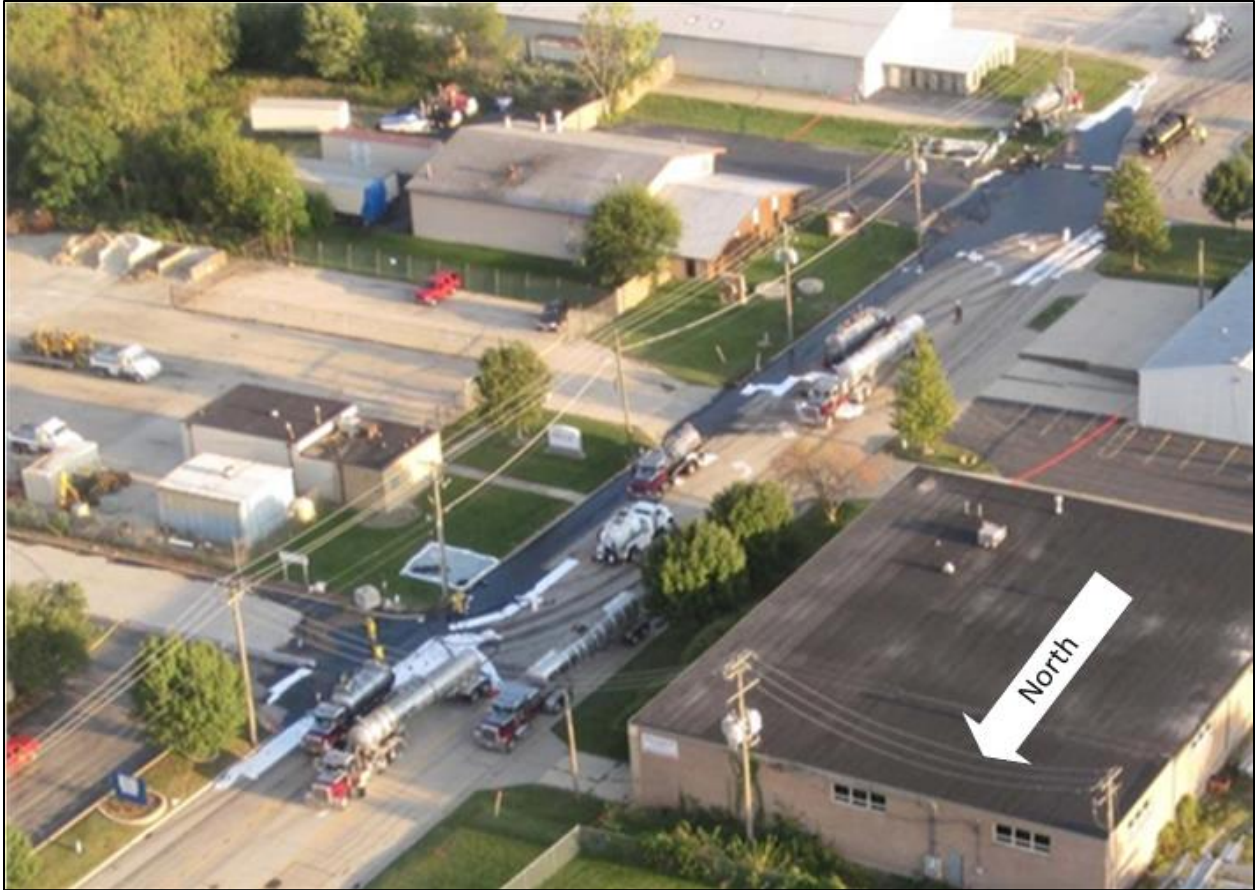
Figure 1. Aerial view of Parkwood Avenue looking southeast, September 9, 2010

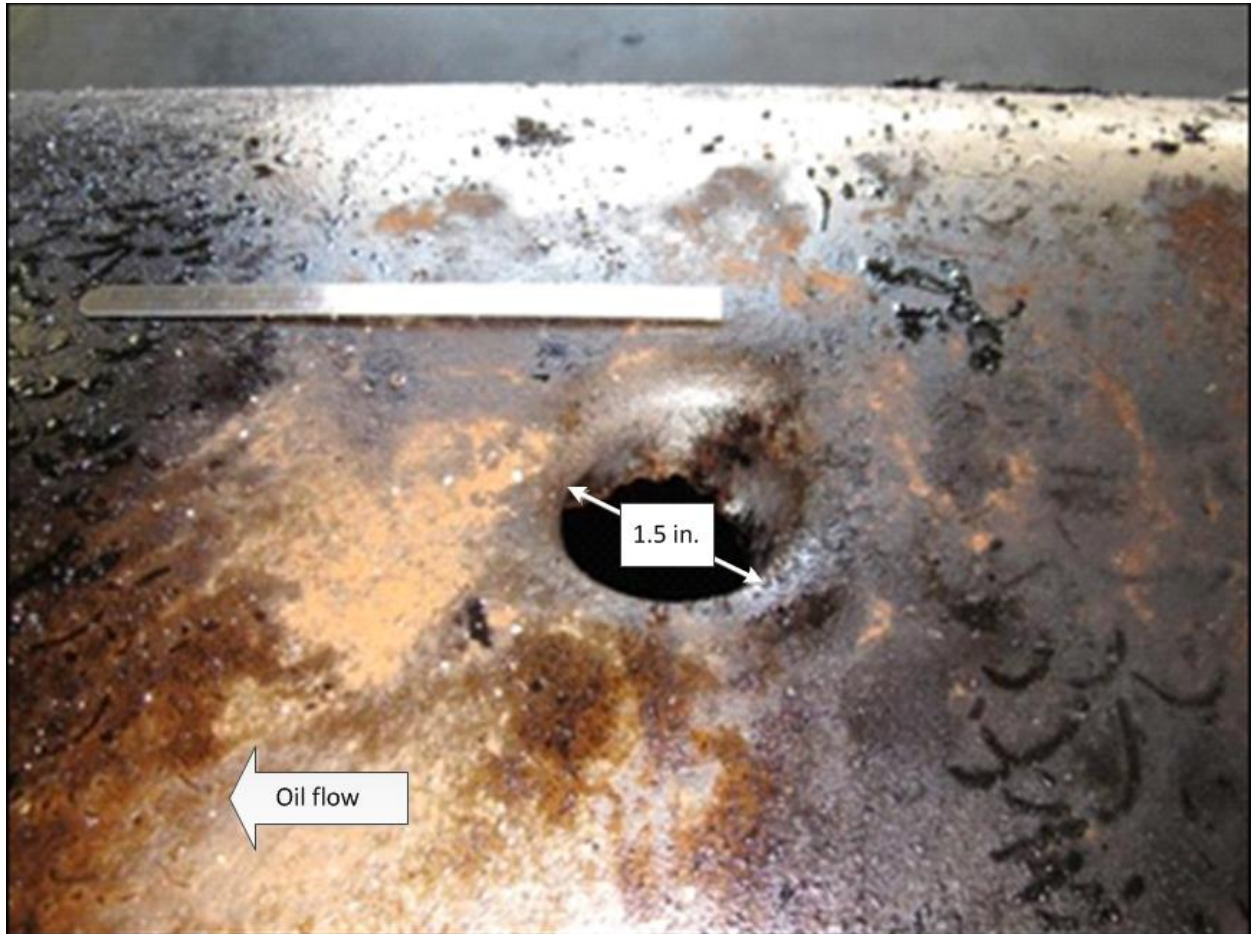
The oil pipeline sustained a 1.5-inch-diameter hole (see figure 2) about the 6:00 o'clock (bottom) position directly above the water pipe that crossed beneath it. The pipeline wall was thinned and deformed inward around the edges of the hole.

Figure 2. External view of the hole in the bottom of the 34-inch-diameter oil pipeline

The outer surface deformed inward within a diameter of about 3 inches and was visible on the interior surface of the pipe. Piles of small rocks about 0.125 inch in diameter were covered in oil and stuck to the interior surface of the pipeline.

The holes in the water pipe became larger from the jetting water flow. The high-velocity, spraying water with suspended sand and small gravel began striking the oil pipeline until a through-wall hole developed.

The National Transportation Safety Board determines that the probable cause of the Enbridge Energy, Limited Partnership oil pipeline leak and crude oil release near the Des Plaines River in Romeoville, Illinois, on September 9, 2010, was erosion caused by water jet impingement from a leaking 6-inch diameter water pipe 5 inches below the oil pipeline.

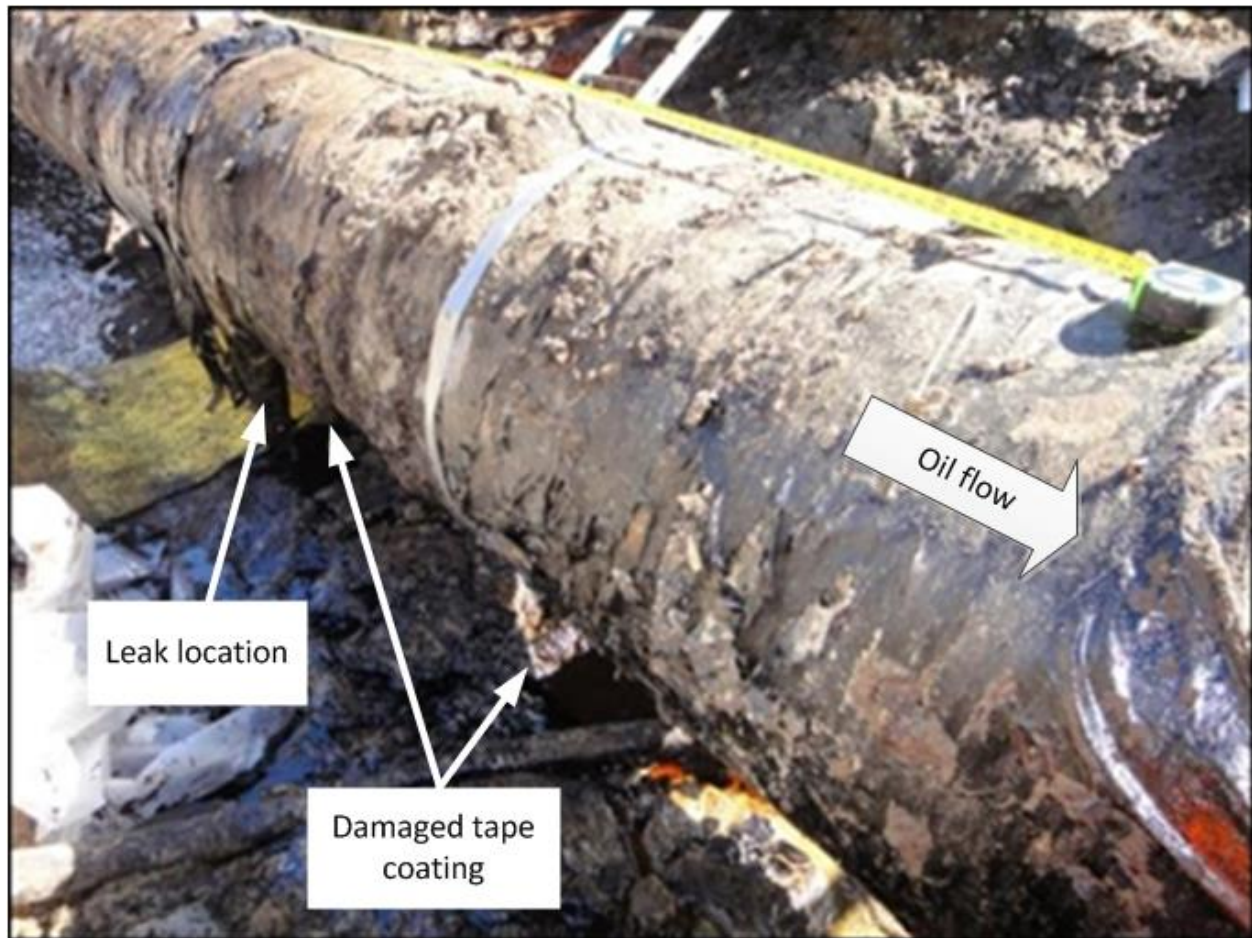
The oil pipeline tape coating was heavily damaged in the area above the water pipe, likely from the water jetting against it. Strips of ripped and disbonded coating and tape hung down from the sides of the pipeline in the vicinity of the leak location (see figure 3).

Figure 3. View of the damaged tape coating on the oil pipeline in the excavated trench

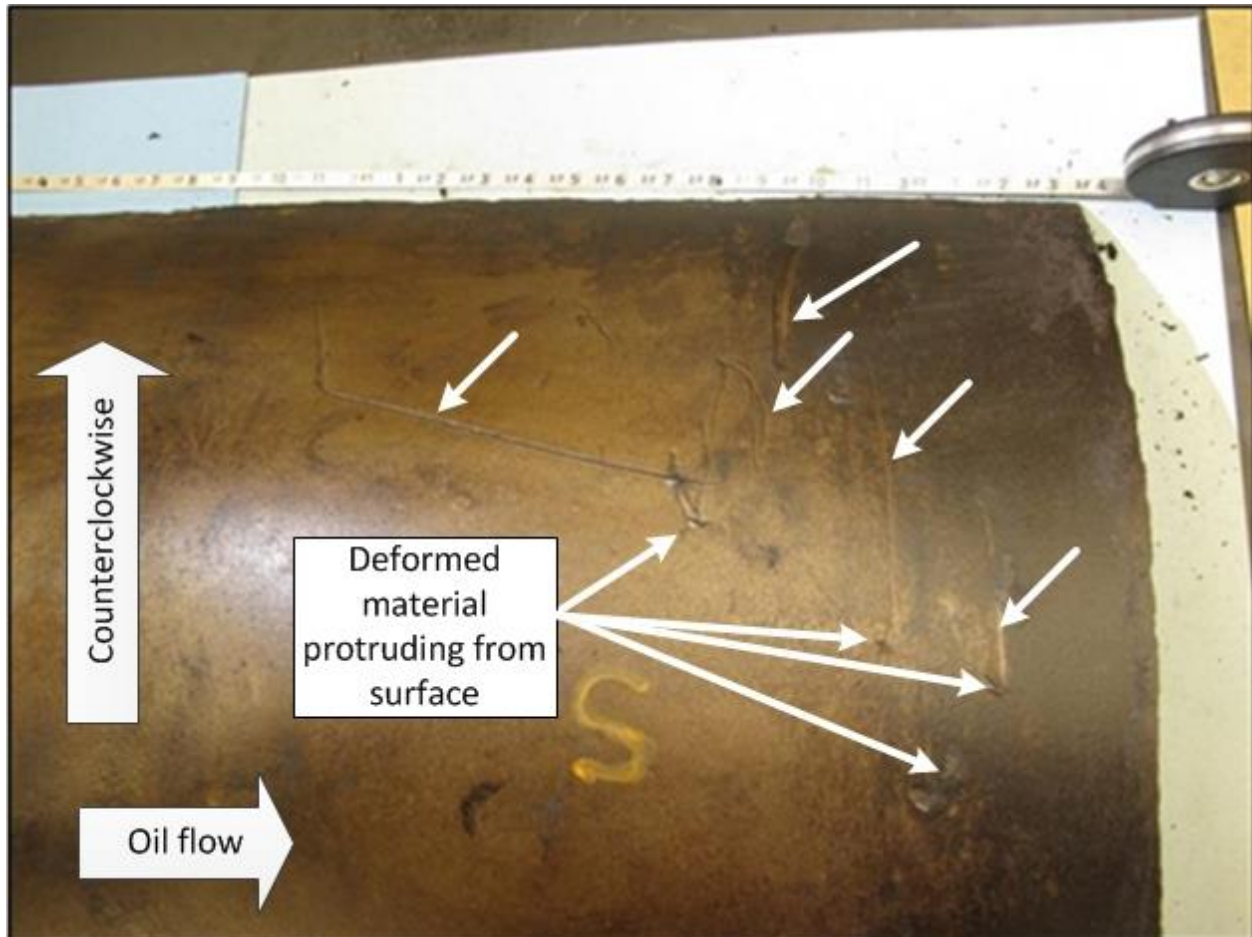
Sliding contact damage (gouging) on the outer surface of the oil pipeline was observed within 24 inches downstream from where the water pipe passed under the pipeline (see figure 4). Deformed pipe wall material protruded from the surface of many of the marks, most likely caused by digging tool strikes that occurred during the excavation work when the water pipe was installed.

Figure 4. Sliding contact gouges (individual arrows) and deformed material on the outer surface of the oil pipeline near the water pipe intersection

Although the oil pipeline was installed with a protective coating, NTSB investigators determined the coating was most likely damaged during the water pipe installation, as evidenced by the gouges observed on the oil pipeline. The damaged oil pipeline coating provided a pathway for stray current to lead to extensive, deep corrosion on the upper side of the water pipe. Eventually, the ductile iron water pipe was so degraded that the concrete liner was unable to contain the water pressure.

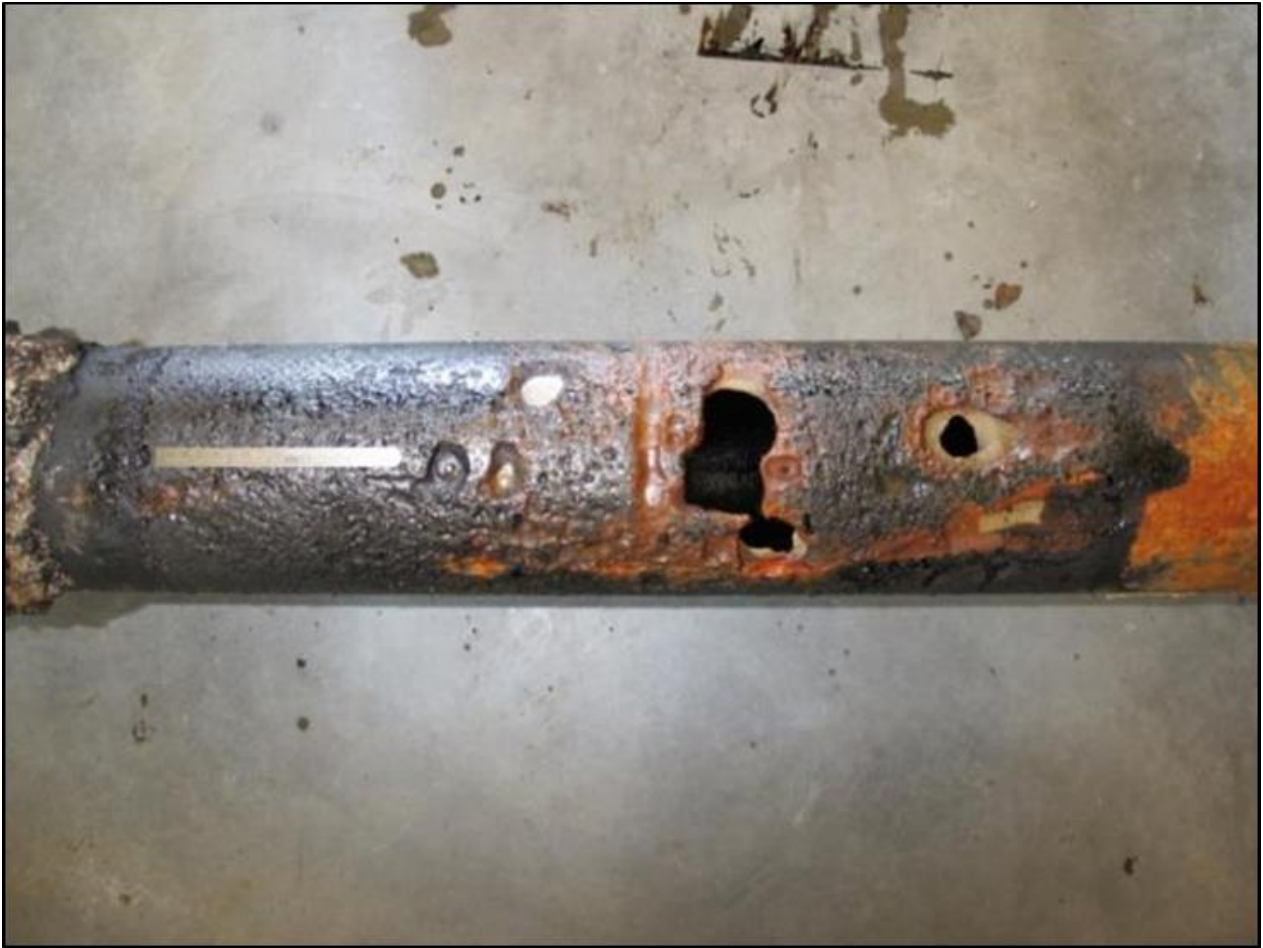
The water pipe was corroded and had three large holes through the pipe wall and concrete liner on the upper half of the pipe in the immediate area directly below the oil pipeline (see figure 5). The largest hole measured 5.1 inches around the circumference and had an irregular shape. The metal edges of the holes were rounded and oxidized. A corrosion pitted area extended about 16 inches upstream and downstream along the top and sides of the pipe from the center of the largest hole. The bottom of the pipe as well as the entire circumference upstream and downstream beyond the corroded area did not exhibit significant corrosion.

Figure 5. Large holes and corrosion damage on the top of the 6-inch-diameter water pipe

Holes were observed in the water pipe and the oil pipeline. Most likely, the large holes in the water pipe developed first due to stray current corrosion, and the hole in the oil pipeline developed due to erosion from water jet impingement on the oil pipeline.

The oil pipeline is cathodically protected with an impressed current system. A metallic object in close proximity to the oil pipeline, such as the water pipe, can disrupt the electric current flow and cause the metallic object to corrode, which is likely what caused the heavy local corrosion on the water pipe. Being only 5 inches away, the water pipe was close enough to disrupt the cathodic protection currents on the oil pipeline.

According to an article published by the Ductile Iron Pipe Research Association,¹² when a ductile iron pipe crosses a cathodically protected pipe, the ductile iron pipe should be encased with polyethylene for a 20-foot distance in each direction from the nearby cathodically protected pipe. Alternatively, a sacrificial anode could be attached to the water pipe to discharge the current from the anode instead of from the water pipe back to the oil pipeline. Contrary to these recommended practices, the water pipe was not provided either protection method.
