National Transportation Safety Board

Pipeline Accident Brief

Birmingham Public Housing Gas Explosion

Accident No.:	DCA14MP001
Type of System:	Natural gas main pipeline
Accident Type:	Rupture and fire
Location:	Birmingham, Alabama
Date:	December 17, 2013
Time:	2:29 a.m. central standard time
Owner/Operator:	Alabama Gas Corporation
Fatalities:	1
Injuries:	3
Damage/Clean-up Cost:	\$505,300
Material Released:	Natural gas
Quantity Released:	147,000 cubic feet
Pipeline Pressure:	19 pounds per square inch, gauge
Maximum Allowable Operating Pressure:	25 pounds per square inch, gauge
Component Affected:	2-inch cast iron distribution pipeline

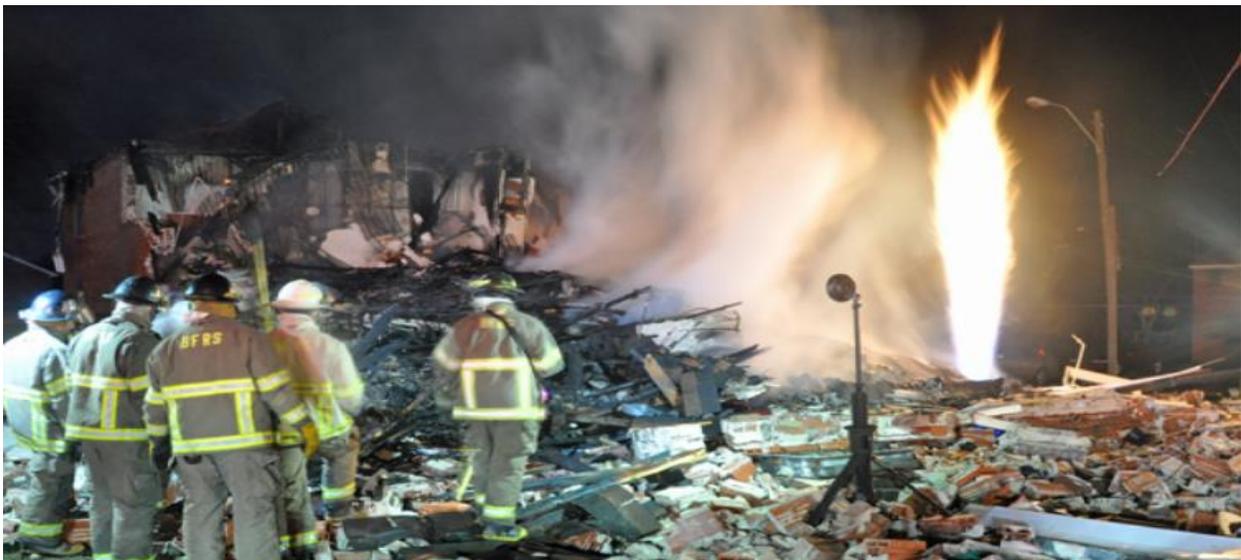
The BFRS arrived at the scene at 2:34 a.m. and extinguished the structure fire by 3:16 a.m. Meanwhile, a separate, torch-like fire continued to burn from the broken natural gas service pipeline riser adjacent to the building. (See figure 2.) Alabama Gas Corporation (Alagasco) crews assisted with the recovery and rescue efforts and searched for a debris-free path to uncover the natural gas service line to the affected apartment. At 6:14 a.m., an Alagasco crew isolated the gas flow at the riser valve stopping the fire.

Figure 2. The riser fire shoots up from the ground amid the rubble at Charles P. Marks Village.

About 6:00 a.m. when technicians were still unable to locate the buried service line to stop the riser fire, Alagasco decided to shut off the gas using the riser isolation valve directly below the venting, burning gas. At 6:14 a.m., the technician closed the service isolation valve, which stopped the gas flow.

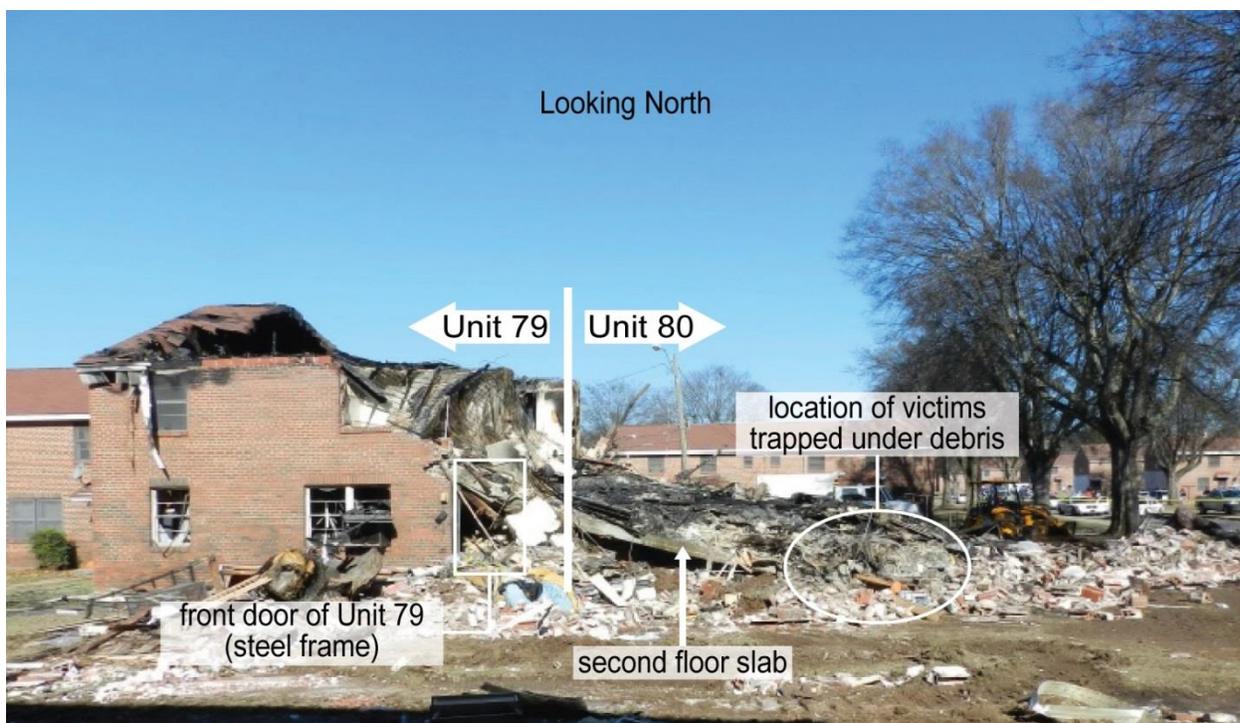
The explosion destroyed unit 80. Unit 79, the other half of the duplex, sustained less severe damage, mostly from the post-explosion fire. The common wall between units 79 and 80 pushed away from unit 80; debris from the top of the wall landed into the living areas of the first floor of unit 79. (See figure 3.)

Figure 3. Units 79 and 80 after the explosion.

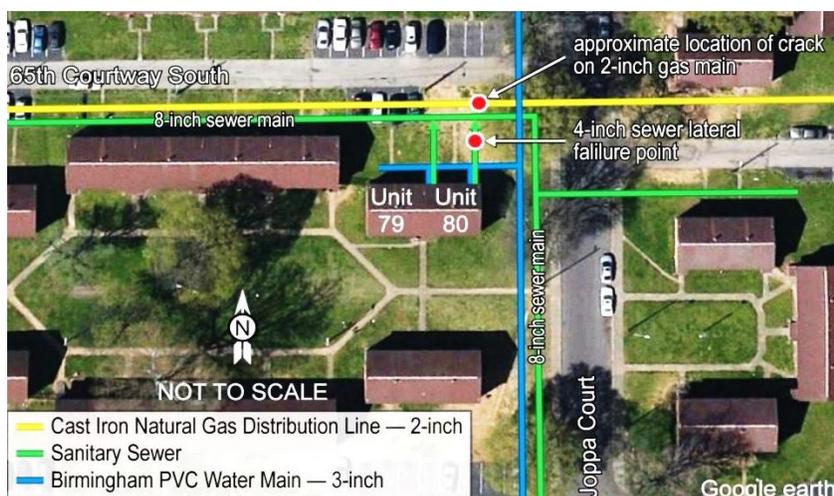
A 2-inch, cast iron natural gas main operating at 19.5 pounds per square inch gauge (psig) ran along the north side of units 79 and 80 parallel to 65th Courtway South. One and one-half-inch service lines supplied gas to units 79 and 80. (See figure 4.) The natural gas lines from the meter outlets into the duplex consisted of threaded, black-iron pipe. The unit 80 line entered the apartment through the wall about 3 feet above the concrete slab at the northeast corner of the unit. From this point, the line followed the north wall and turned south into the kitchen. The gas service line continued vertically into the structure along the wall, turned horizontally directly below the second level concrete slab, and traveled the length of the kitchen toward the back of the building. The pipe dropped vertically on the wall behind the sink to provide gas to the range. The pipe continued downward where it supplied the water heater; it then passed through an adjacent wall to supply gas to the living room heater where flues for the heater and water heater joined and routed to a central chase in the closet with the water heater.²

Figure 4. Aerial view showing route of underground utilities near unit 80.

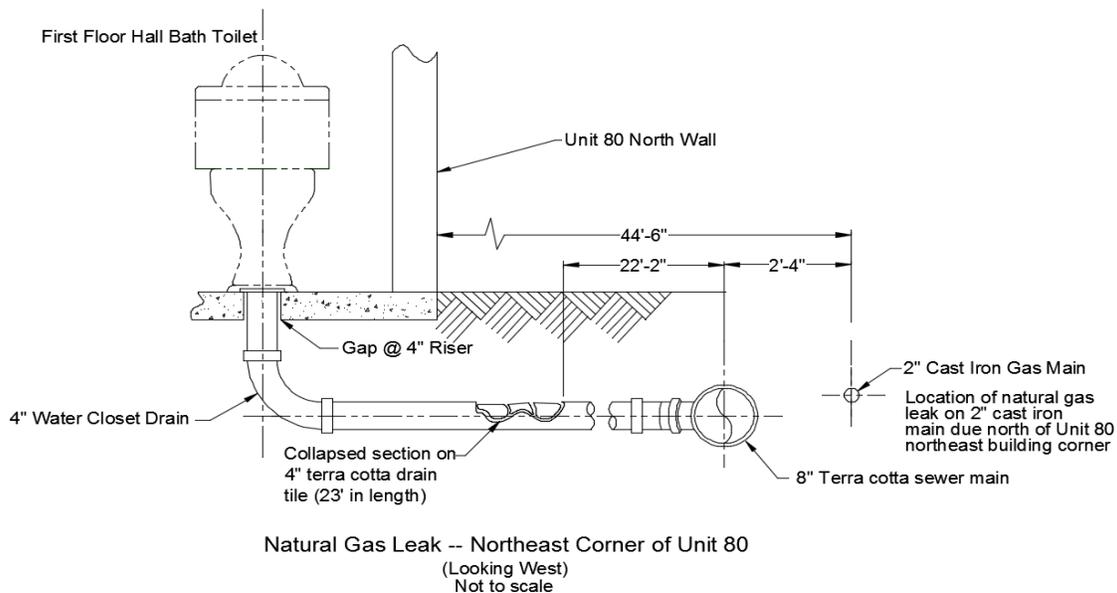
Figure 5. Cross section of underground piping to the northeast corner of the half-bath in unit 80.

The NTSB determined that one credible path for the natural gas to enter unit 80 was by migrating through the soil from the cracked cast iron gas main to the buried sewer main about 3 feet away. It then traveled along the exterior of the buried sewer main to the building about 45 feet away. (See figure 5.) It accumulated under the first floor slab and entered the unit where the sewer pipe passed through the concrete slab at:

- The annulus around the 4-inch cast iron sewer pipe below a toilet located in the northeast corner of unit 80 on the first floor. Close examination of the floor penetration around the pipe revealed gaps in the annulus.
- The 4-inch waste piping penetration through the slab near the kitchen sink, the area at the annulus of the 4-inch penetration also had gaps.

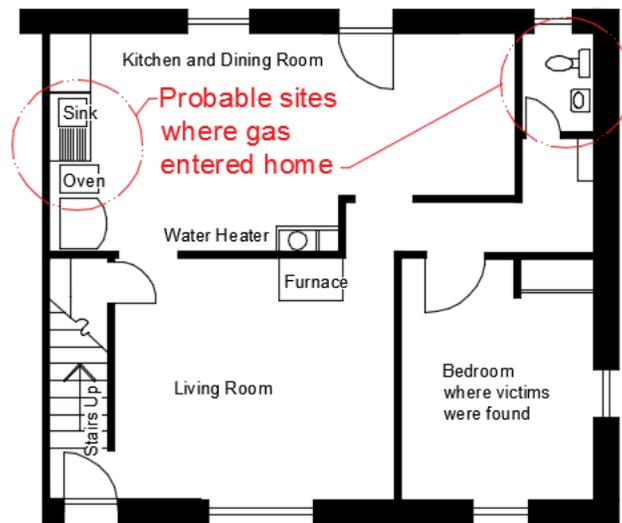
The second credible path involved the gas leaking inside of the 4-inch sewer at the collapsed section described earlier. In this scenario, gas flowed through the soil from the cracked gas main and into the collapsed, 4-inch sewer lateral about 22 feet away. Gas could travel inside the sewer pipe and pass through the water traps in the toilet and under the bathroom sink and into the ground floor. Based on the nearly 20 psig gas pressure, the expected gas flow volume out of the cracked gas main, and the breach in the 4-inch sewer, natural gas likely bubbled through the water seals in the toilet and the sink drains. From either route, the appliances provided the ignition source for the gas inside the apartment; the range had three open, active pilots, and the room heater had one pilot and might have had the main burner operating. (See figure 6.)

Figure 6. First level of unit 80 showing areas gas entered the apartment.

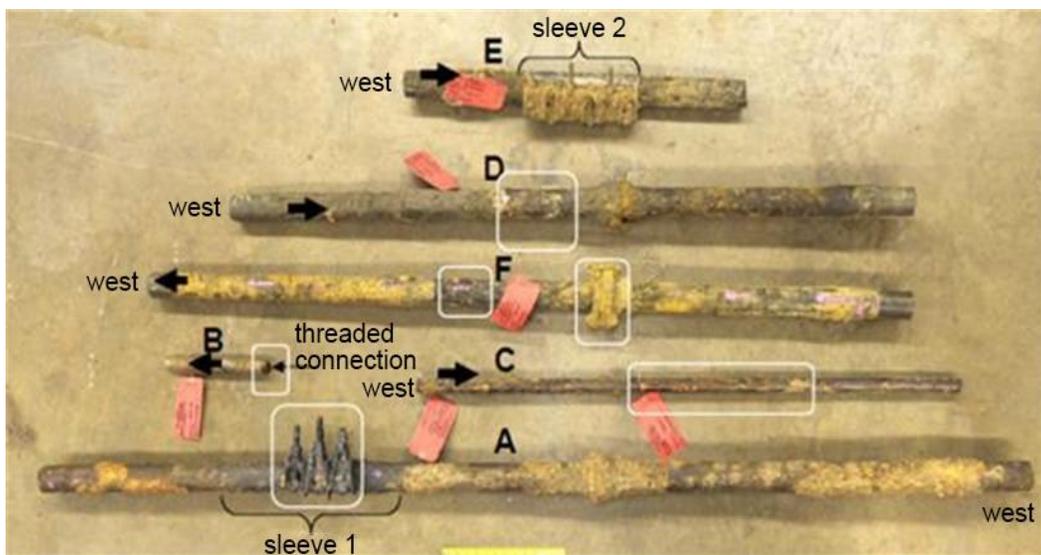
At the request of the NTSB, Alagasco leak-surveyed the community for indications of a natural gas leak near the damaged unit 80 as well as other addresses within the property in the days following the accident. In areas where technicians suspected a leak, they excavated the region to approximately 3 feet below grade to expose the suspected leak location. In total, excavations would involve the removal of six gas-piping segments, labeled A through F. (See figure 7.) All the segments were shipped to the NTSB laboratory in Washington, DC, for examination. Alagasco technicians detected gas leaks at the locations marked with the white rectangles. The clamp on segment A (sleeve 1 in figure 7) was installed the morning after the explosion to stop the leak and stabilize the pipe for removal.

Figure 7. Pipe segments recovered from the accident; rectangles indicate the leak locations.

Prior to destructive testing, several pipe segments were pressure tested with compressed air at the NTSB Materials Laboratory to verify the leak locations; determine pressure decay with time; and estimate the leak rate. In summary, the leak tests showed that pipe segments C, D, and F contained leaks in the same respective areas as those identified during the on-scene accident investigation and revealed evidence of a leak at the ends of the sleeve 2 that was not detected previously. Pipe segment B was not pressure tested since Alagasco reported the leak to be at the threaded connection on the segment and the fitting had been disconnected in the field.

Alagasco technicians identified segment E to be of interest and submitted it for testing because it contained an existing sleeve. Testing revealed evidence of leaks at both ends of the sleeve that were not detected during the on-scene pressure testing. Visual examination of segment F (a 2-inch nominal diameter cast iron pipe) revealed a 4-inch long linear indication at the 12 o'clock position. Leak testing confirmed the field test results and identified two additional leaks at the 10 o'clock and 1 o'clock positions. The length of the 10 o'clock and 1 o'clock cracks measured approximately 3.6 inches and 2 inches, respectively, along the pipe axis.

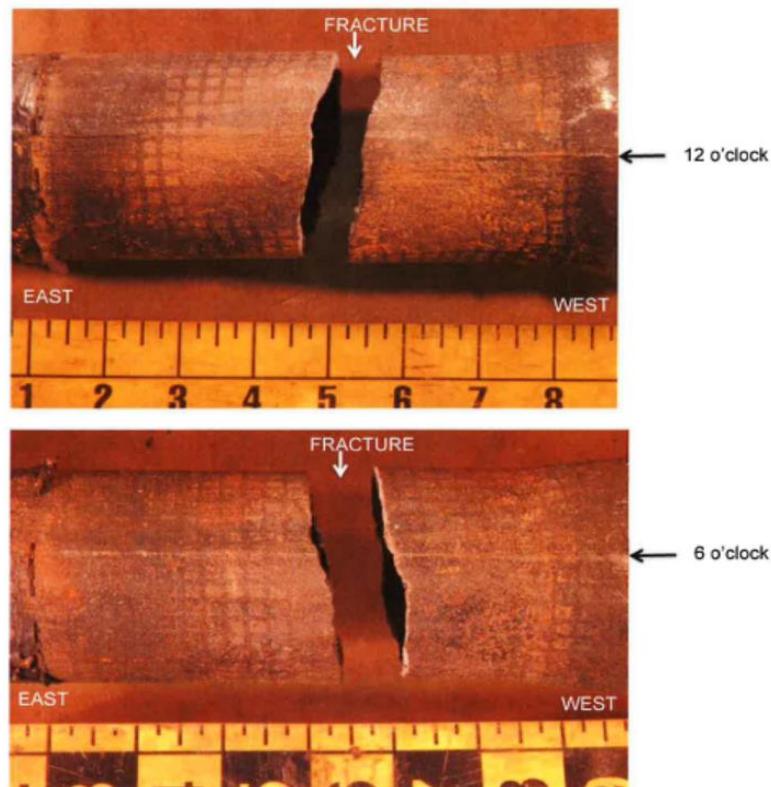
NTSB investigators disassembled and removed the new clamp on pipe segment A. They discovered a fracture that extended circumferentially around the pipe. (See figure 8.) The fracture surface revealed a radiating pattern that originated from the outer surface at the bottom of the pipe. The fracture extended from each side of the fracture origin and propagated circumferentially up toward the top of the pipe.

Figure 8. Pipe segment A after the new clamp was removed to expose the crack.

The National Transportation Safety Board determines that the probable cause of the accident was the release of natural gas through a large crack in the 62-year-old, cast iron gas main that resulted when tree growth cracked the corroded pipe. Once the accumulating gas reached the explosive limit inside the apartment, an active pilot light on an appliance ignited the gas. Contributing to the accident was the absence of the odorant, which was absorbed by the soil and prevented residents from smelling the gas.
