NATIONAL TRANSPORTATION SAFETY BOARD

PIPELINE ACCIDENT REPORTS

**BRIEF FORMAT
SUMMARY FORMAT
ISSUE NUMBER 1 -- 1982**

NTSB-PAB-82-1

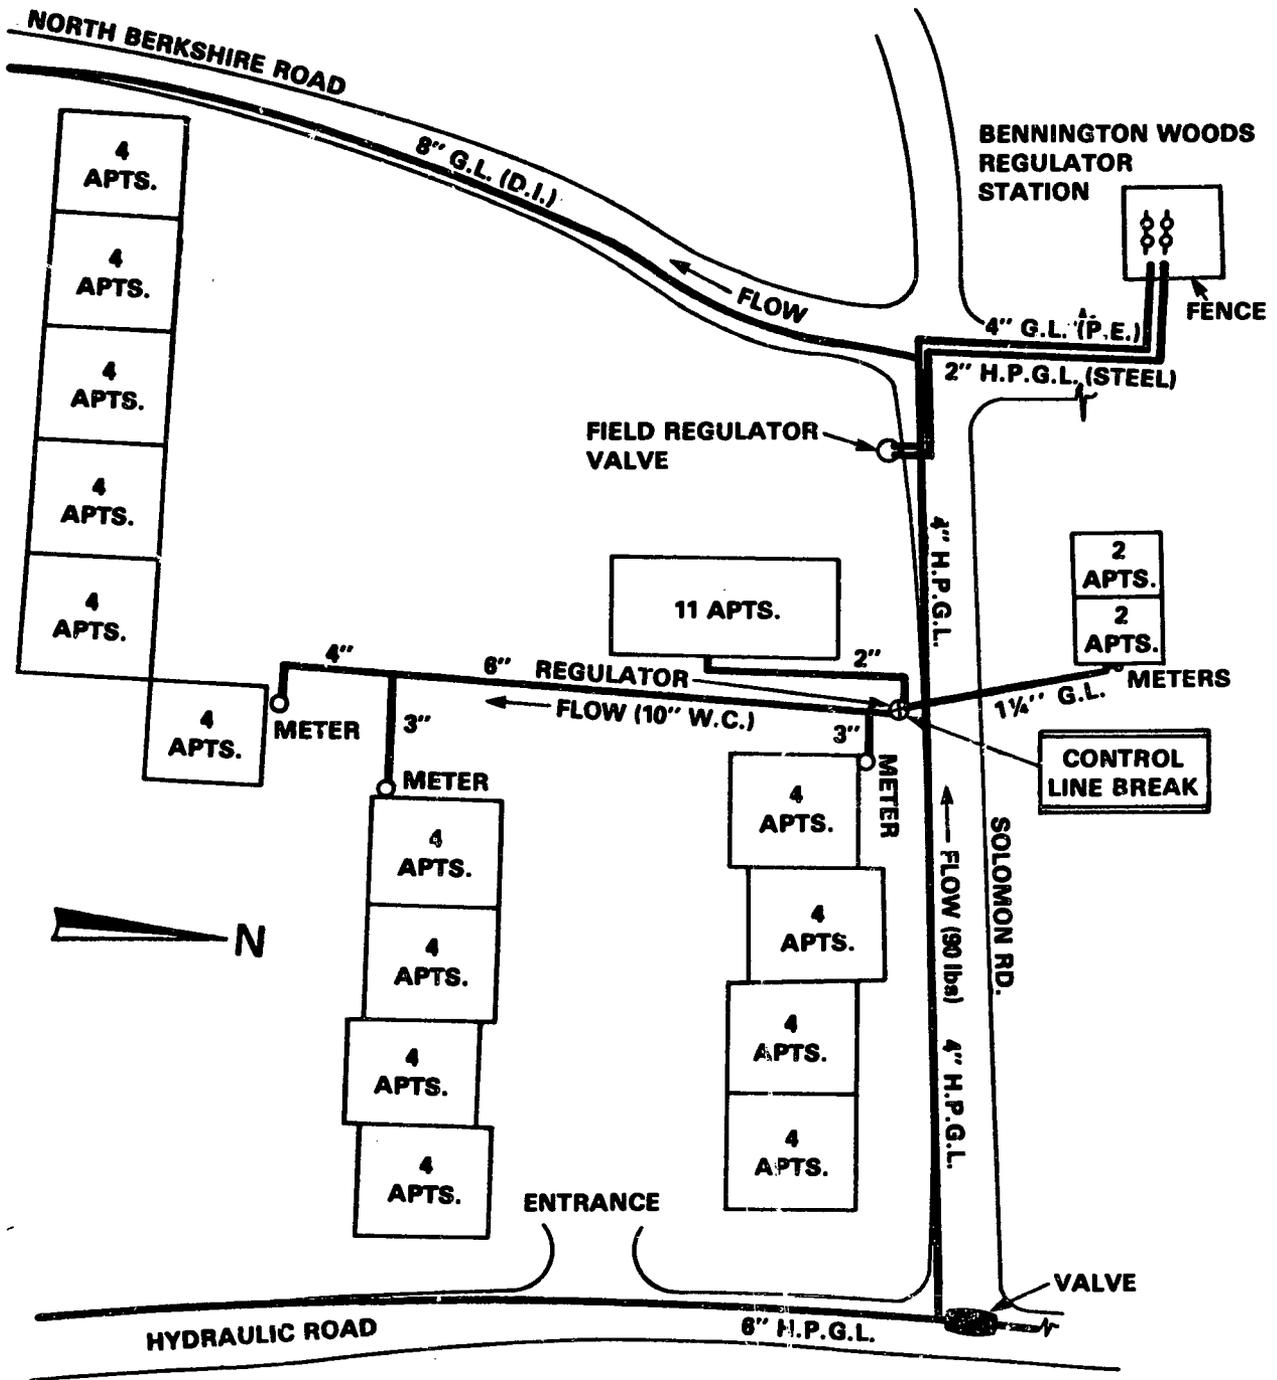
Figure 1. Plan View of Accident Site

The National Transportation Safety Board determines that the probable cause of the accident was the ignition by an undetermined source of uncontrolled high pressure natural gas which had flowed through mains into an apartment complex as a result of the rupture of a regulator control line by excavating equipment.

After the accident, the gas company completed updating its system by eliminating the master meter system serving the 71 apartments. This involved replacement of the 2-, 3-, 4-, and 6-inch mains with 2-inch pipe. (Figure 1 shows preaccident conditions.) Gas was then supplied by the new regulator station, and a customer meter was set at each apartment with a service regulator and internal relief valve.

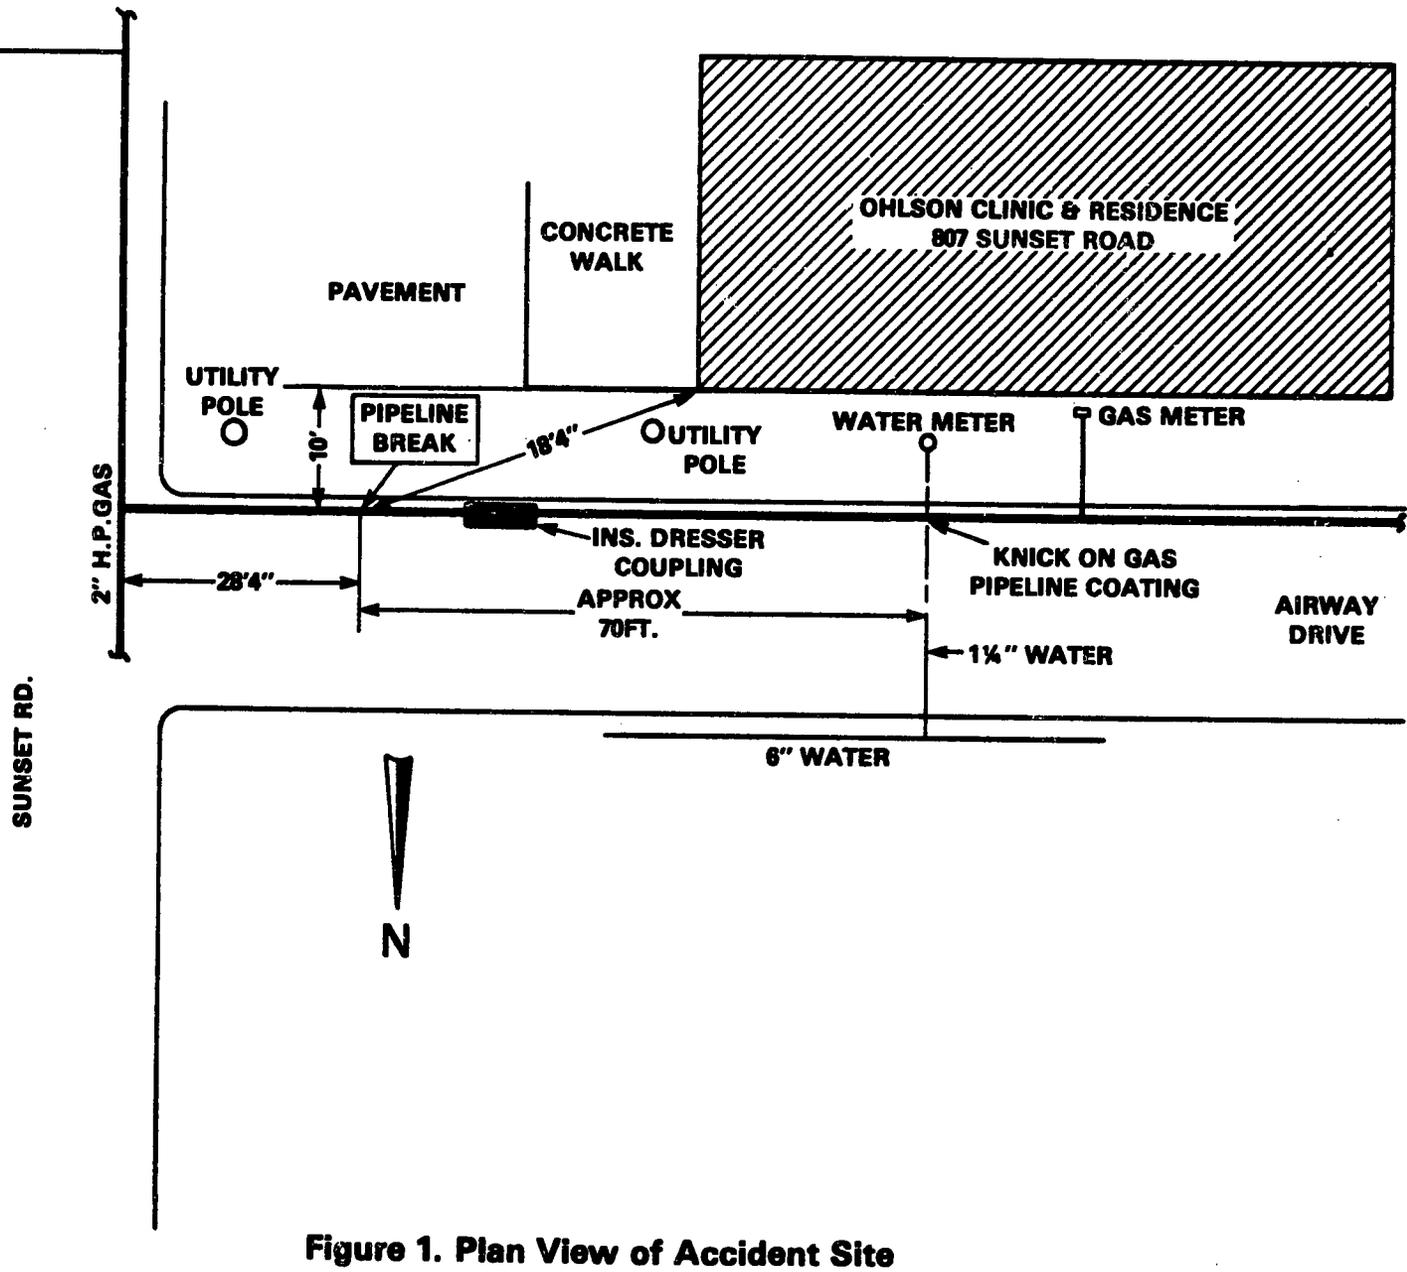
Figure 1. Plan View of Accident Site

At 8:58 a.m., m.d.t., on December 2, 1979, the Ohlson Clinic at 807 Sunset Road, S.W., Bernalillo County, New Mexico exploded and burned. (See figure 1.) Natural gas at 38-psig pressure had escaped from a break on a 2 3/8-inch-outside-diameter, steel coated and wrapped gas main, located 18 feet from the destroyed house. The natural gas migrated into a crawl space under the clinic and residence and spread into the living areas. Gas accumulated, formed a combustible mixture, and exploded when it was ignited by an undetermined source.

Inspection of the area around the pipeline break indicated no noticeable discoloration of vegetation, but the soil was dry in an 18-inch deep and 22-inch wide cross sectional area around the break. Metallurgical examination of the damaged pipe showed that the origin point of the failure was an area of mechanical damage to the outside surface of the pipe, where it appeared to have been struck by construction equipment such as a backhoe because the bottom of the pipe showed evidence of dents and gouges in the metal surface and the pipe was bent upward. The pavement in the accident area, however, did not show any signs that any recent excavation had been done.

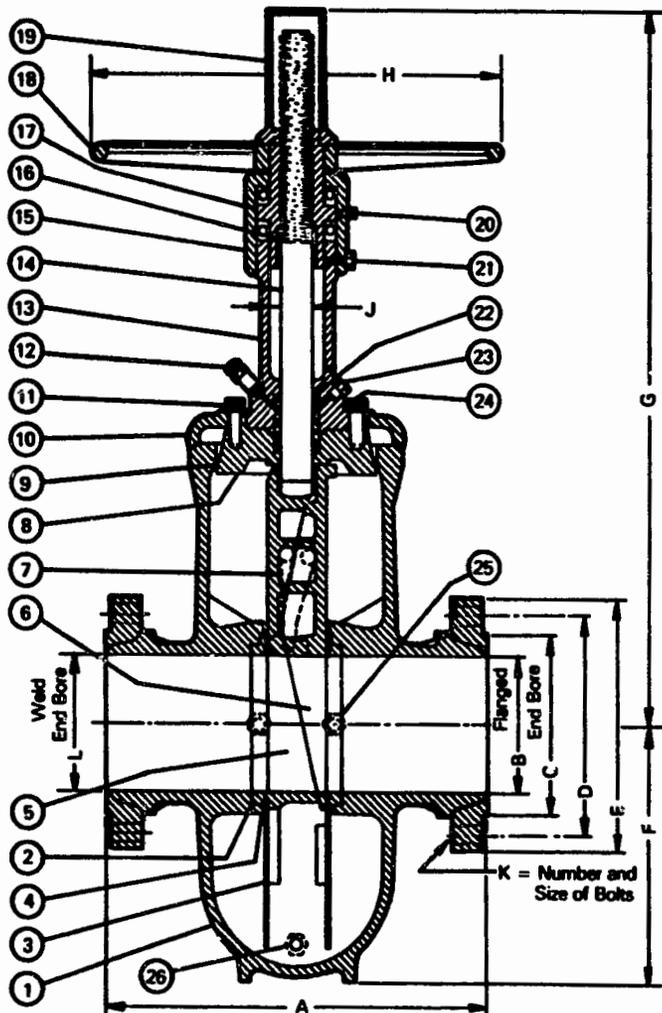
Hydraulic pressure during lubrication overpressured the valve cavity and led to the explosive failure. The grease gun, rated at 15,000 psig, had more than sufficient capacity to rupture the valve. The crewmembers, for reasons unknown, lubricated the upper body grease fitting without using the safety pressure relieving tool, as specified in the W-K-M manual for "Installation, Operation & Maintenance of W-K-M Through-Conduit ANSI Gate Valves." The pressure relieving tool was found in the truck; dirt covered the lower body grease fitting of the valve where the tool would have been applied if proper procedure had been followed.

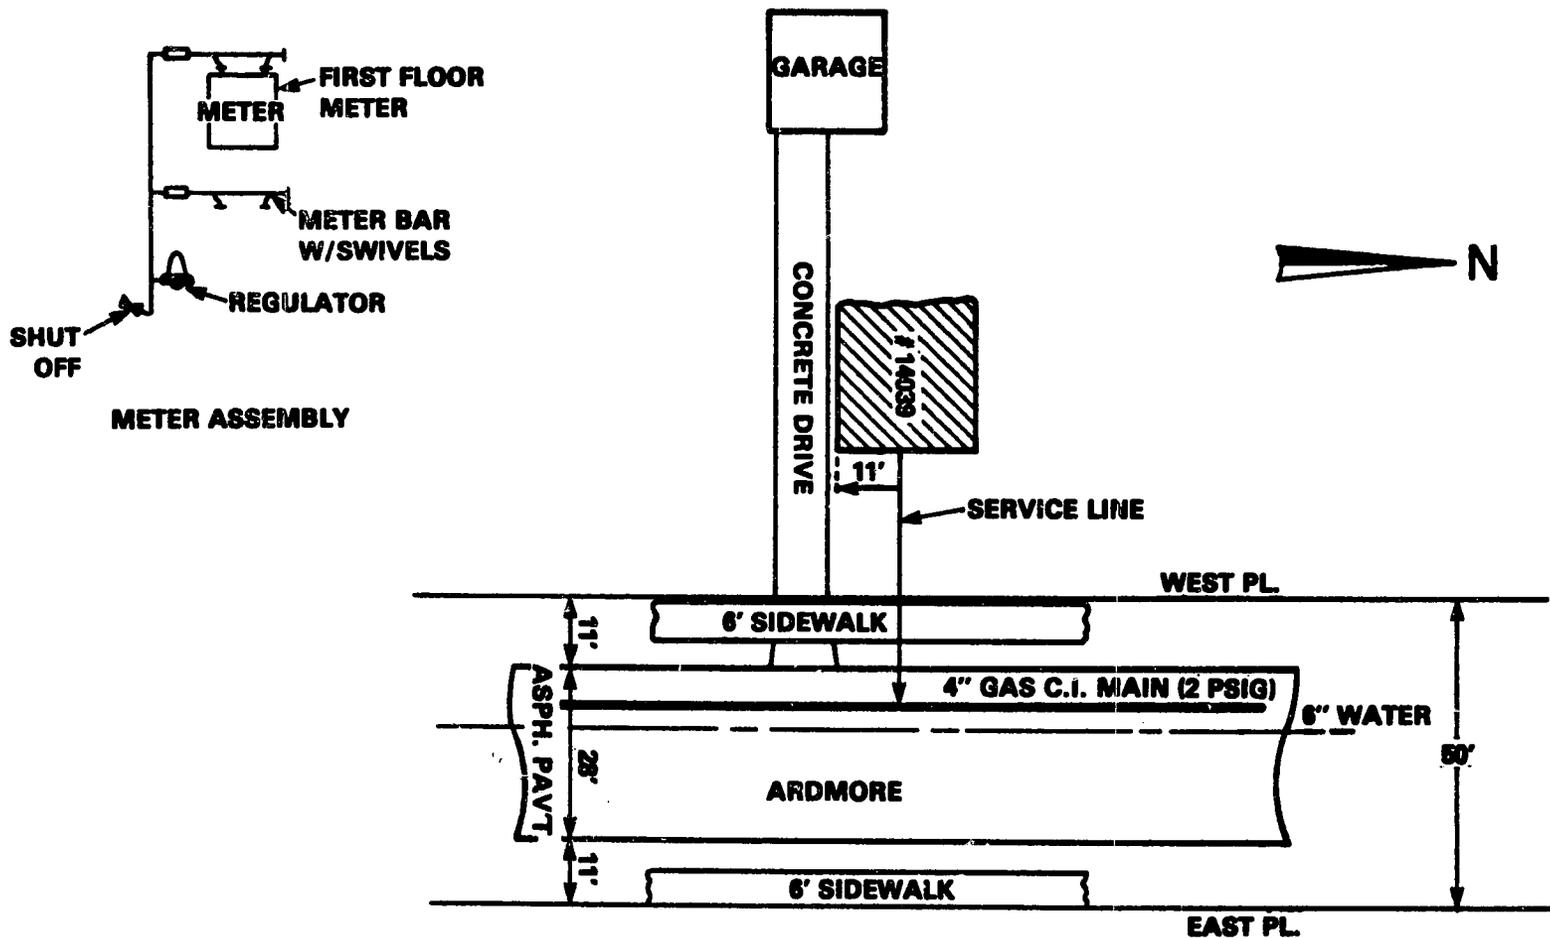
Figure 1. Plan View of Accident Site

Investigation on June 5, 1979, of the explosion and fire revealed that the shutoff valve in the meter bar had been turned on by breaking the locking device. Since the shutoff valve on the first floor gas meter was also in the open position, it appears that the piece of garden hose had been connected to the upstream side of the first floor gas meter to illegally obtain natural gas for consumption. The garden hose failed and natural gas leaked into the building. Ignition of the accumulated gas by an undetermined source resulted in the explosion and fire.

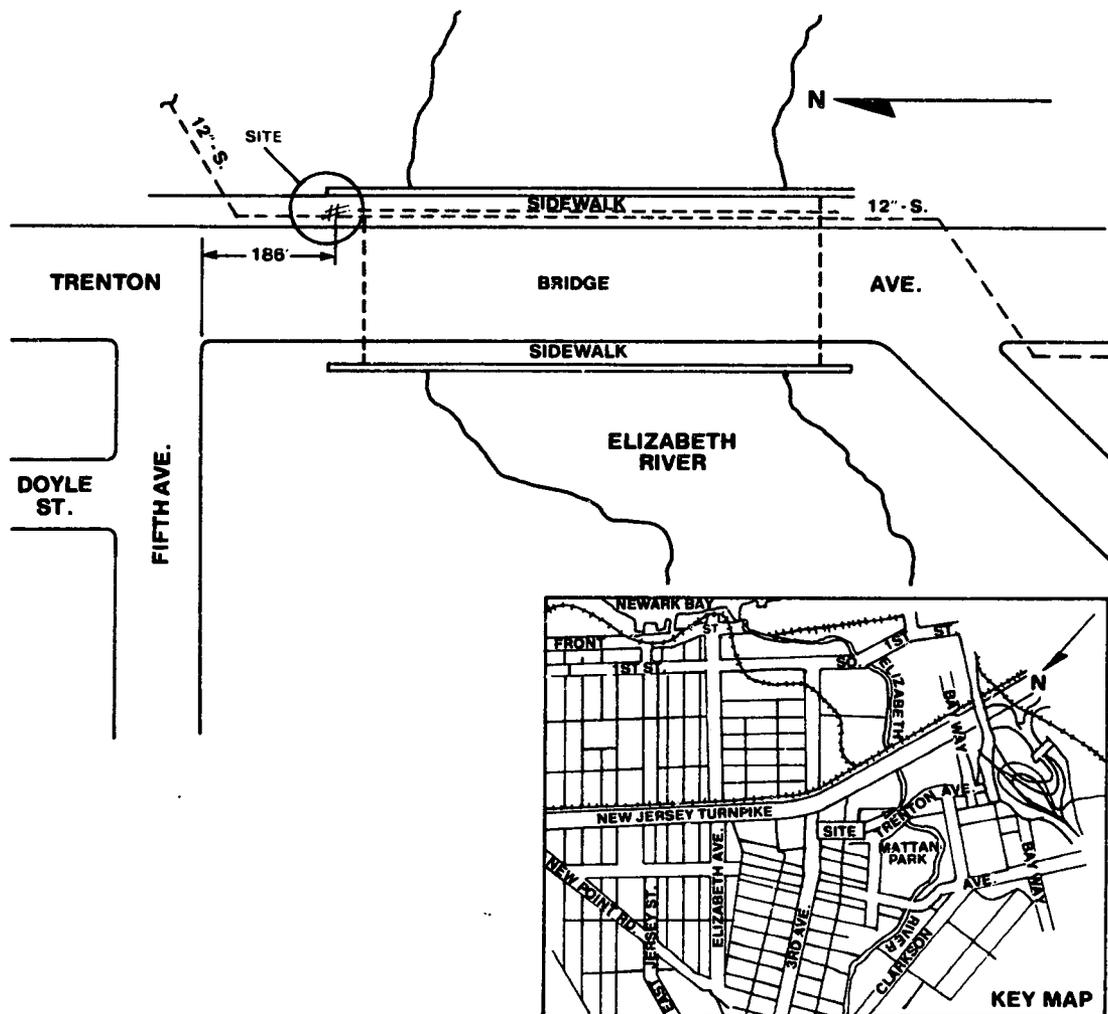
**FIGURE 1. PLAN VIEW OF ACCIDENT SITE
ELIZABETH, NEW JERSEY**

Upon smelling gas, however, the foreman ordered the workers to leave the ditch. Before leaving the worksite, the foreman instructed the workers to let the remaining gas, which was near atmospheric pressure, dissipate before going back into the trench. Soon after the foreman left, both men reentered the open trench, but one returned to the service truck to get a tool. At this time, seven of the eight nuts and bolts on the Dresser coupling had been removed. As the workman who remained in the trench tried to remove the eighth nut and bolt with a hammer and chisel, the natural gas ignited, sparks from the hammer and chisel apparently were the source of the ignition. The workman in the trench was burned critically. He died 11 days later.

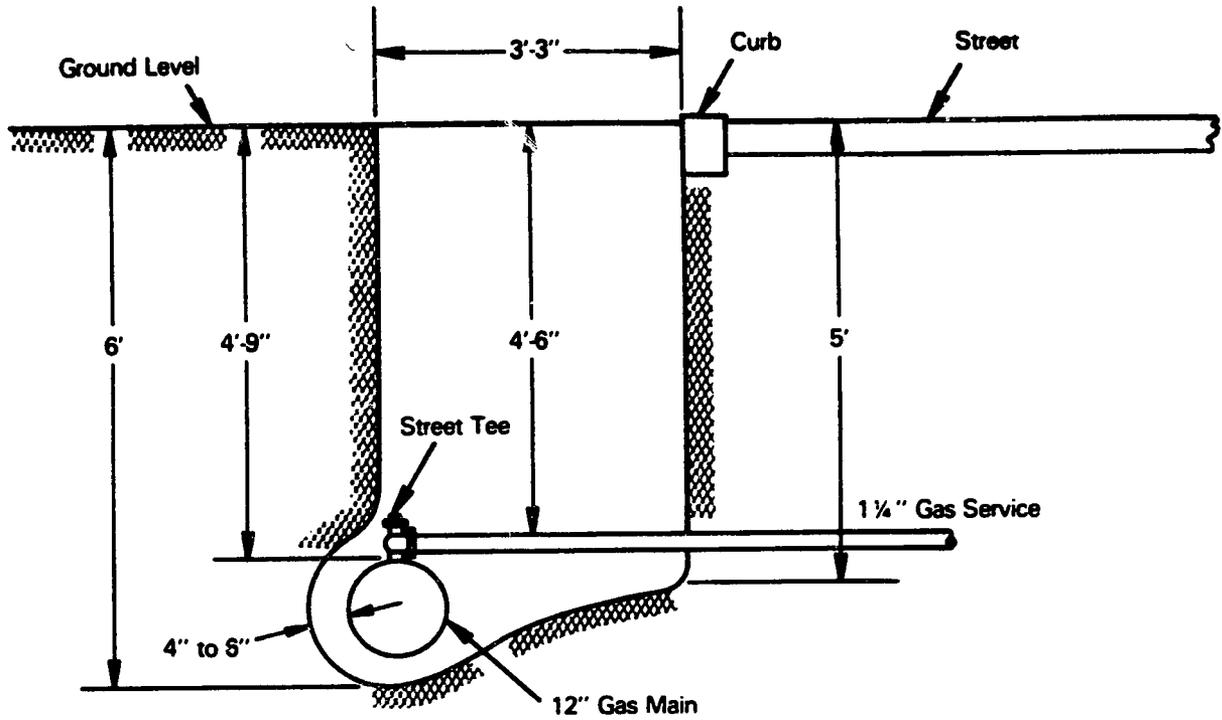
Accident Site — Bellhole at
Long-Side Service Tap for
515 W. Columbia Ave.,
Reading, Ohio

Gas Company Emergency crews were dispatched to the accident site. Pressure was reduced to 5 psig. The service tap bellhole, in which no shoring had been installed, was 31 inches by 39 inches and 5 feet deep. (See figure 1.) After the bellhole was enlarged with a backhoe, the main was checked with a chisel and found to be cast iron (this was also indicated on the records). Two other chisel marks were subsequently found. A 12-inch by 1-inch steel Skinner-type saddle was partially around the main over a 1 1/4-inch hole. The saddle bolt was loose and the rubber gasket was protruding from one side. Gas was escaping from beneath the saddle and around the gasket. The saddle was designed for use on a steel main and consequently did not fit the cast iron main properly because the outside diameter of the cast iron main was larger than that of a 12-inch steel main. After the saddle was removed, the gas flow was stopped by the use of a 1 1/4-inch plug which was "threaded easily into the main (approximately 2 to 3 seconds)." A saddle was not needed since the crew used a 1 1/4-inch by 1-inch brass street tee with a 1-inch brass 90° compression anti-pullout ell. The job was completed by inserting the old service line with 1-inch plastic.

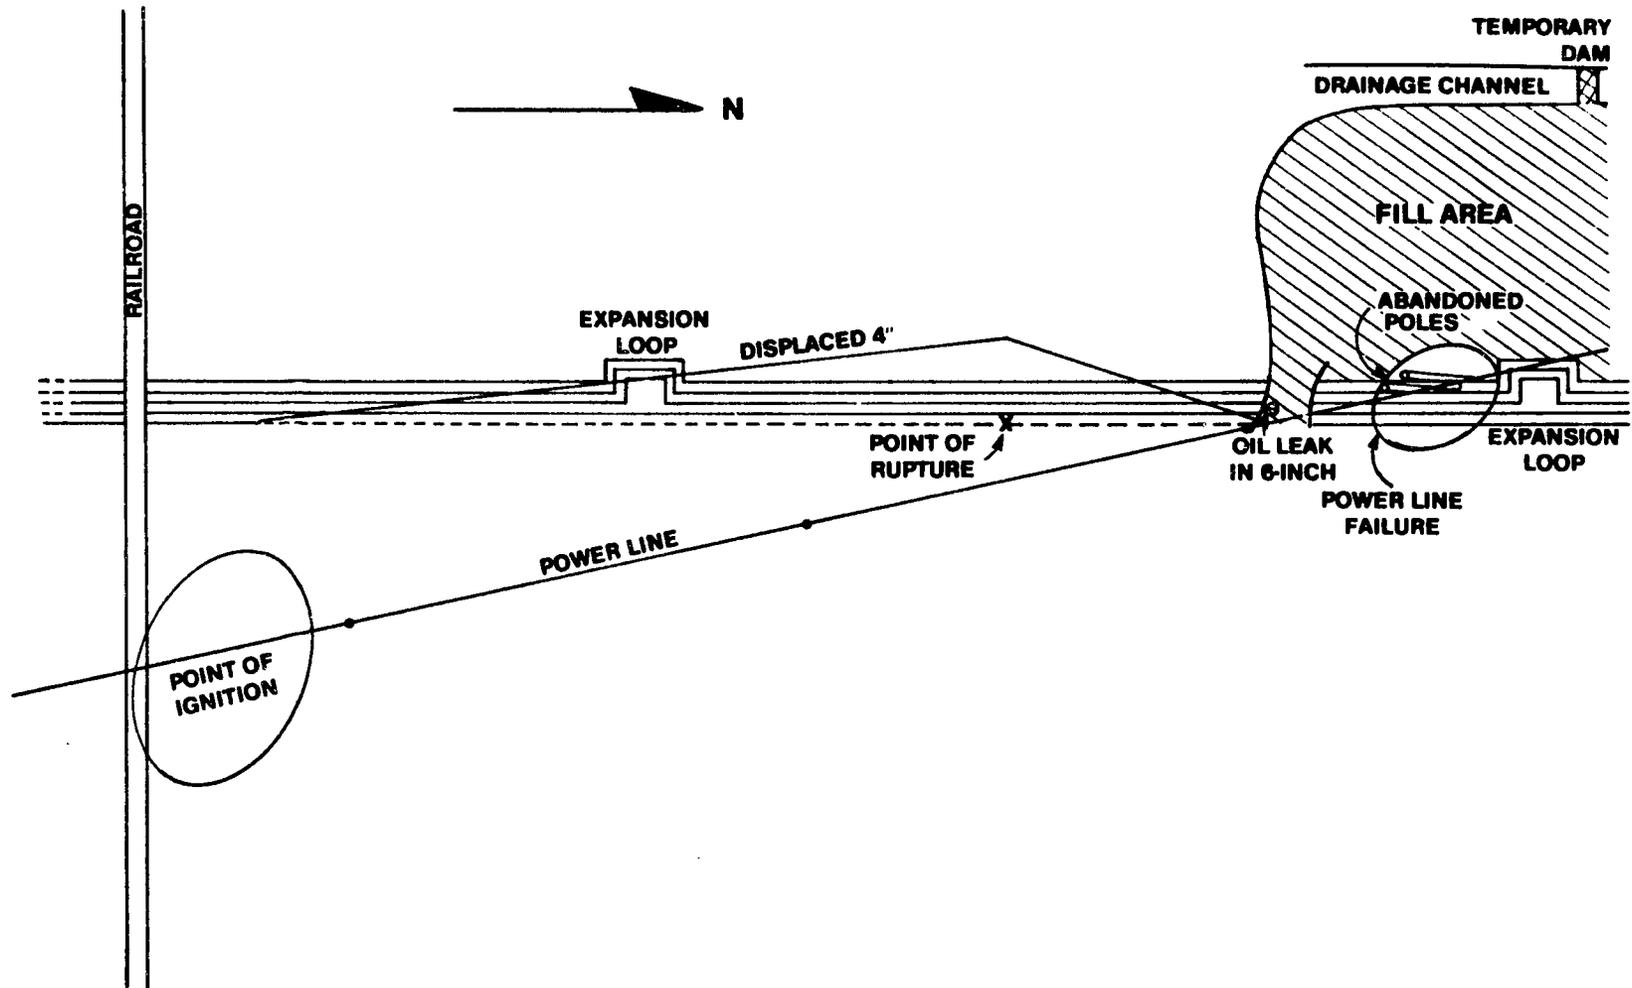
**FIGURE 1. PLAN VIEW OF ACCIDENT SITE
SULPHUR, LOUISIANA**

Upon reaching the oil spill, the fire fed on the oil and intensified in two critical locations: a low spot beneath the five pipelines where they were elevated on a rack 4 feet above the ground level; and a spot about 300 feet further north, where some old utility poles had been left along the pipeline right-of-way, beneath the power lines. Fueled by the burning oil and poles, the fire reached and burned through three of the overhead power lines, causing a power failure at 3:30 p.m.

As a result of the power loss, the spring-loaded actuator on the downstream block valve of the EPC's steel propylene line closed. The spring-loaded actuator was designed to fail closed. The block valve closure stopped the flow of propylene in the 4-inch pipeline, causing pressure to increase and the pipe to heat to a point of rupture. The

sudden release of propylene under an approximate pressure of 400 psig and its explosive ignition by the burning oil exerted intense stress on the pipe. Many of the posts on the pipe support racks loosened. About 650 feet of the 4-inch pipe whipped off the rack, with a maximum lateral displacement of 50 feet from the point of rupture. The 4-inch pipeline was damaged both by fire and displacement stress, and an estimated 400 barrels of propylene were consumed by fire.

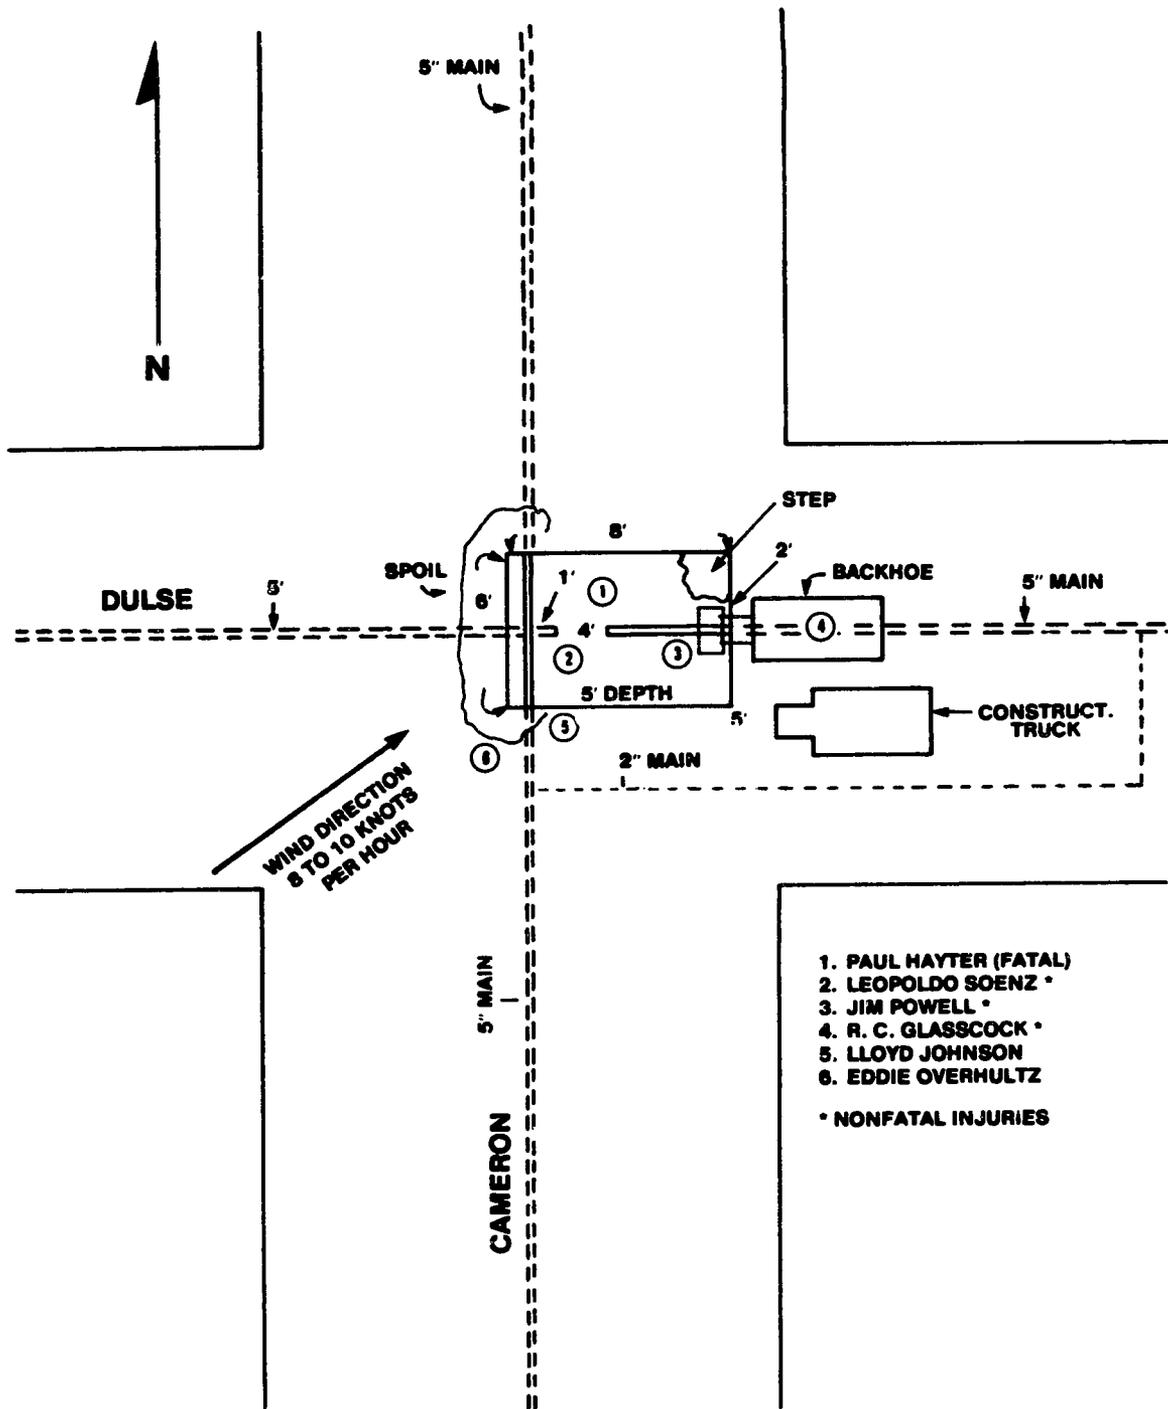
**FIGURE 1. PLAN VIEW OF ACCIDENT SITE
TYLER, TEXAS**

At 10:50 a.m., the foreman started the backhoe begin, in preparation for positioning the bucket. Electrical arcing from the starter ignited natural gas leaking around the slide gate at 7 to 8 psig. The three crewmen in the bellhole and the foreman suffered burn injuries from the resulting fire. One of the crew died later as a result of his injuries.
