# National Transportation Safety Board

## Pipeline Accident Brief

Pipeline Accident Number:	DCA-98-MP-002
Type of System:	Refined products transmission
Accident Type:	Pipe failure and leak
Location:	Morgan Falls Landfill, Sandy Springs, Georgia
Date and Time:	Discovered March 30, 1998; 3:48 p.m.
Owner/Operator:	Colonial Pipeline Company
Fatalities/Injuries:	None
Damage/Clean Up Cost:	\$3.2 million
Material Released:	Gasoline
Pipeline Pressure:	384 psig at site of failure
Component Affected:	40-inch-diameter steel pipe

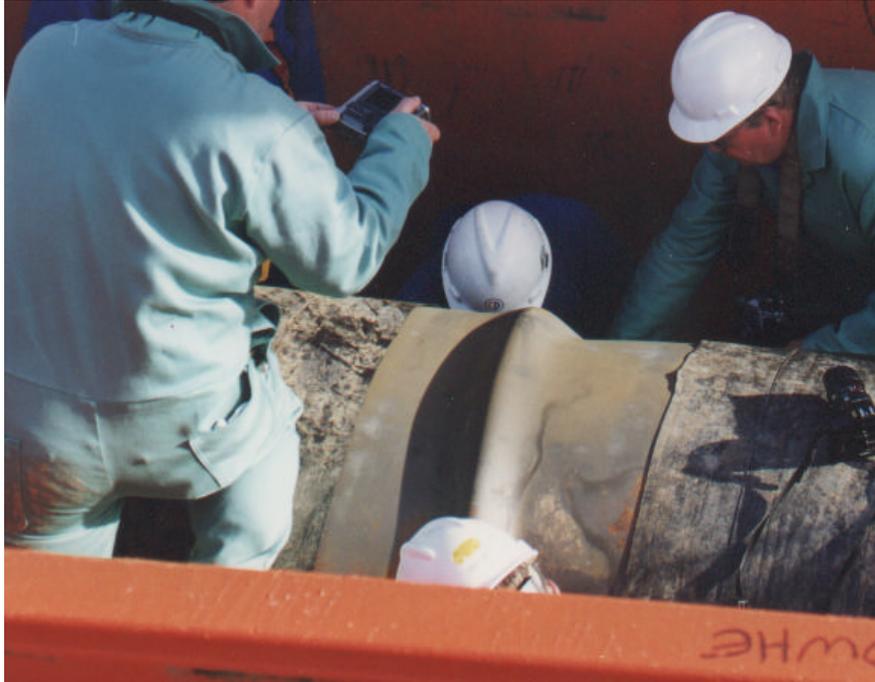
examination. Visual examination of the pipe segment revealed circumferential buckle deformation on the upper side of the pipe. (See figure 1.) The deformed area contained a through-the-wall crack measuring 6 inches on the exterior surface. (See figure 2.) The outside diameter surface of the pipe also showed several diagonal and circumferential cracks. No damage such as dents, gouges, or corrosion was noted on the outside surface of the pipe in the area of these cracks.

Figure 1. Buckle (raised area) in 40-inch-diameter steel pipe

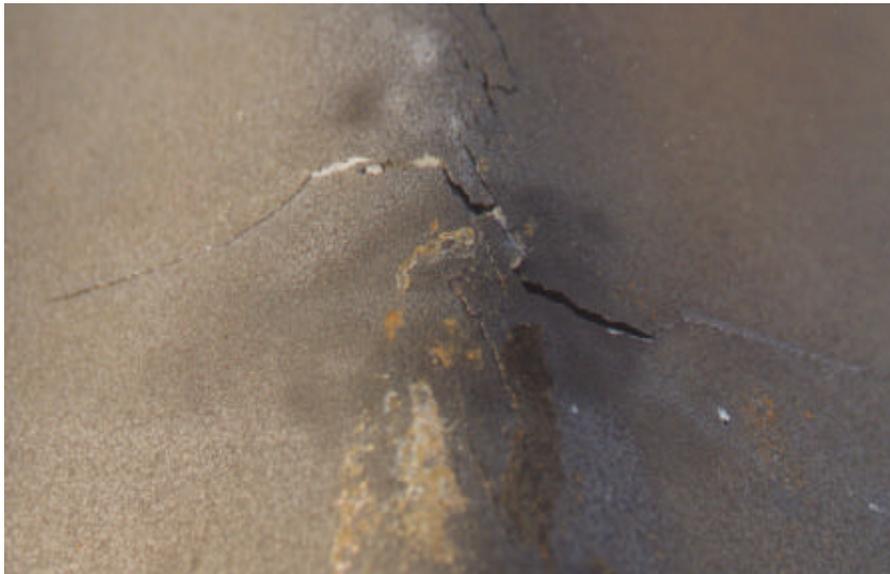
The exposed through-the-wall crack contained a discolored region that measured 1.2 inches circumferentially and extended approximately one half the wall thickness. Crack arrest marks found within this region indicated that the crack had propagated in several phases over time. The remaining through-the-wall crack was more consistent with a rapid failure of the remaining pipe wall. Cracking in the pipe was consistent with stress damage due to soil settlement underneath the pipe.

Figure 2. Close-up view of buckled area showing through-the-wall crack.
