Natural Gas-Fueled Building Explosion and Resulting Fire
New York City, New York
March 12, 2014

Accident Report

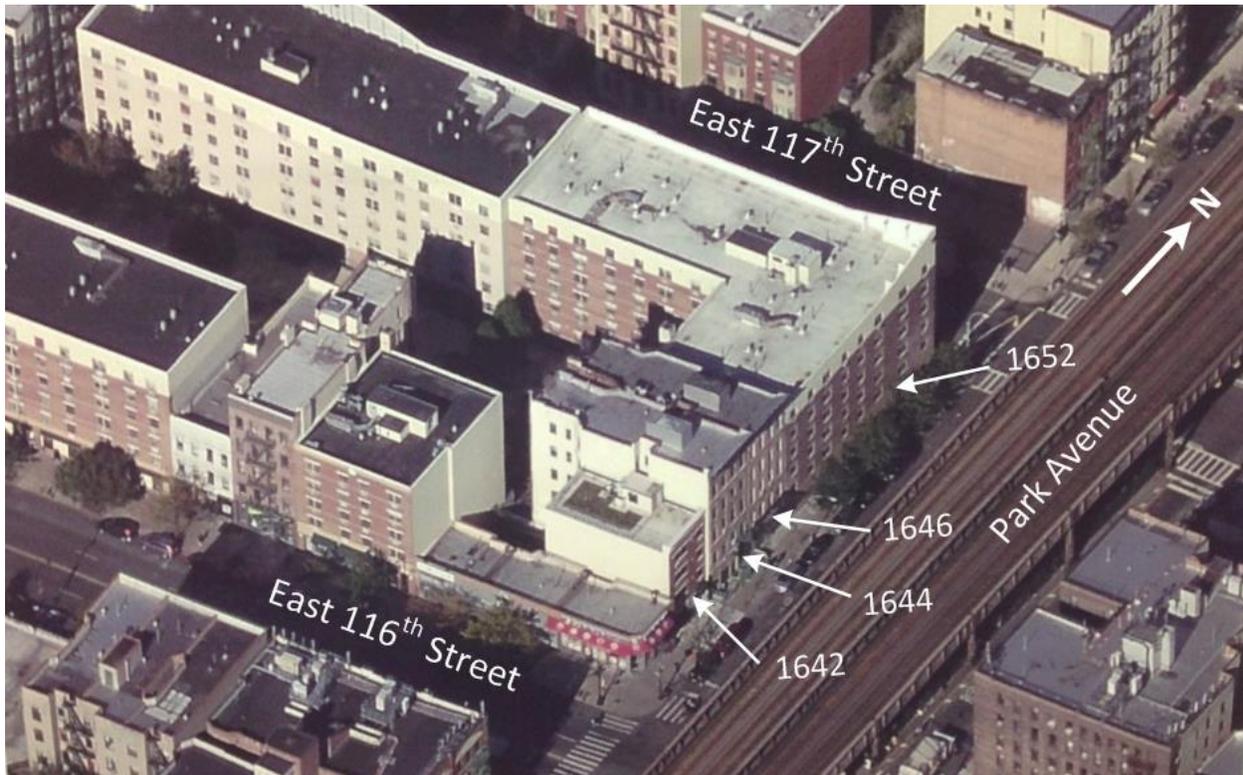
Figure 1. Buildings on west side of Park Avenue between East 116th and East 117th Streets before March 12, 2014, accident.

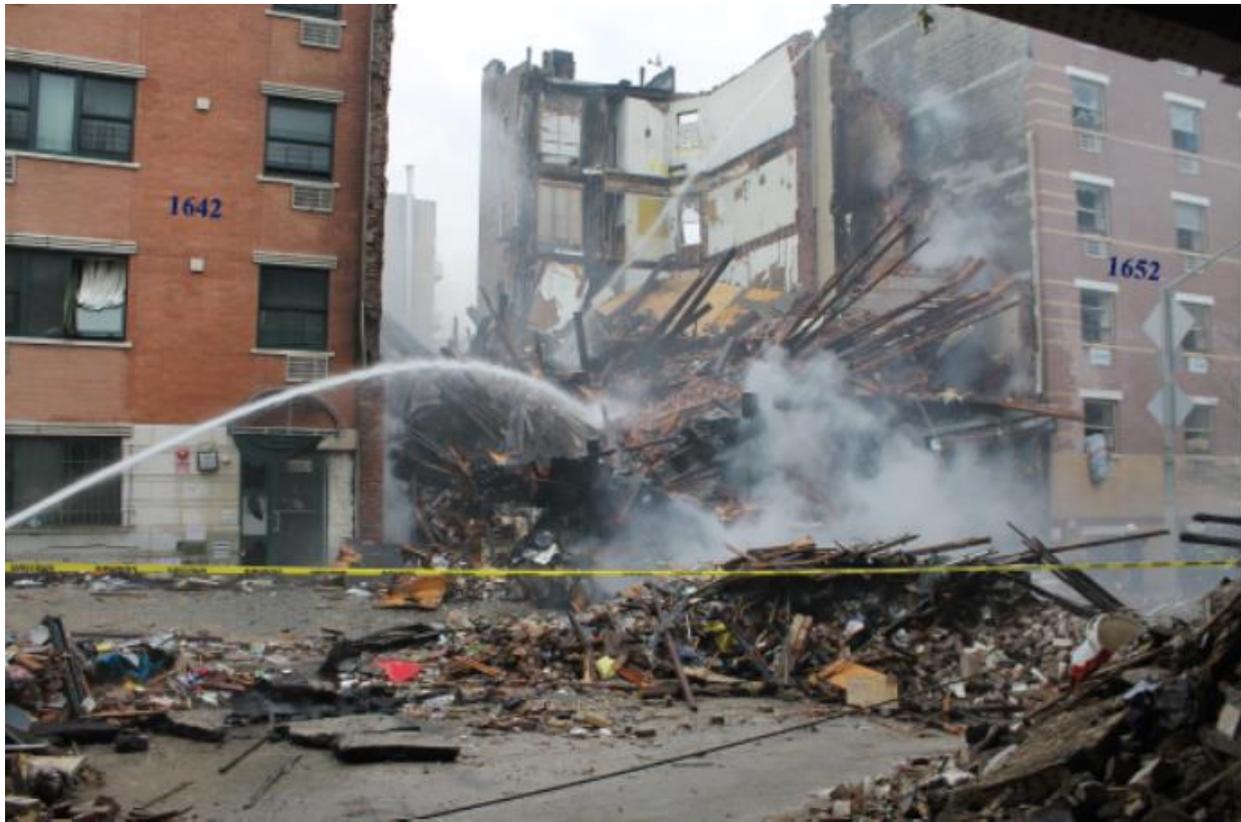
Figure 2. Buildings 1644 and 1646 Park Avenue in New York City after March 12, 2014, explosion.

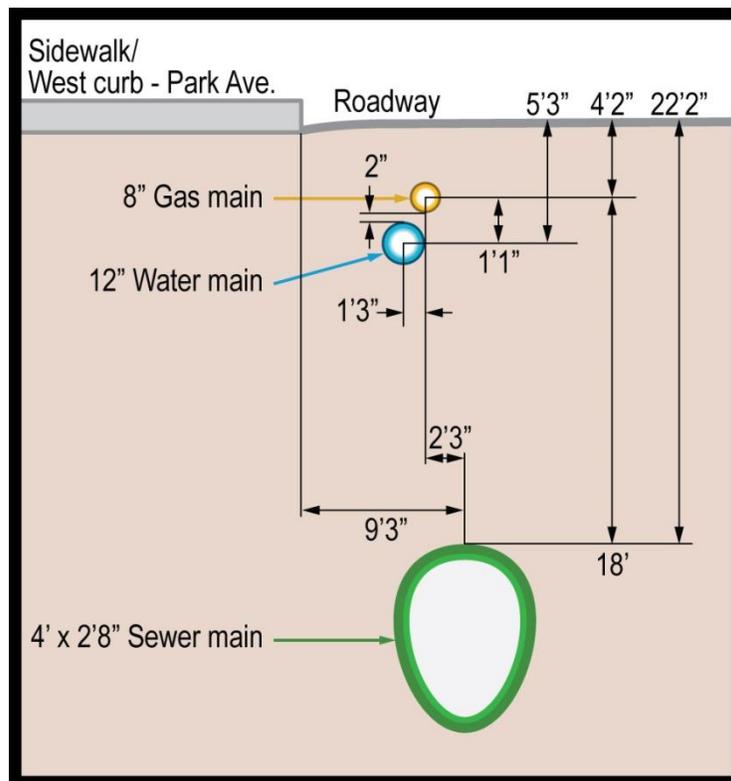
Figure 4. Gas main, water main, and sewer main positions below road at gas service tee location.

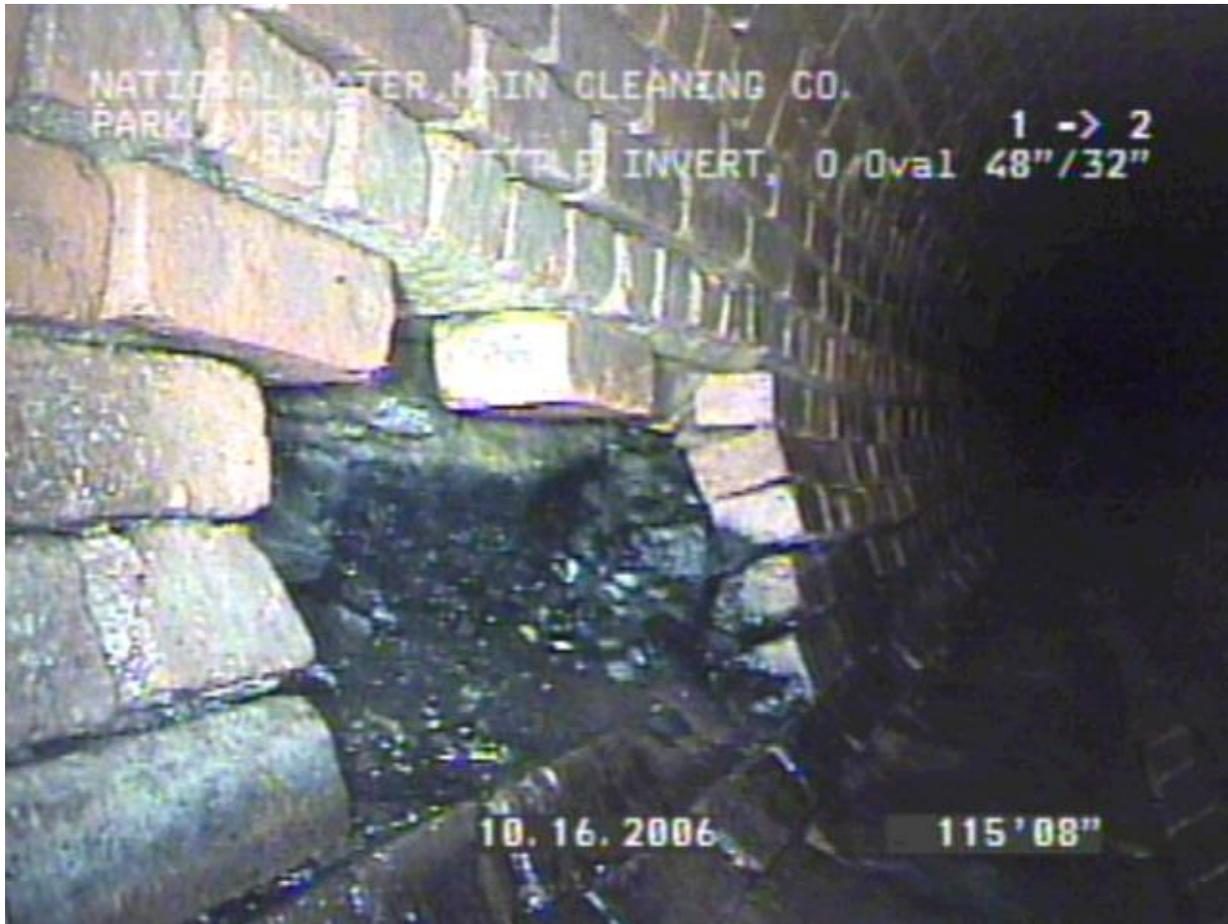
Figure 5. Sewer damage on south-facing video frame from October 2006 inspection.

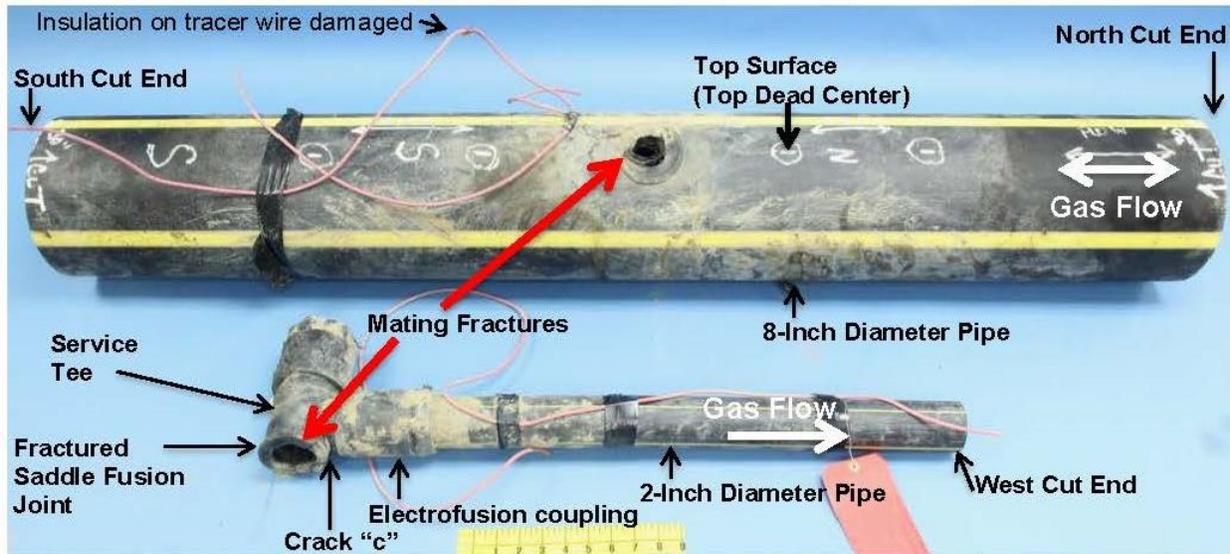
Figure 9. Accident 8-inch-diameter HDPE service main (top) and HDPE service tee at left of 2-inch-diameter HDPE service pipe (bottom).

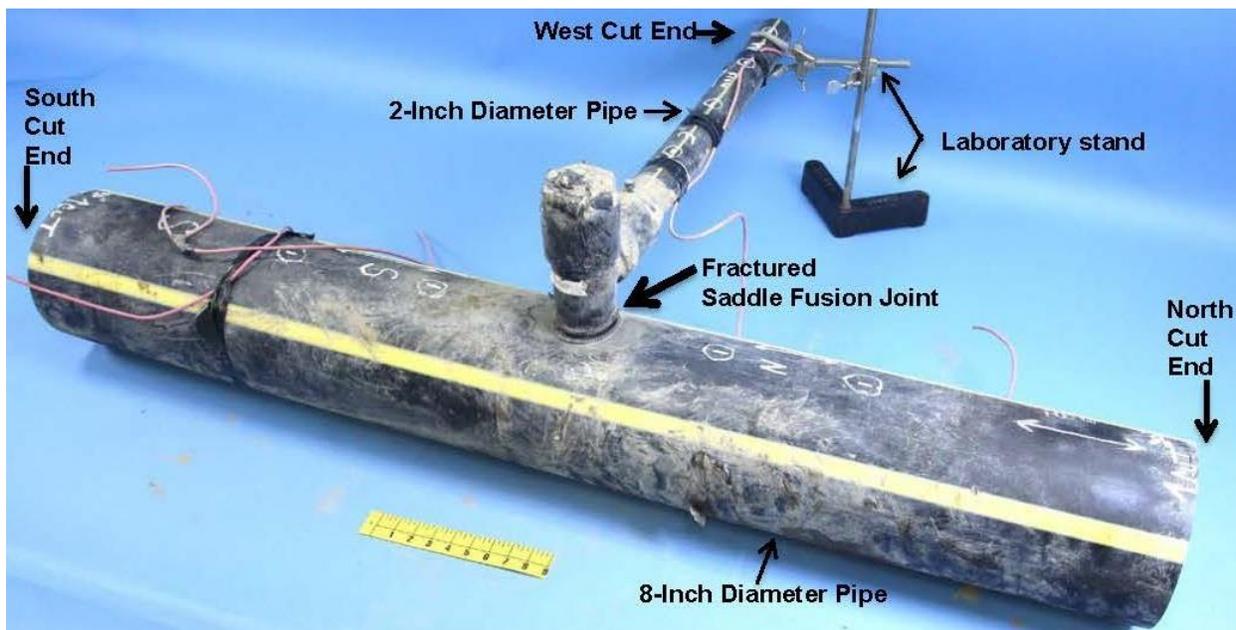
Figure 10. Installed configuration of accident 2-inch-diameter service pipe and 8-inch-diameter main.

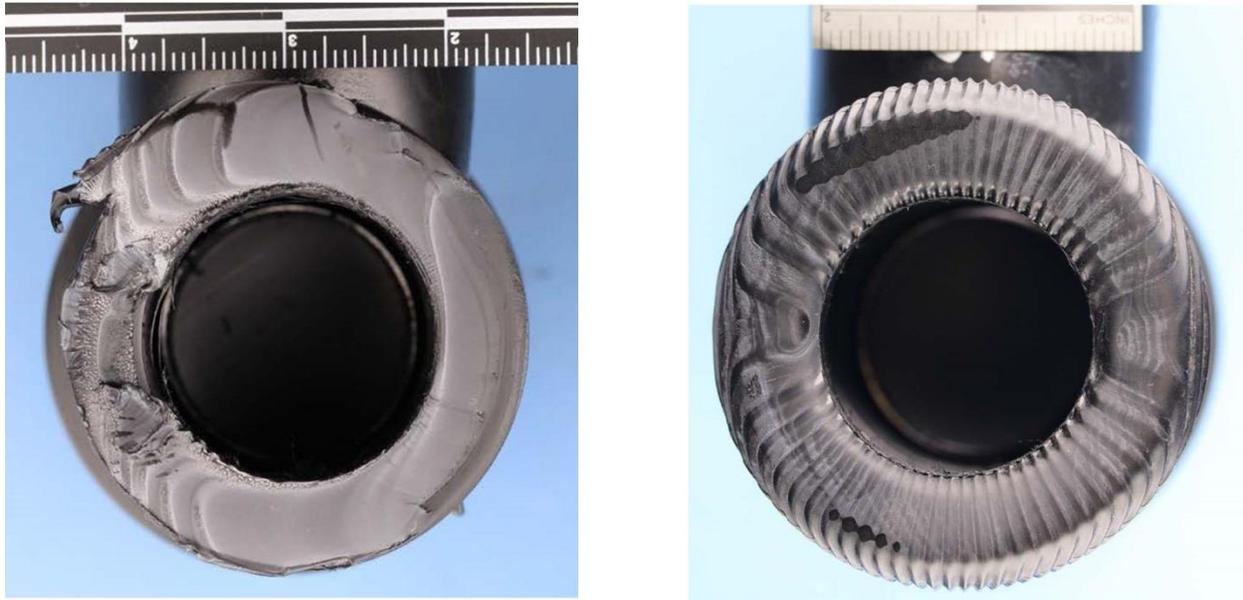
Figure 13. Fracture faces after drop weight tests on exemplar service tee inlet fusion joint from the sound fusion joint (left) and the oil-contaminated fusion joint (right).

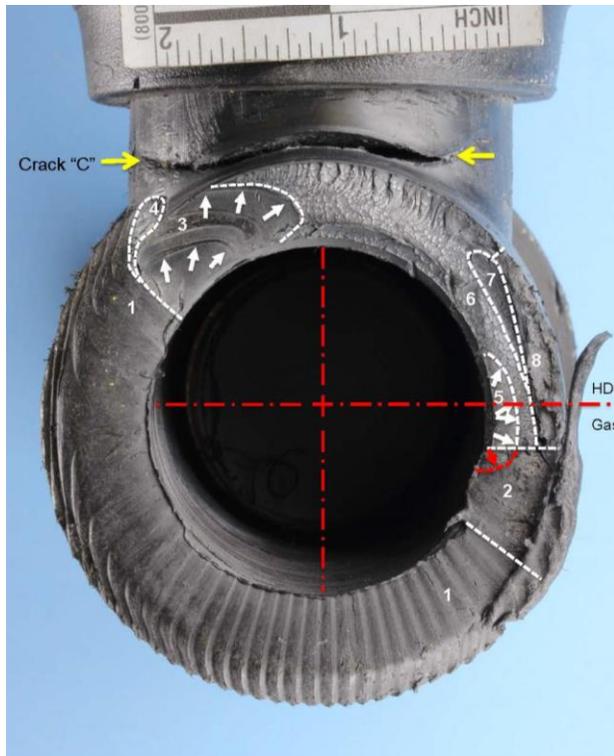
Figure 14. Upper fracture face (saddle end) recovered from accident saddle fusion joint.

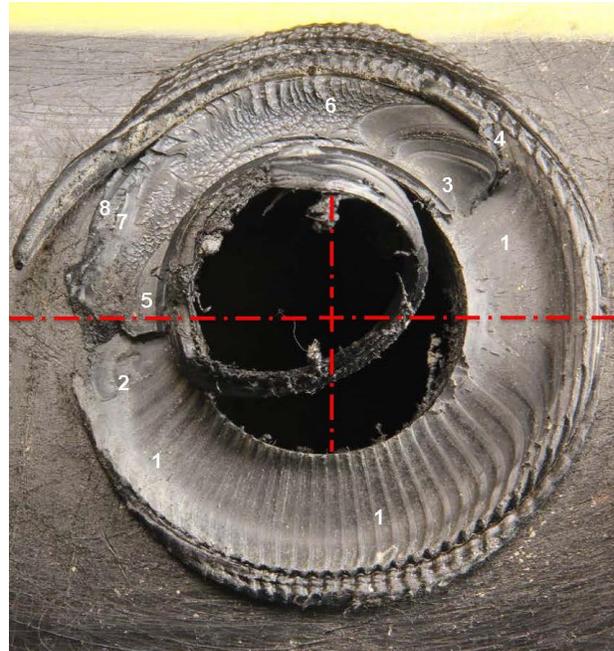
Figure 15. Fusion joint on 8-inch gas main recovered from accident site.

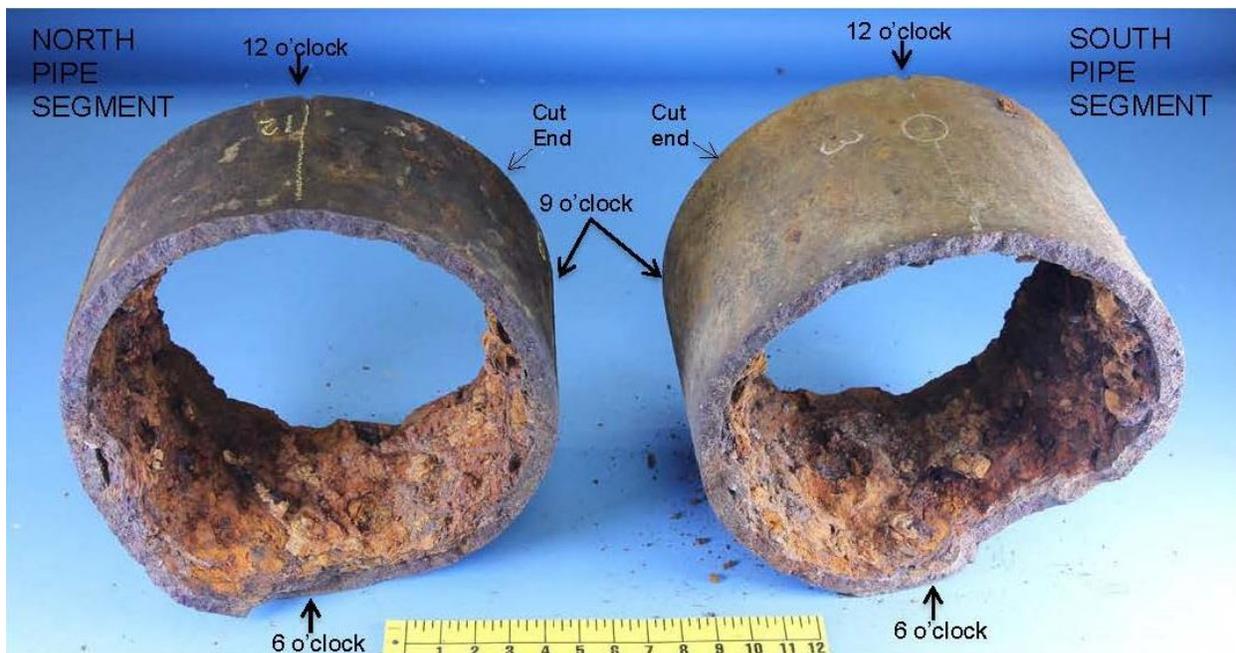
Figure 17. Mating fracture faces of 12-inch cast iron water main.

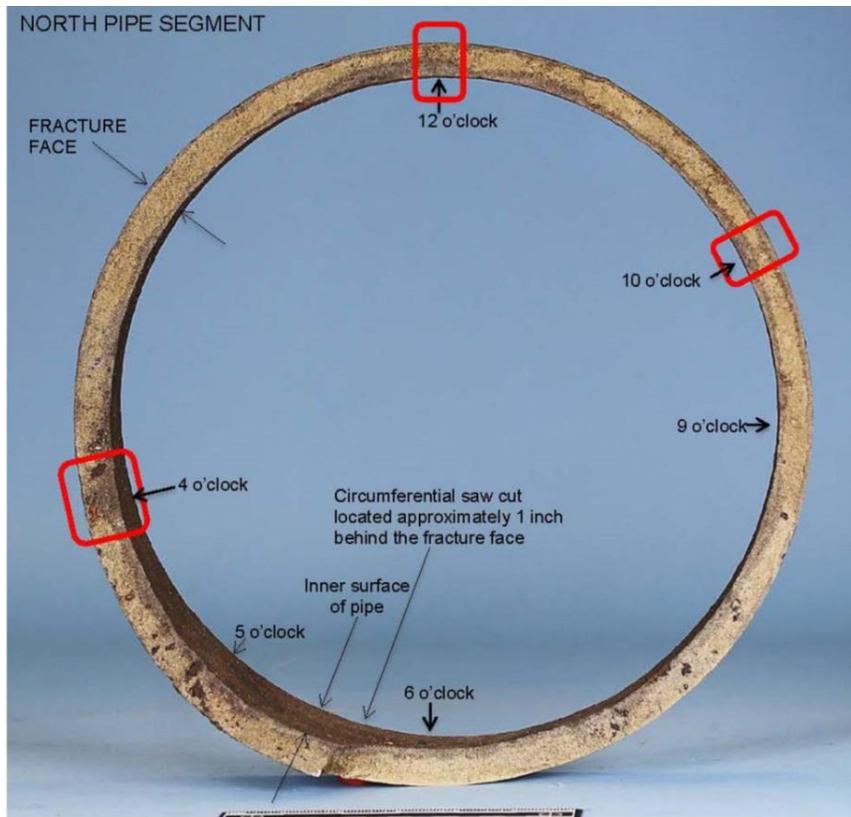
Figure 18. North water main pipe segment fracture face showing regions of graphitic corrosion that appear as dark features adjacent to outer and inner surfaces.

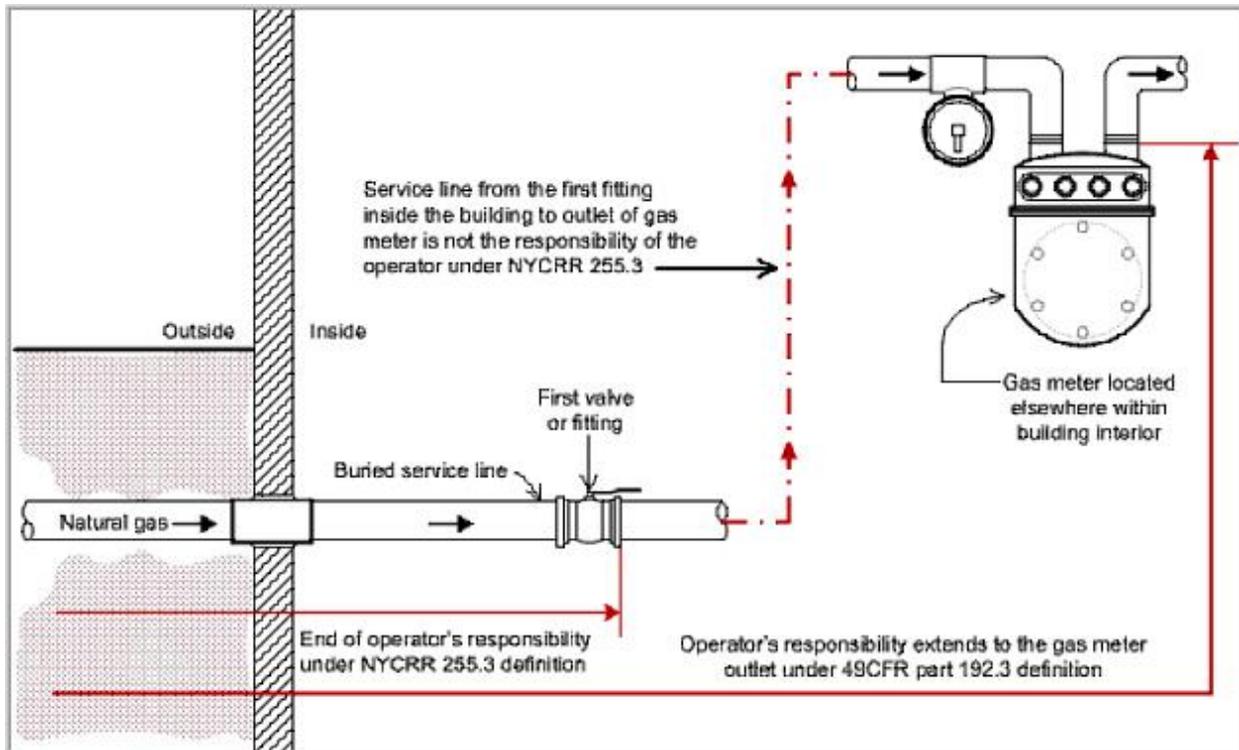
Figure 19. Schematic comparing federal and New York regulatory definitions of service line leading to a gas meter inside a building.

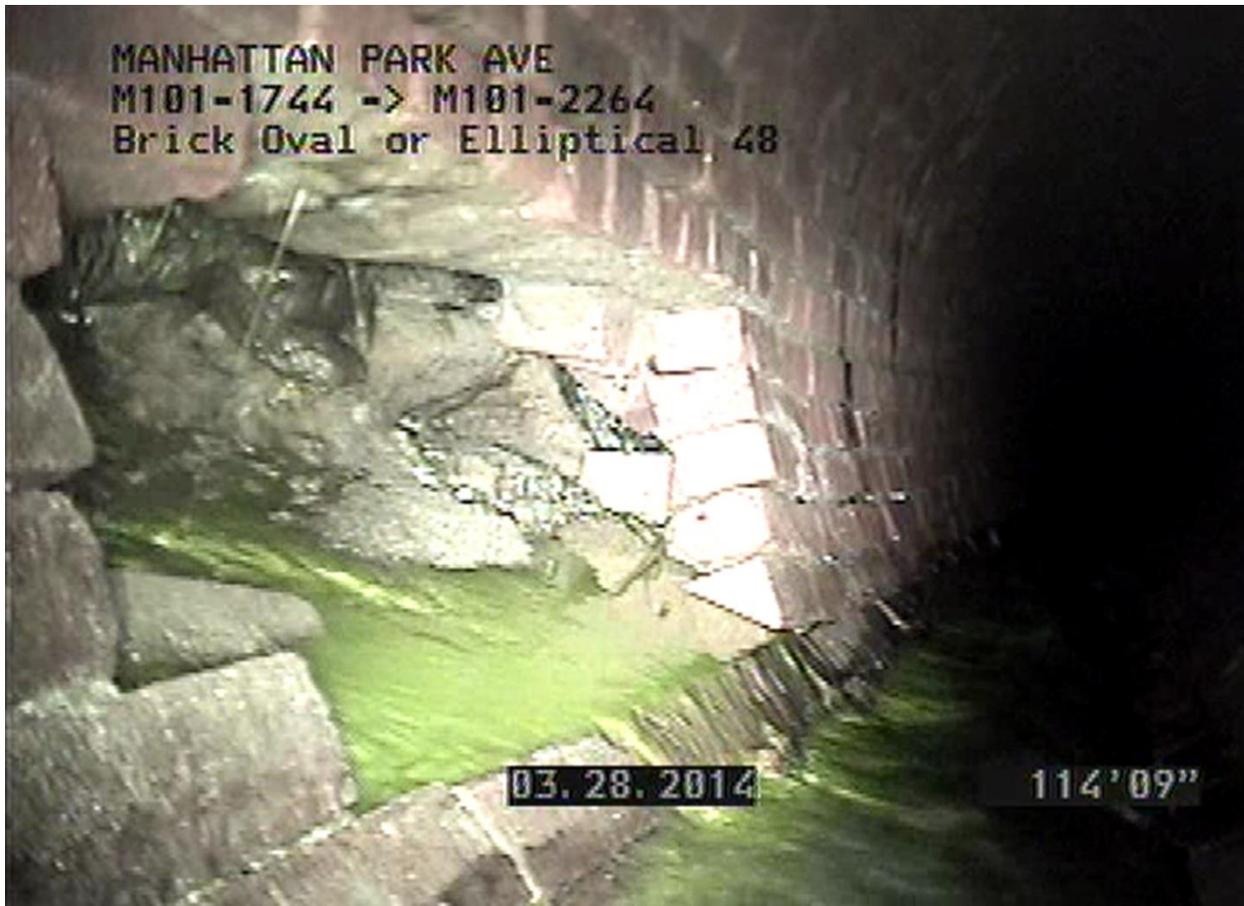
Figure 20. Water containing fluorescent dye flowing into sewer main through damaged area in east side of sewer main as shown in a video frame from March 28, 2014, inspection.

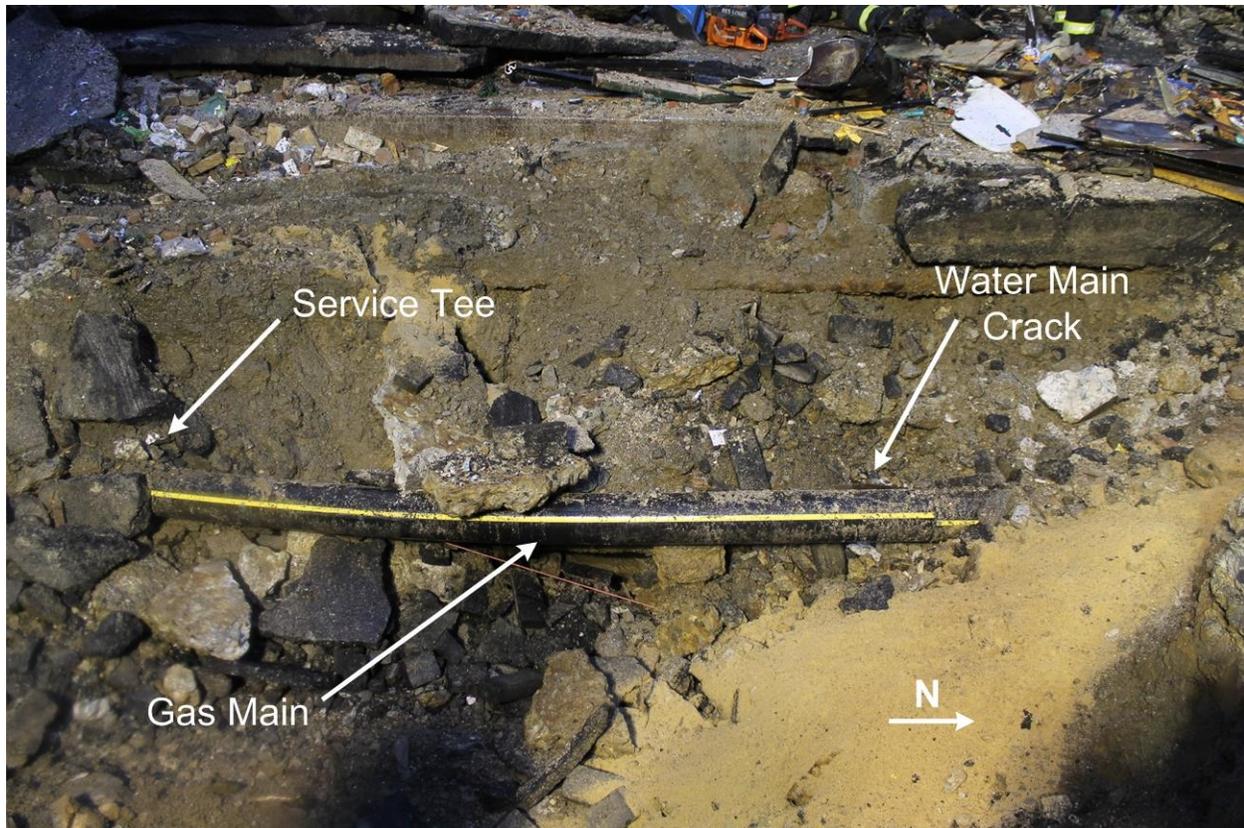
Figure 21. Circumferential crack in exposed 12-inch cast iron water main near 8-inch HDPE gas main.

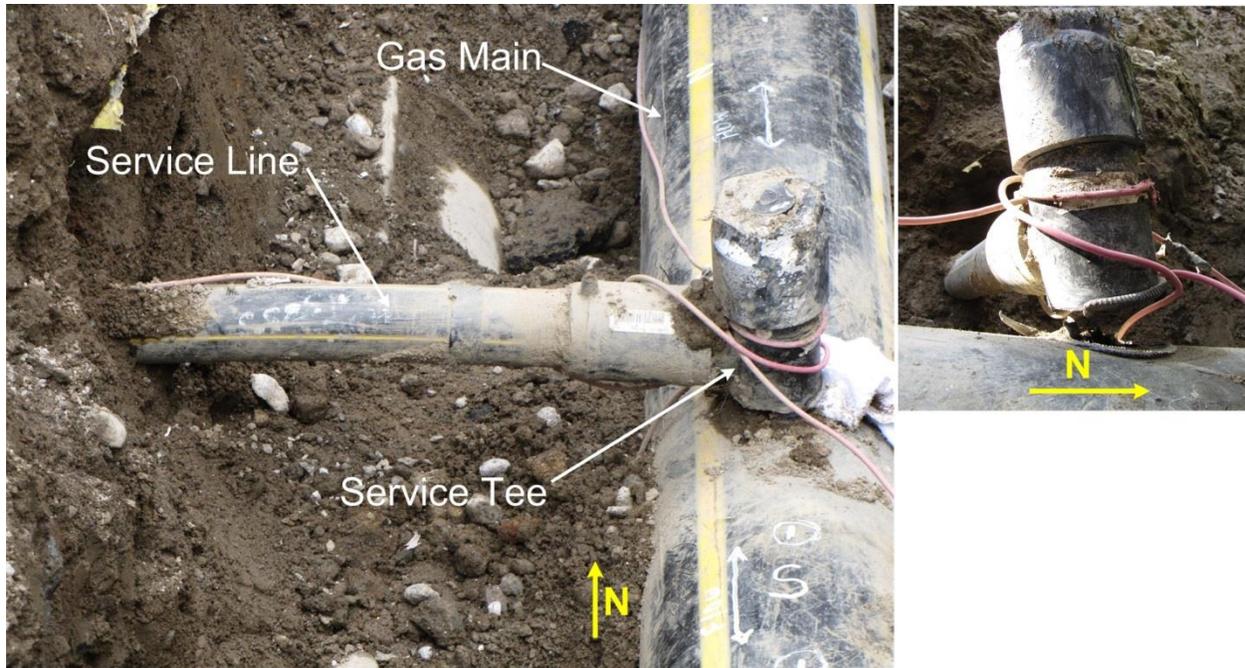
Figure 22. Eight-inch HDPE gas main, detached service tee, and service line in front of Building 1642 with closeup of detached service tee.

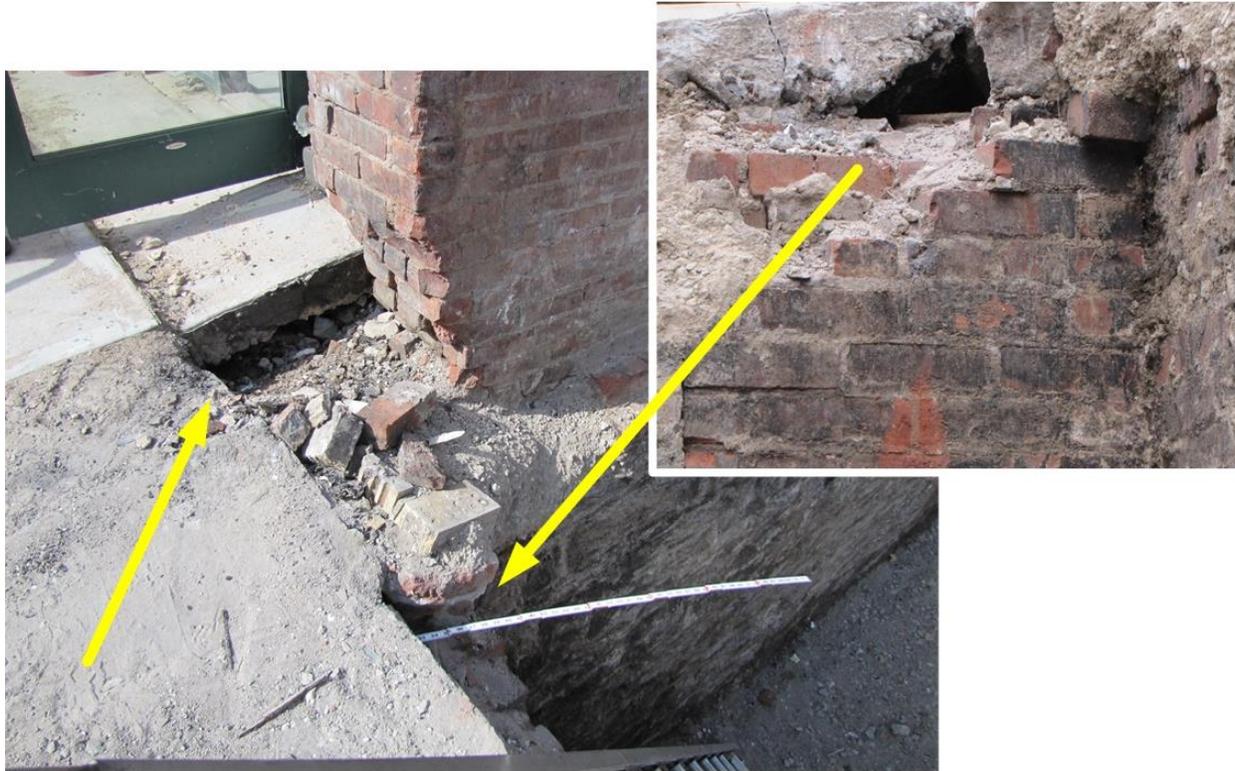
Figure 23. Voids and gaps in ground beneath sidewalk in front of Buildings 1642 and 1644. Inset photo shows void above brick basement foundation at Building 1644.
