PIPELINE ACCIDENT SUMMARY REPORT

PIPELINE RUPTURE, LIQUID BUTANE RELEASE,
AND FIRE
LIVELY, TEXAS
AUGUST 24, 1996

**NTSB/PAR-98/02/SUM
PB98-916503
Notation 7081
Adopted: November 6, 1998**

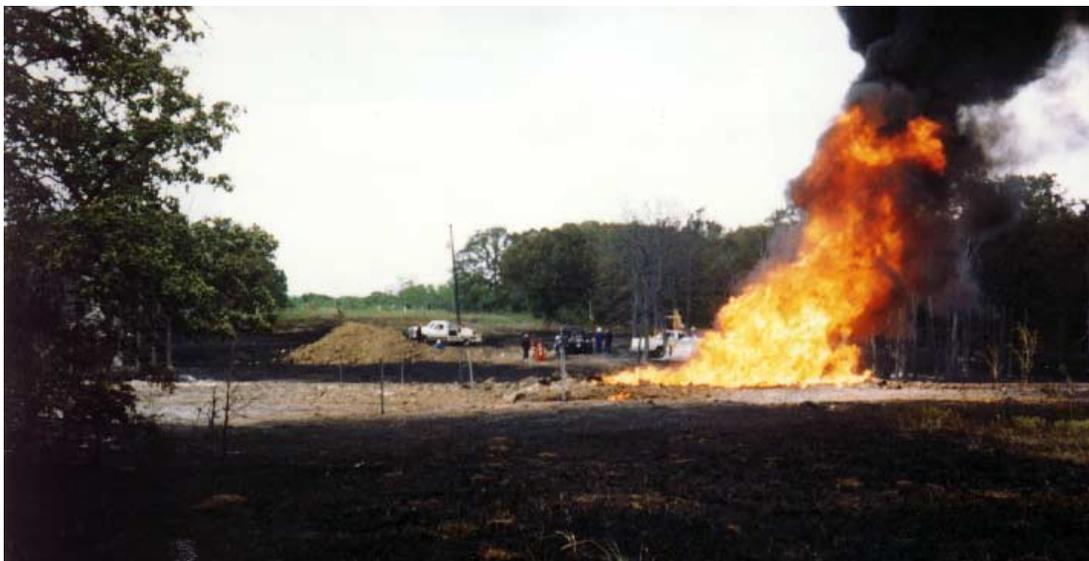
Figure 2. Accident site before the butane fire was extinguished

When the pipe ruptured, it sent a butane vapor cloud into the surrounding residential area. The butane vapor ignited (figure 2) as two residents in a pickup truck drove into the vapor cloud on their way to a neighbor's house to report the release to 911. Therefore, the analysis also examines the effectiveness of Koch's public education program, particularly with respect to educating residents near the pipeline about recognizing hazards and responding appropriately during a pipeline leak.

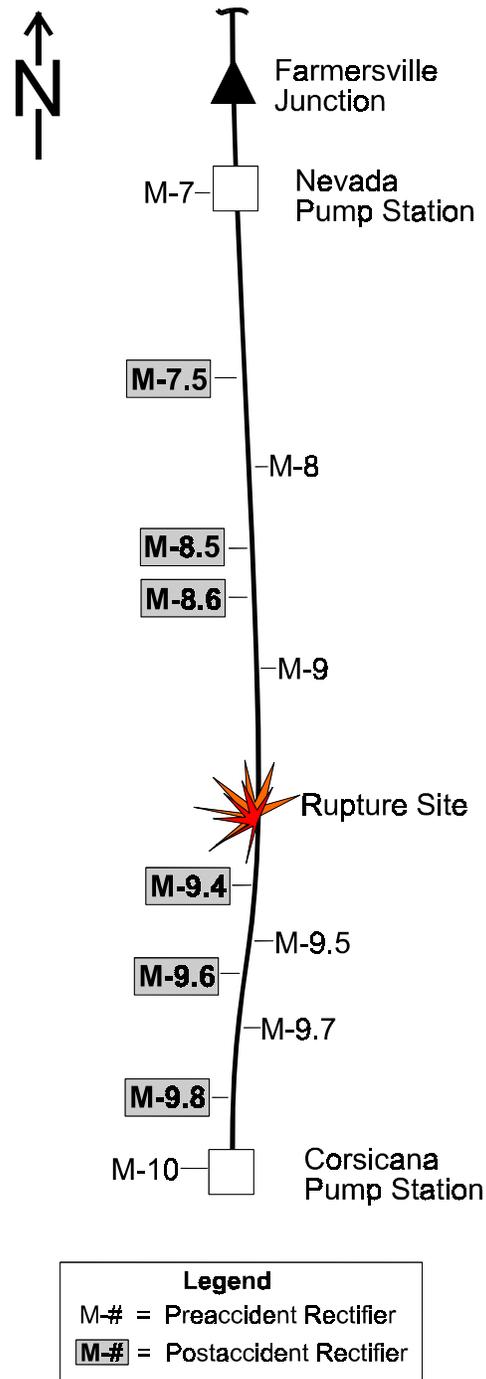
Figure 4. Koch pipeline rectifier sites M-7 through M-10

Before the accident, six rectifiers were used in the pipeline cathodic protection system from Nevada to Corsicana pump stations. In the first quarters of 1994 and 1995, Koch personnel conducted an annual corrosion control survey that indicated the pipeline met the company standard for cathodic protection (pipe-to-soil potentials at least as negative as -0.85 V). During the annual survey in February 1996, potentials below the company's accepted protection level were recorded between rectifiers M-7 and M-10. The pipeline rupture occurred between rectifiers M-9 and M-9.5, which were the existing units on either side of the rupture location. (Figure 4 shows the location of the rectifiers and the rupture.)

On February 6, 1996, during Koch's 1996 annual survey, the output of rectifier M-8 was increased to improve pipe-to-soil potentials. On February 13, 1996, potentials as low as -0.68 V were recorded between rectifiers M-7 and M-8. Additionally, seven of nine readings taken on that date between rectifiers M-8 and M-9 were less negative than -0.85 V. These low potential measurements were in the -0.62 to -0.72 range.

Potential measurements taken between rectifiers M-9 and M-10 on February 13, 1996, were -0.815 V about 1.3 miles north of the rupture location and -0.827 V about 1.5 miles south. In addition to these readings, the lowest potential recorded on that date between rectifiers M-9 and M-10 was -0.78 V.

In a memorandum dated February 19, 1996, the corrosion supervisor recommended that a new rectifier be installed north of the eventual rupture site between M-8 and M-9. The area from rectifiers M-9 to M-10 was reported by the corrosion supervisor as having “good” readings. On February 26, 1996, Koch division personnel authorized installation of a new rectifier, which was initially labeled M-8.5 but was subsequently redesignated M-8.6.

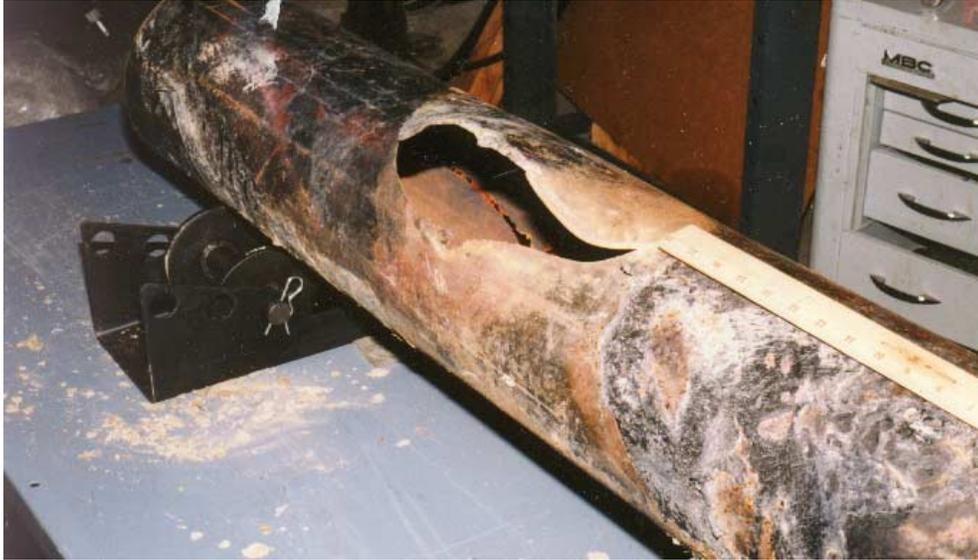
Figure 5. Pipe section containing 12.5-inch rupture

The pipe rupture was longitudinal, approximately 12.5 inches long (figure 5, right to left). The rupture occurred at the 4 o’clock circumferential position relative to the pipe’s position in the ground, with 12 o’clock being the top of the pipe. Significant corrosion was found at the center of the pipe rupture. Most of the tape coating on the ruptured segment was destroyed in the fire, thus the coating condition before the rupture could not be determined.

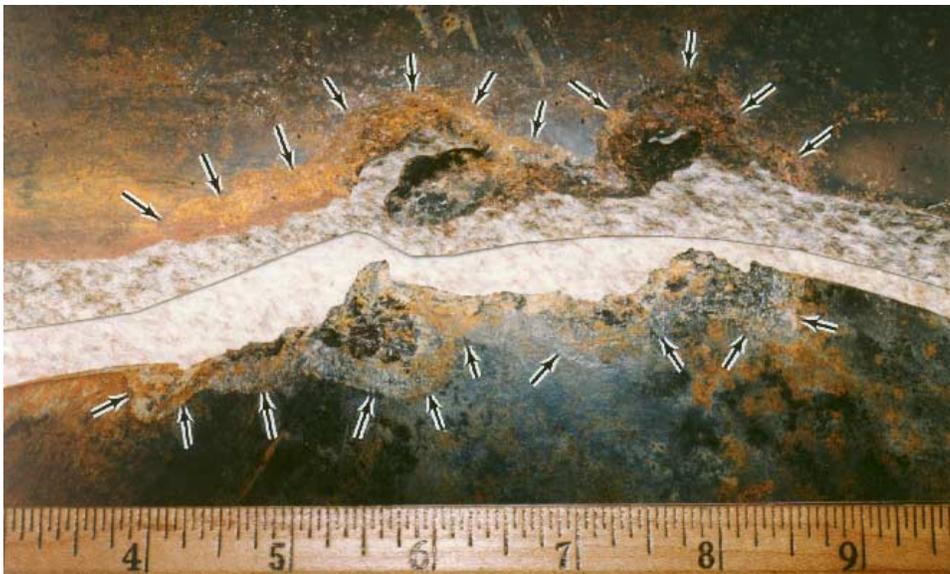
Figure 6. Composite photograph showing corroded area at center of rupture

The center of the rupture contained an area of corrosion about 5 inches long by 3 inches wide. In the rupture area, corrosion pits appeared to have substantially penetrated the pipe wall indicating nearly 100-percent wall-thickness loss. No other pitting was observed on the remainder of the 46-inch section of pipe containing the rupture. No evidence of a material flaw or of mechanical damage (dents, gouges, or scrapes) to the pipe was observed. Figure 6 is a composite of two photographs, one of each side of the rupture, constructed to show the two sides of the corroded area in proximity. The arrows in the photo indicate where corrosion pitting had substantially penetrated the pipe wall.

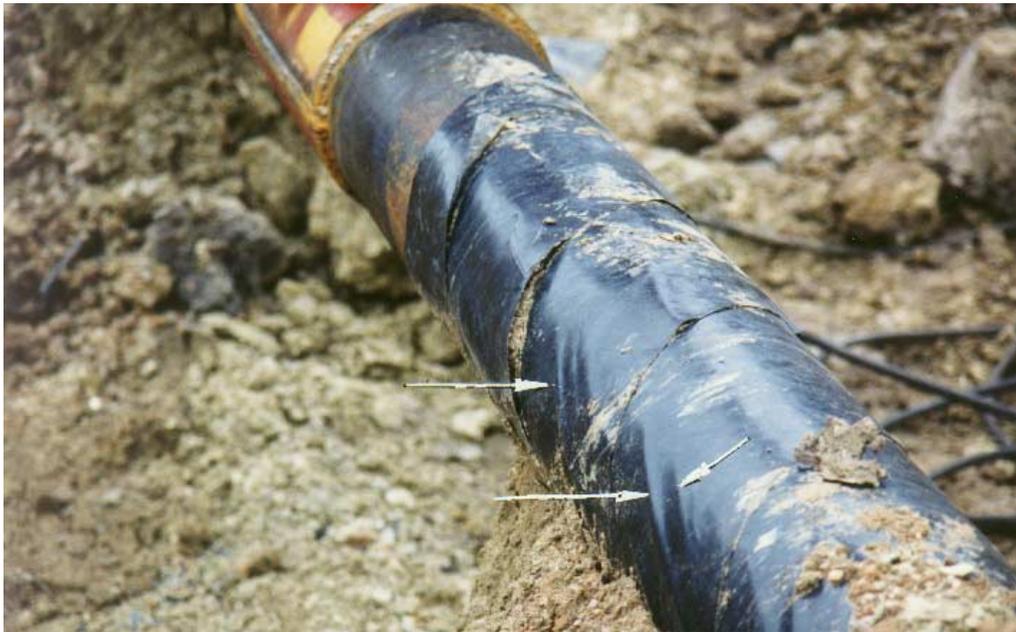
Coating damage as observed in the field is shown in figures 7 and 8. The three pipe sections (both upstream and downstream of the rupture) brought to the Materials Laboratory for testing had disbonded and cracked spiral wrapped tape coating at several locations. Mechanical damage to the tape coating similar to damage caused by a pipe-locating probe was also observed. Scratches were found on the pipe at several of the coating tears. Corrosion was observed on the exposed pipe surfaces at the damaged areas.

Figure 7. Disbonded tape coating on 8-inch pipe extracted at accident site (Arrows show disbonded area under tape coating.)

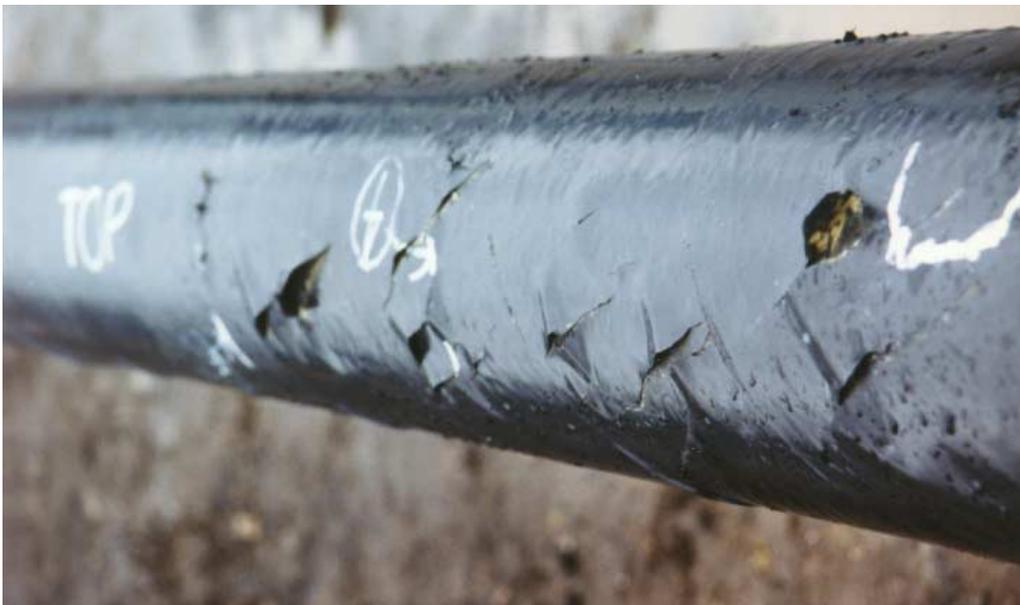
Figure 8. Cracks in the tape coating on 8-inch pipe excavated at accident site
