PRELIMINARY REPORT PIPELINE

Natural Gas-Fueled Explosion of Residence Dallas, Texas

February 23, 2018

PLD18FR002

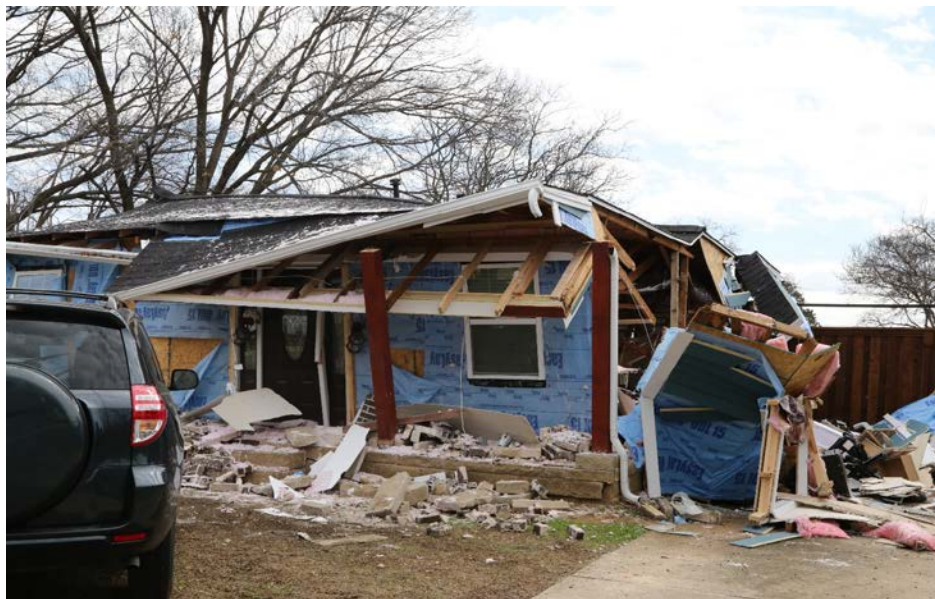
On February 23, 2018, about 6:38 a.m. central standard time, a natural gas-fueled explosion occurred at a newly renovated single-story residence at 3534 Espanola Drive in Dallas, Texas. The Dallas Fire-Rescue Department (DFRD) quickly dispatched units to the scene. The DFRD reported significant structural damage to the house; however, neither smoke nor fire was present.

Figure 1. Post-explosion view of the residence at 3534 Espanola Drive.

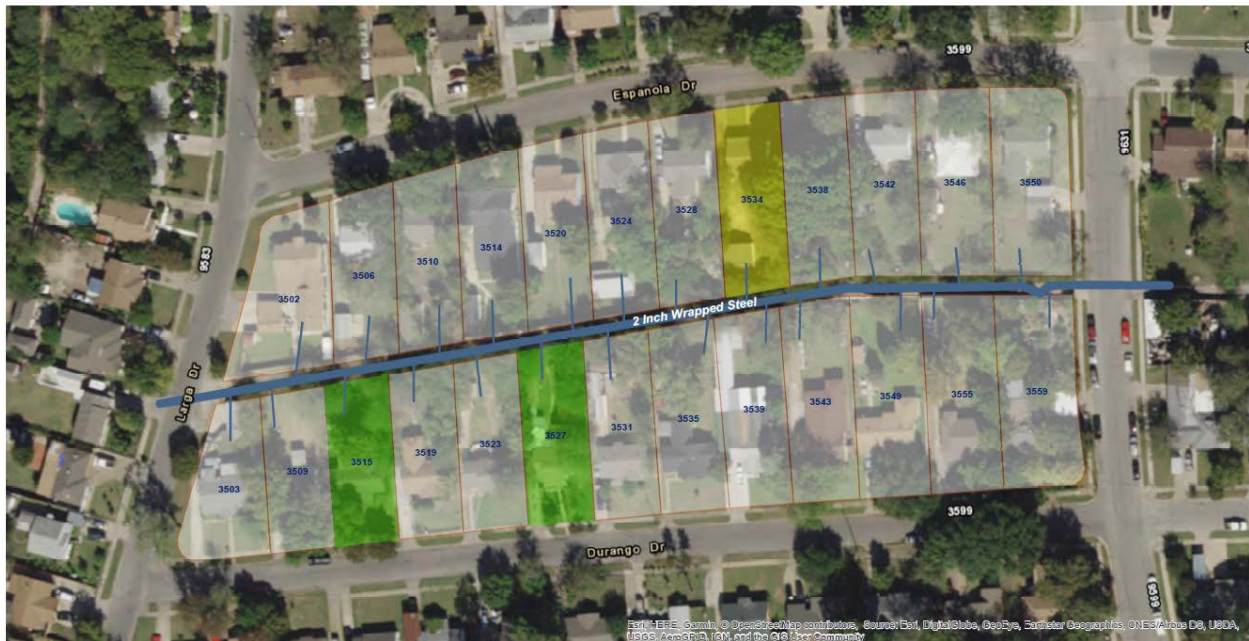
Figure 2. This highlighted grid shows the location of three destroyed residences: yellow indicates the residence destroyed by an explosion on February 23, 2018; green indicates the two residences destroyed by fire on February 21-22, 2018. (Photo provided by Atmos Energy.)

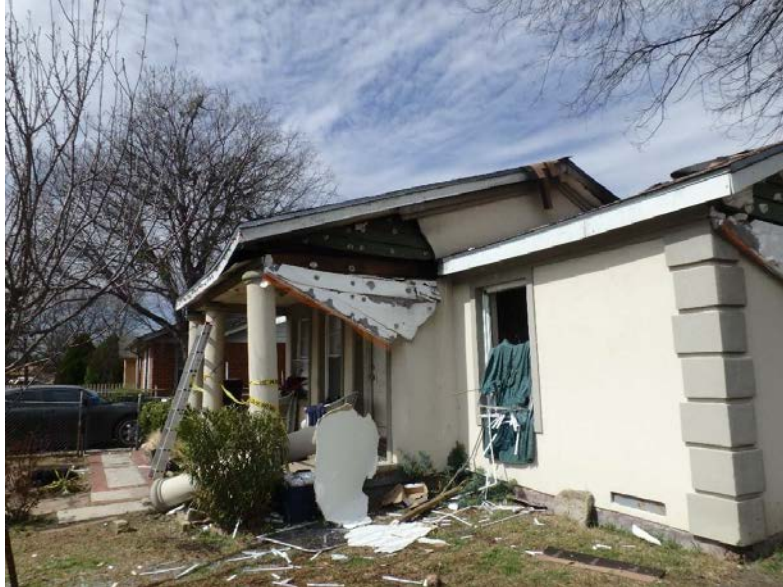
On February 21, 2018, about 5:49 a.m., an explosion and subsequent fire occurred at 3527 Durango Drive. (This site is about 415 feet from the Espanola Drive house explosion.) The resident told arson investigators from the DFRD that about 2:00 a.m. he awoke to a “popping” noise from his heating, ventilation, and air conditioning (HVAC) unit. When he went to the attic, he saw the cover plate for his HVAC unit was on the floor; the loose cover plate was not mounted on the unit as usual. He also noticed that the pilot light on the HVAC unit was not working. When he placed the cover plate on his HVAC unit, an explosion occurred. He was thrown several feet; he received second degree burns. Figure 3 shows the post-explosion view of the residence at 3527 Durango Drive.

Figure 3. Post-explosion view of the residence at 3527 Durango Drive.

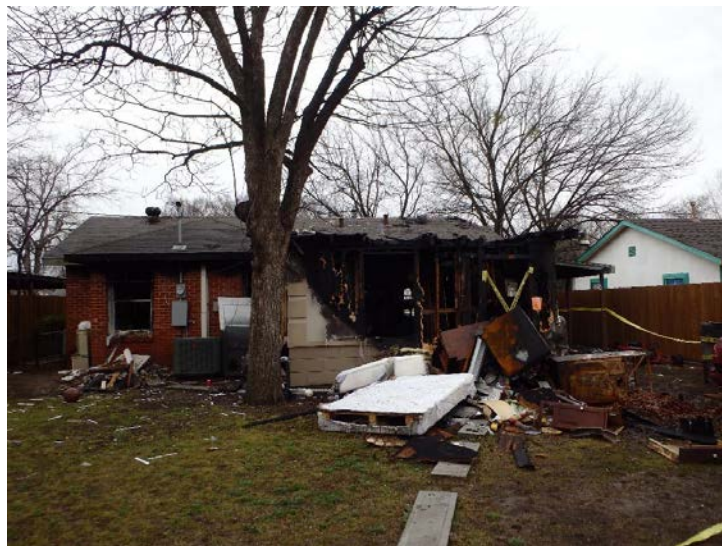
On February 22, 2018, about 10:21 a.m., a structural fire occurred at 3515 Durango Drive. (This location is less than 310 feet from the Espanola Drive house explosion.) The resident told DFRD arson investigators that while he was boiling water on the stove in his kitchen, the flames from the stove were “red and out of control.” The resident had second degree burns to his right arm and right leg. As the fire moved from the stove to the attic, it caused significant fire and smoke damage. As a result, the residence was a total loss. Figure 4 shows a post-fire view of the residence.

Figure 4. Post-fire view of the residence at 3515 Durango Drive.

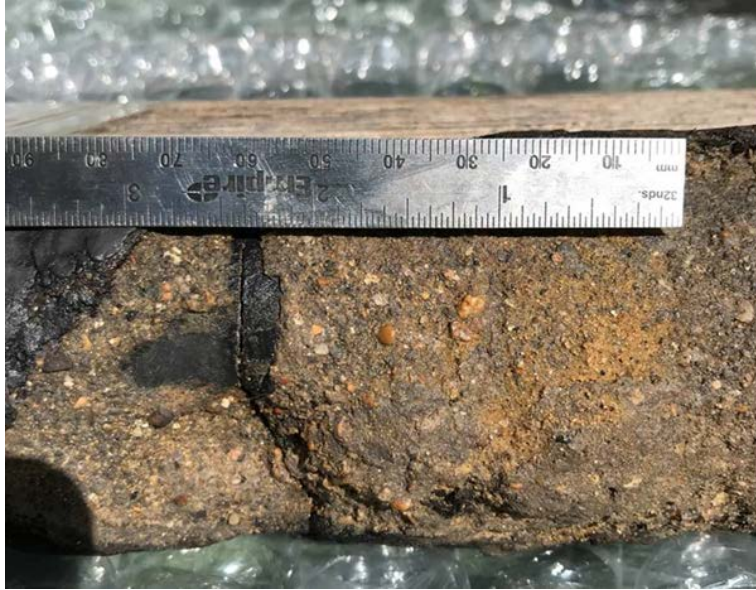
While on scene, the NTSB investigators identified three sections of the pipe that failed a pressure test. One section was behind the residence at 3534 Espanola Drive; it had a circumferential crack. Sections of the pipe that failed the pressure test were shipped to the NTSB metallurgical laboratory in Washington, DC. Figure 5 shows the circumferential crack on the pipeline.

Figure 5. Circumferential crack in steel 2-inch-diameter pipeline.
