PRELIMINARY REPORT

PG&E Third-Party Natural Gas Line Strike and Fire

San Francisco, California
February 6, 2019
PLD19MR001

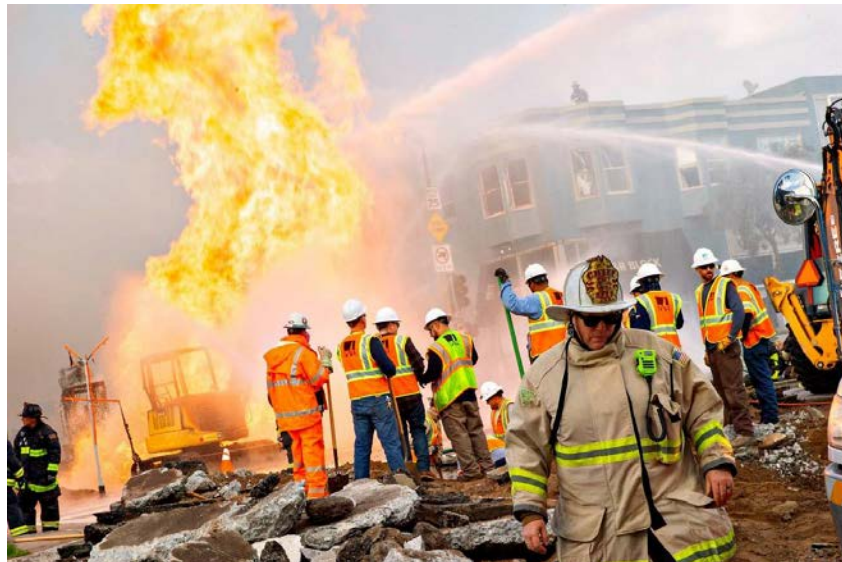
Figure 1. Emergency responders at the accident location. (Photograph by Santiago Mejia, *The Chronicle*.)

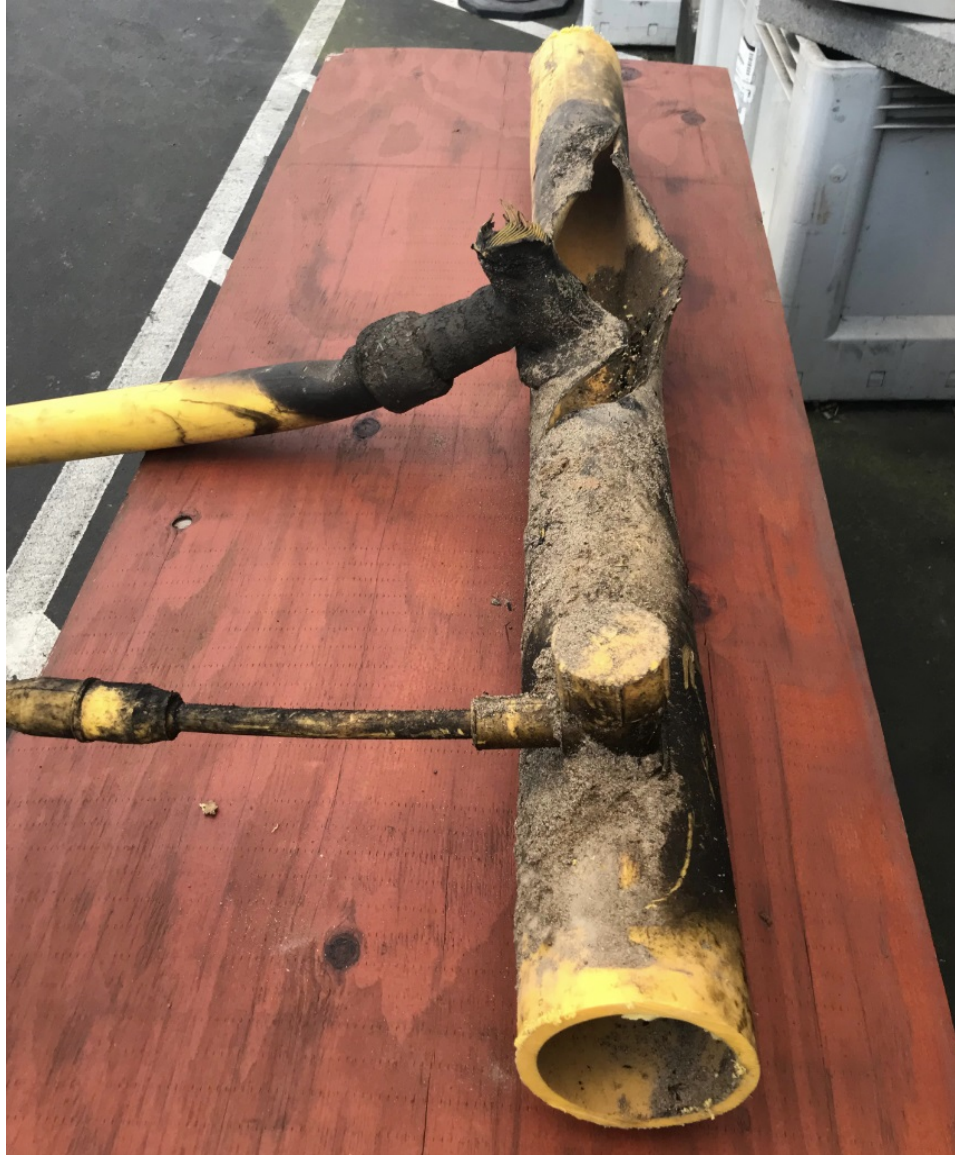
The 2-inch section of pipe removed at the site was deformed consistent with an impact from an outside force. Furthermore, the screwed cap on the 2-inch branch was torn from the assembly in a manner consistent with outside force impact as can be seen in figure 2.

Figure 2. Postaccident damaged pipe. (Photograph courtesy of PG&E)

After the gas-fueled fire was extinguished, SFFD began work to contain and control the building fires started by the initial fire. PG&E replaced the damaged portion of pipeline with like

materials and began work to purge and restart the line. By 10:00 p.m. the following day, all services were either relit, or one attempt to relight had been made.³
