National Transportation Safety Board
Washington, D.C. 20594

Railroad Accident Brief

Accident No.:	DCA-02-FR-014
Location:	Jamaica, New York
Date of Accident:	September 27, 2002
Time:	12:25 p.m. eastern daylight time
Light Rail Transit:	AirTrain-JFK (Port Authority of New York and New Jersey) (Bombardier Total Transit Systems)
Fatalities:	1
Injuries:	None
Property Damage:	\$7.65 million
Type of Accident:	Derailment

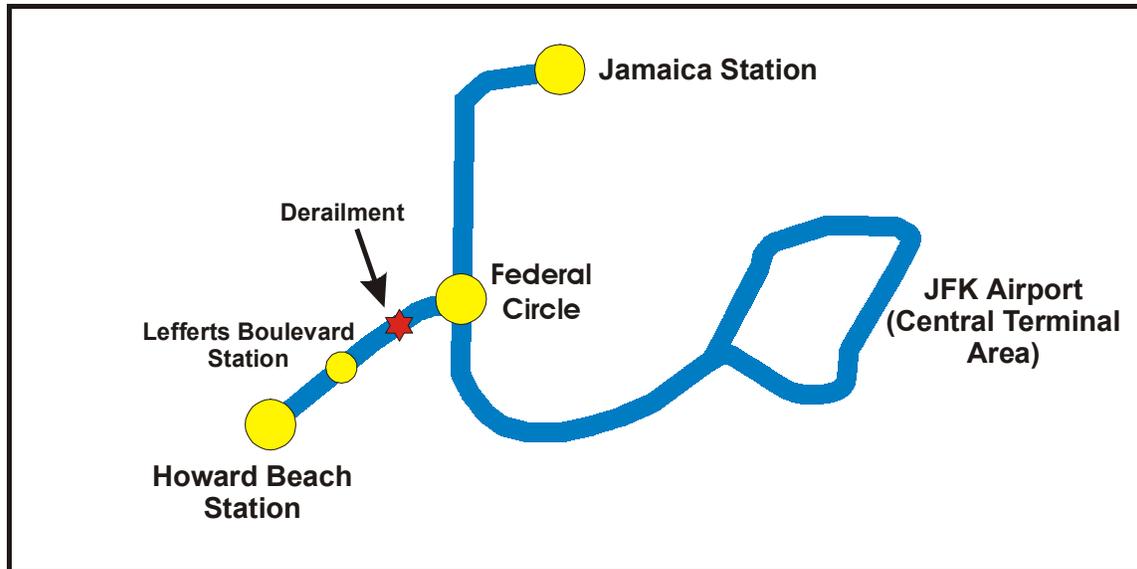
The AirTrain-JFK system. For the September 27, 2002, test, train No. 202 departed the Howard Beach station at the same time train No. 121 departed Lefferts Boulevard station, both inbound toward Federal Circle.
