National Transportation Safety Board

Railroad Accident Brief

Railroad Accident Number:	DCA-03-FR-004
Location:	San Juan Capistrano, California
Date and Time:	April 1, 2003, 1:38 p.m. (Pacific standard time)
Accident Type:	Train striking maintenance-of-way workers
Companies:	Herzog Contracting Corporation National Railroad Passenger Corporation Southern California Regional Rail Authority
Train:	Amtrak train 774
Injuries:	None
Fatalities:	2

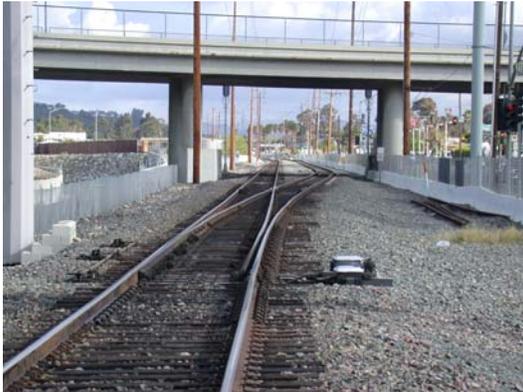
As they walked east, the employee-in-charge and two workers were walking clear of the tracks. Another of the workers was walking between the rails, and another was walking on the tie ends about even with the switch machine motor. All four workers and the employee-in-charge had their backs to the direction from which eastbound Amtrak train 774 was approaching.

the tracks said that he heard the train whistle just before train 774 struck and fatally injured the workers walking between the rails and on the tie ends.

Figure 1: Accident location looking west.

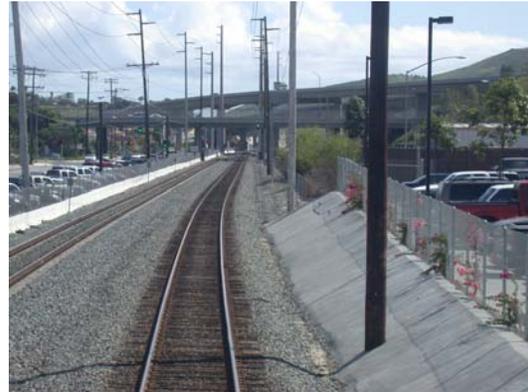
Figure 2: CP Avery viewed from eastbound train.

Sight distance observations indicated that an approaching eastbound train first became visible when it was about 2,415 feet west of CP Avery. At a track speed of 90 mph, the employee in charge had about 3 seconds to detect a train, sound a warning signal, and clear personnel from the track to meet the specified clearance time of 15 seconds before train arrival.
